**2015 SWCA Environmental Consultants Evaluation**

**RE: Integrity Assessment of 180 South Euclid Avenue, Pasadena, Los Angeles County, California**

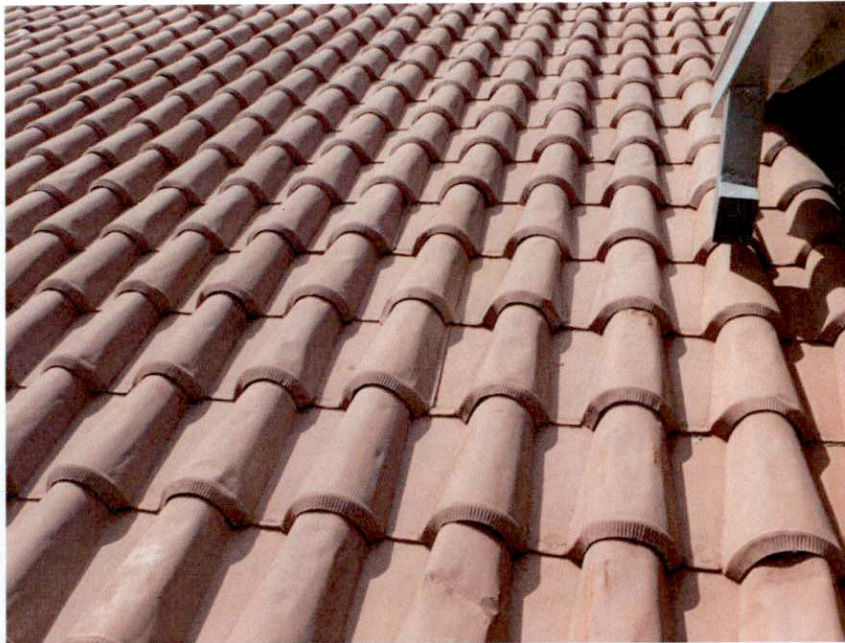
Visual inspection and archival photographs indicate there have been major changes to the exterior and interior of the building since its construction in 1906. During 1940, the original clay tile roof was removed and replaced with a composition roof. It was then replaced and altered with painted sheet metal curved pieces to imitate a red clay tile roof (Figure 1). The existing parapet copings have been altered and are constructed of sheet metal imitating Mission Revival stucco; and the exterior walls have been altered by the resurfacing with rough texture stucco (Figures 2 through 4).

**Figure 1.** Looking east at the sheet metal roofing imitating a red clay tile roof, primary west elevation.

- **Materials** – This building has undergone multiple alterations of materials that include the replacement of the building's original red clay tile roof with replacement sheet metal imitation tiles fabricated to look like clay tiles. All of the original Mission Revival style parapet coping elements have been removed and covered with sheet metal material imitating the stucco character-defining feature. While the building would have been clad with smooth texture stucco, it has been altered and resurfaced with rough texture stucco. Furthermore, the front porch, steps, and yard have been covered with modern Mexican tile porch pavers. Due to the alterations listed above, this property has lost integrity under the aspect of materials.

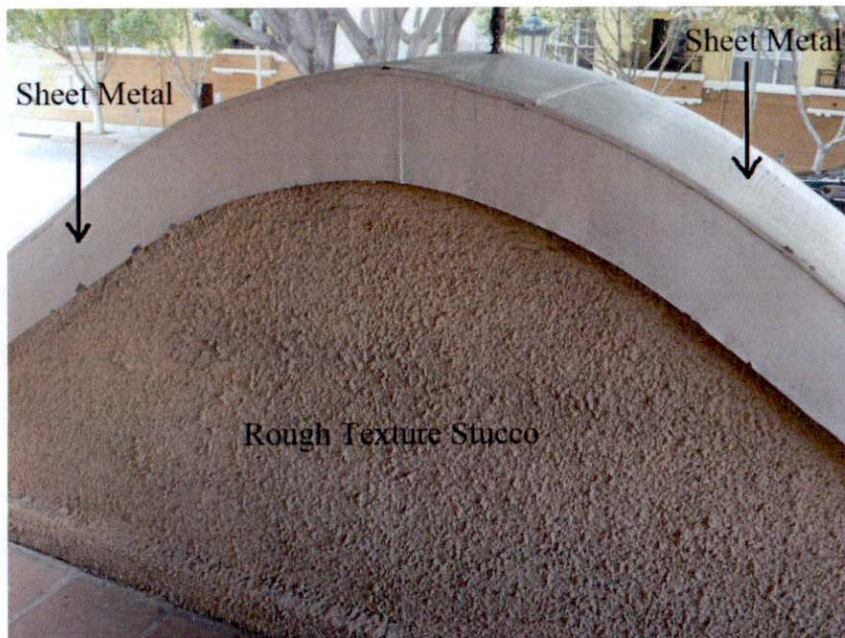
**Figure 2.** Looking west, within upper porch, at the sheet metal coping over parapet with a rough texture stucco wall surface.

- **Workmanship** – Because the building has been resurfaced with rough texture stucco, it has lost the ability to convey the workmanship technology and craft of smooth texture stucco which is an important character-defining feature of the Mission Revival style architecture. As a result of this significant alteration, the property has lost integrity under the aspect of workmanship.

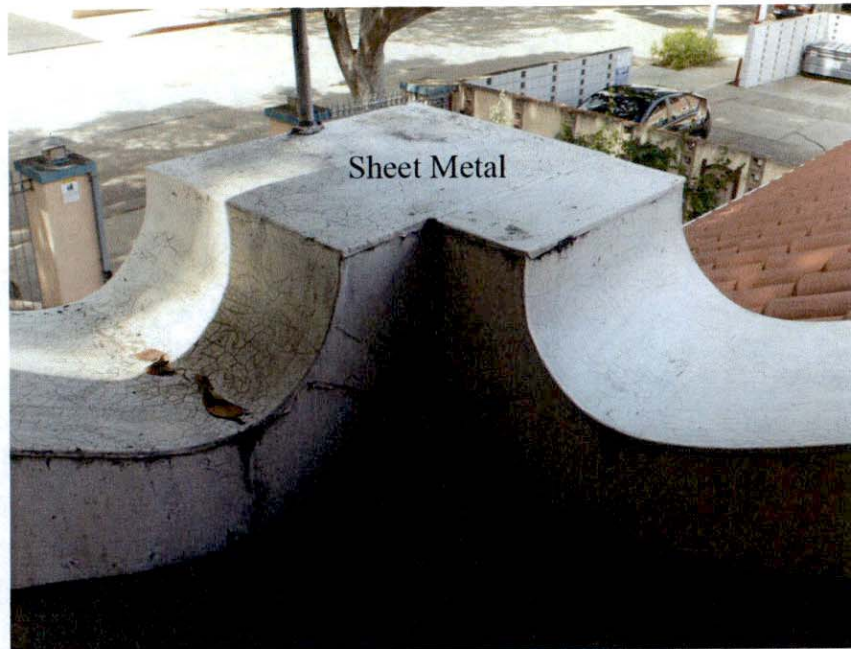
**Figure 3.** Looking northwest at the sheet metal coping imitating a Mission Revival stucco feature.

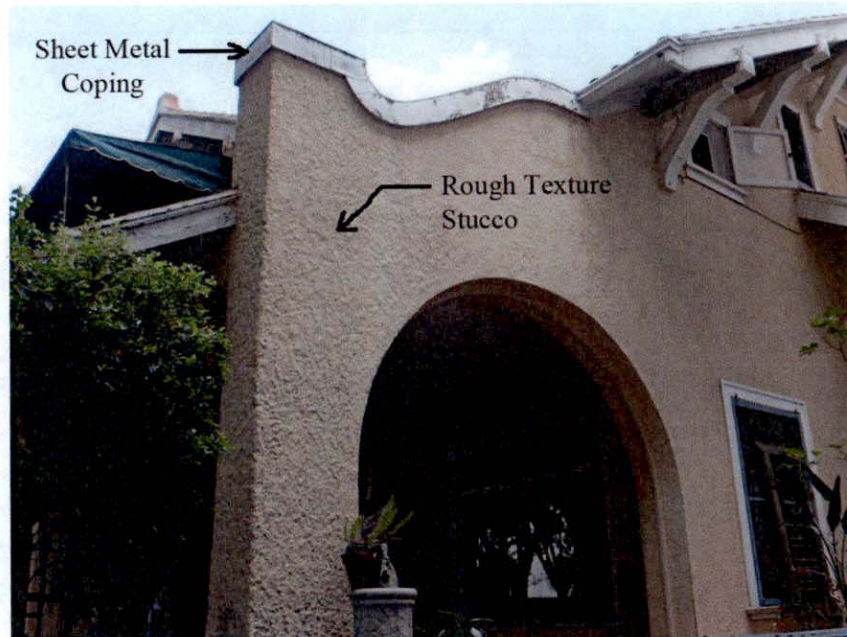
**Figure 4.** Looking northeast at the sheet metal coping imitating a Mission Revival stucco feature, and rough texture stucco wall surface.

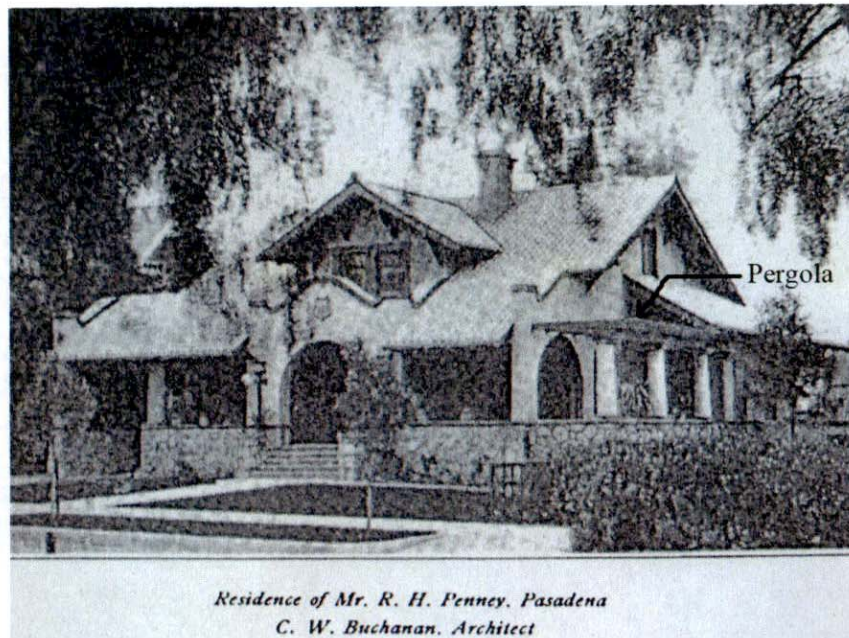
From review of the historic photograph found in the *Architect and Engineer of California*, dated February 1908, a wooden pergola structure was located at the southwest area of the building, supported by three Doric columns. This character-defining feature has since been removed (Figures 5 and 6).

**Figure 5.** Historic photograph from source: *The Architect and Engineer of California, February 1908*. Looking northeast; note the original character-defining pergola design feature.

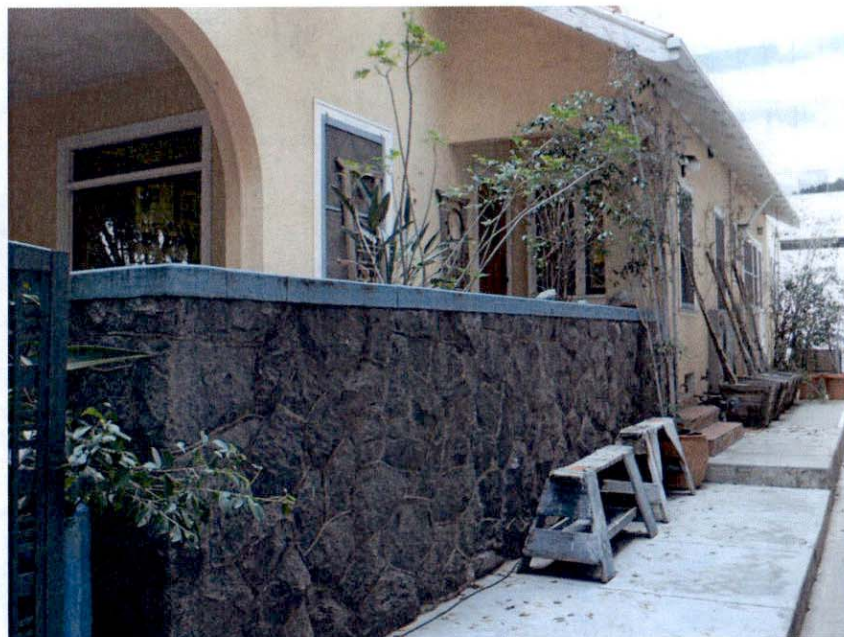
**Figure 6.** Looking northeast at the quartz stone wall, located at the southwest corner of the building. Note the missing Doric columns and wooden pergola structure.

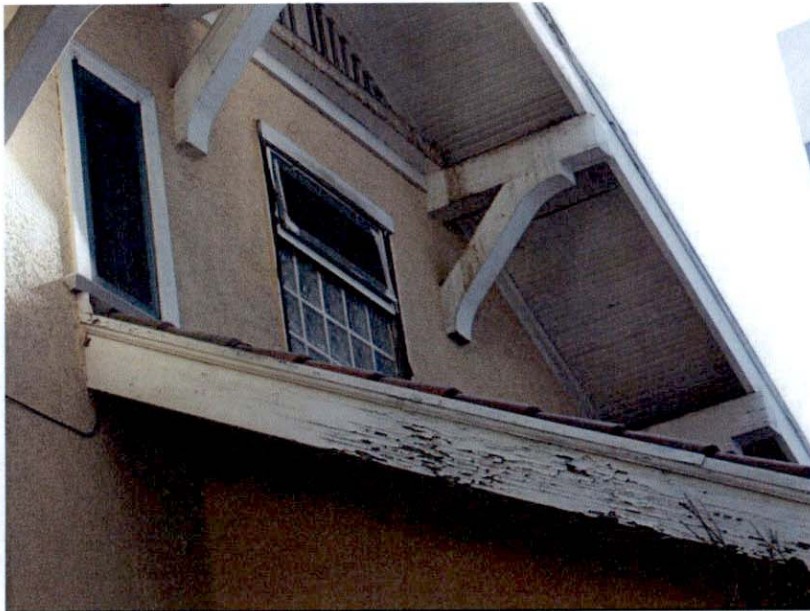
Within the upper gable end of the south elevation, a window opening appears to have been added and a hopper type aluminum window with glass-block has been installed (Figure 7)

**Figure 7.** Looking northeast within the upper gable end showing an aluminum hopper window with glass-block window units.

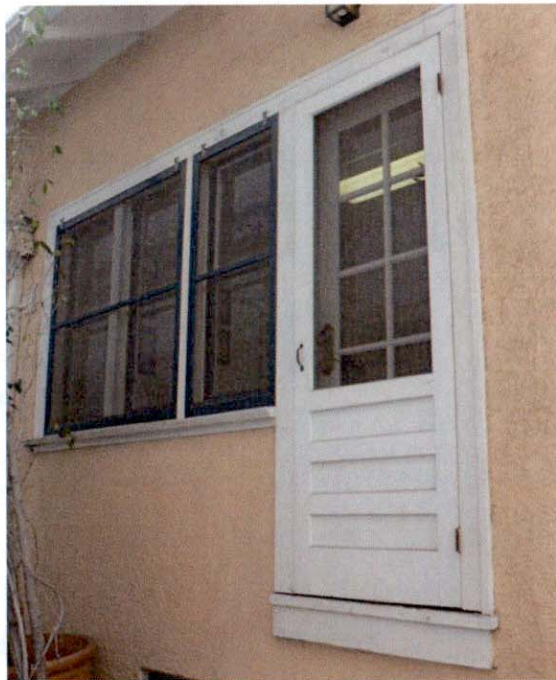
Two windows have been replaced, one located on the south elevation, and the other within the upper story's south elevation, by resizing the window opening for two door openings (Figures 8 and 9).

**Figure 8.** Looking northwest, south elevation, at a window opening resized for door opening; 1994 permit.

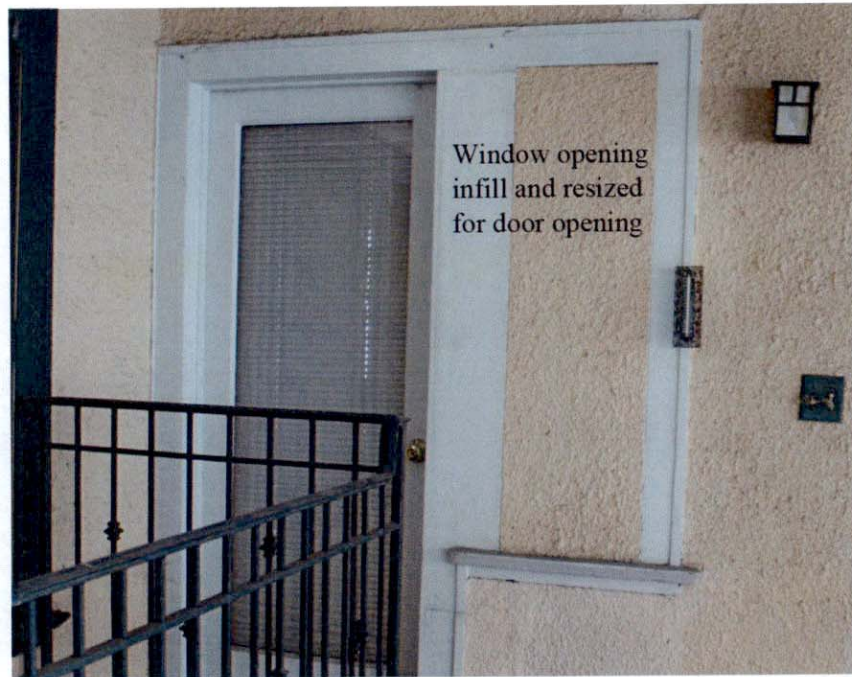
**Figure 9.** Looking north, south elevation of rear upper story, window opening infill and resized for door opening; 1994 alteration permit.

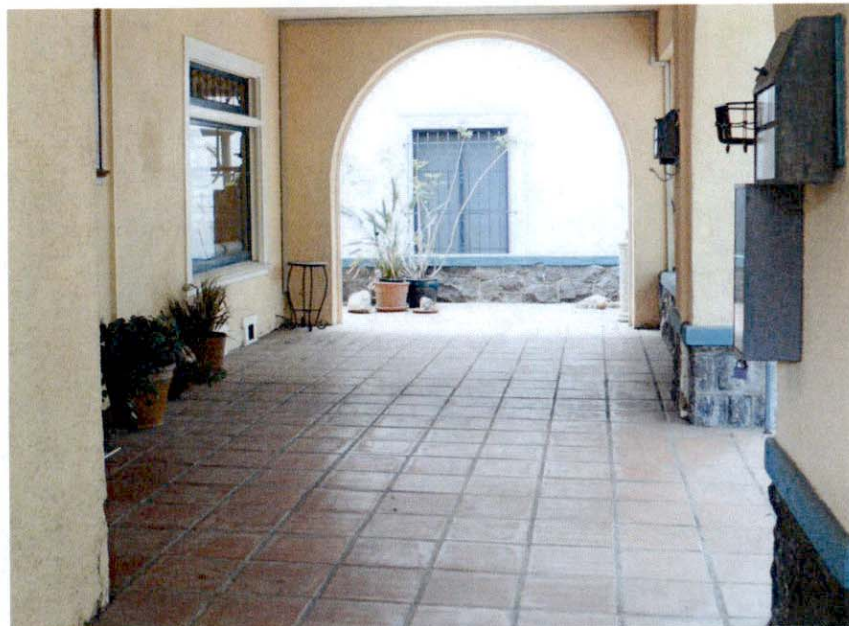
**Figure 10.** Looking south, main front porch replaced with Mexican tile porch pavers.

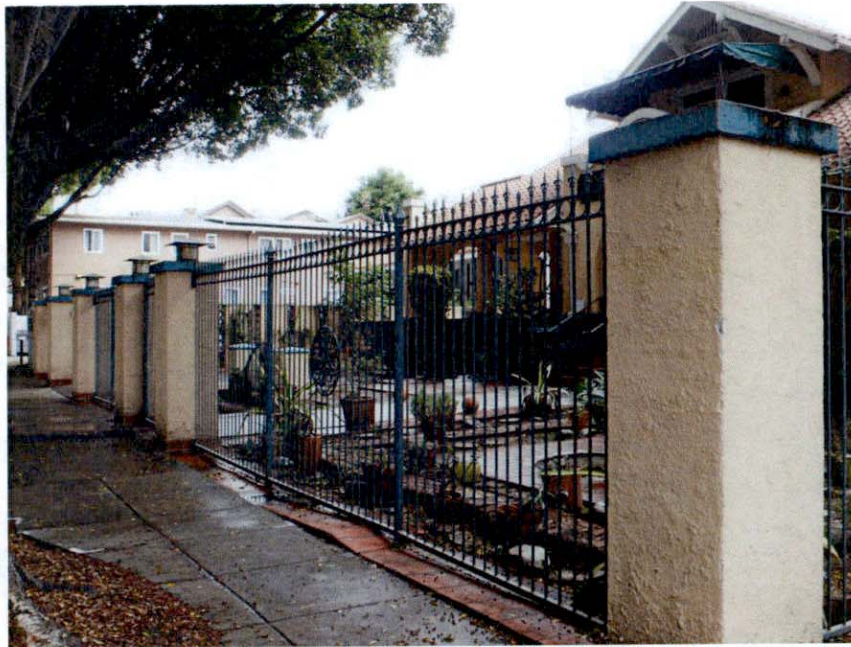
**Figure 11.** Looking northeast along the front yard area and sidewalk with six large piers and iron security fence.

- **Setting** – The property's front yard was originally an open lawn area and it has changed substantially by the replacement of the original landscaping with concrete paving, Mexican tile porch pavers, and six large square piers with iron security perimeter fences. To the rear (east end) of the building, the yard has been paved over with asphalt paving. Furthermore, the surrounding street context area has changed from a residential neighborhood to a modern commercial and apartment building setting. There appears to be no potential for a historic district in this area. Due to the alterations listed above, this property has lost integrity under the aspect of setting.

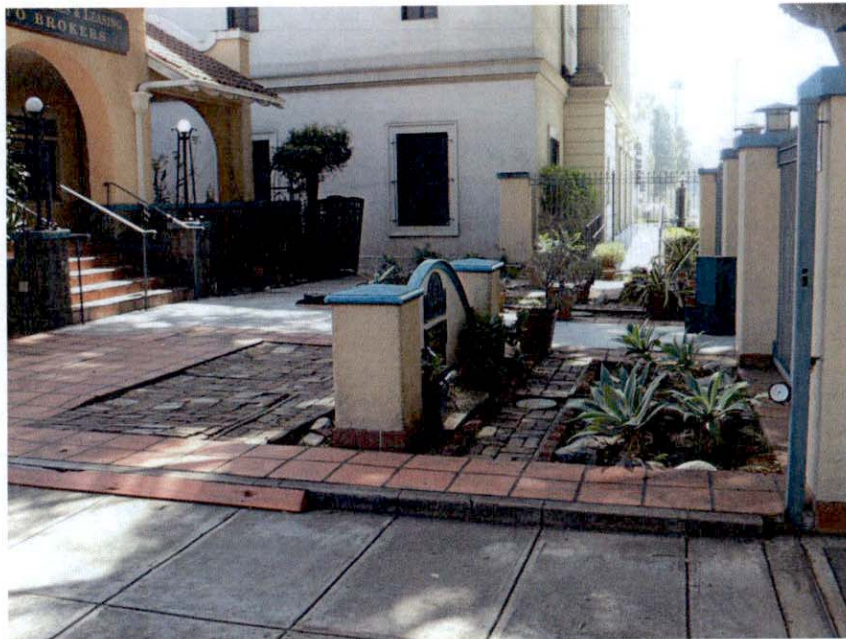
**Figure 12.** Looking south at the front yard area with modern Mexican tile porch pavers, concrete paving, red brick, and square piers with sign.

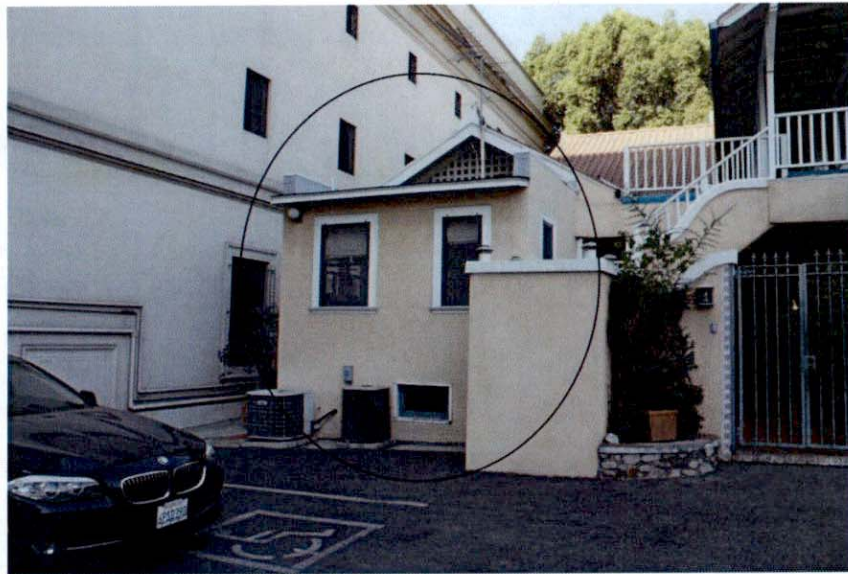
The rear of the house has been substantially altered by an addition to the southeast corner of the building circa 1910-1931 (Figure 13) and the addition of a stairway and upper deck with roof structure constructed in 1992 and 1994 (Figure 14). As architect C.W. Buchanan designed the residential house consisting of a

**Figure 13.** Looking southwest at the addition to the southeast corner of building.

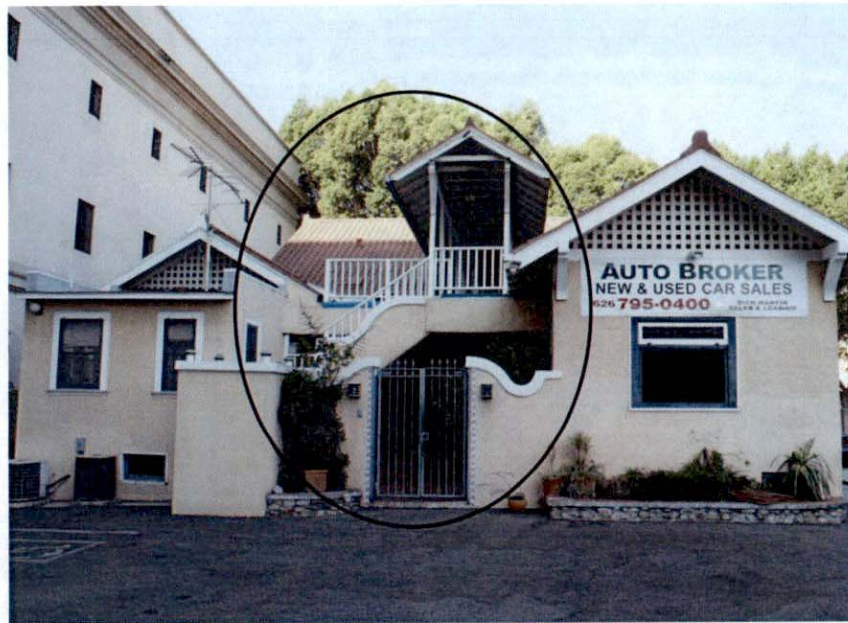
U-shaped plan with an open courtyard to the rear, the introduction of a stairway, upper porch, and roof within this once open area has drastically changed the original design.

**Figure 14.** Looking west at the rear yard area showing the addition of stairs, upper porch and porch roof alteration.

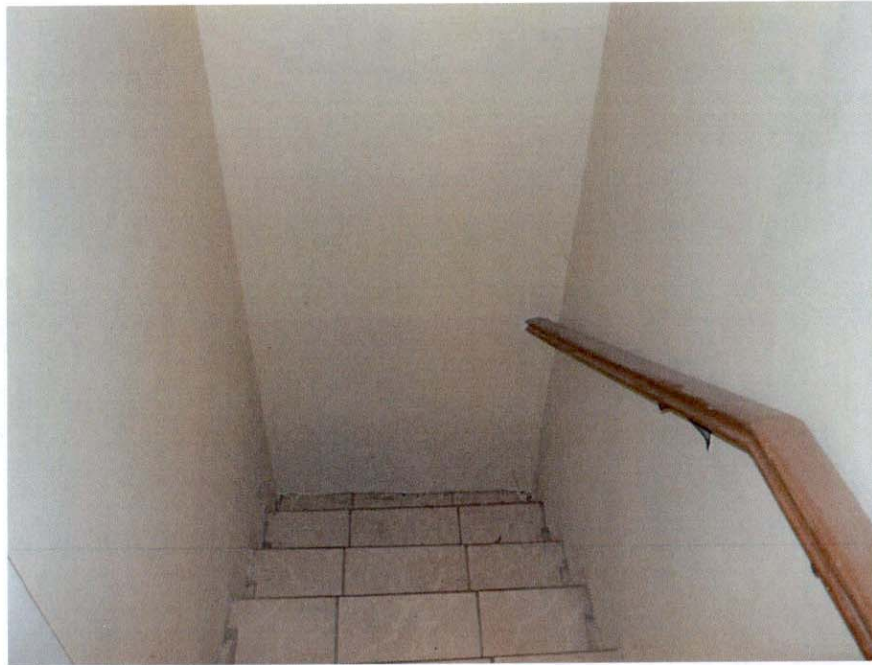
“The rear of the house, other than the porch area, has been substantially modified, with at least two later additions and a staircase added to the second floor, to provide access to a modern upstairs apartment currently occupied by the owner. There is also an internal staircase that goes from the upper hall to the south side of the building. That staircase has been sealed at the bottom allegedly due to some fire ordinance calling for separation between commercial and residential uses” (Figure 15).

**Figure 15.** Looking south down the second-story stairs ending in a sealed wall closed off to the first floor.

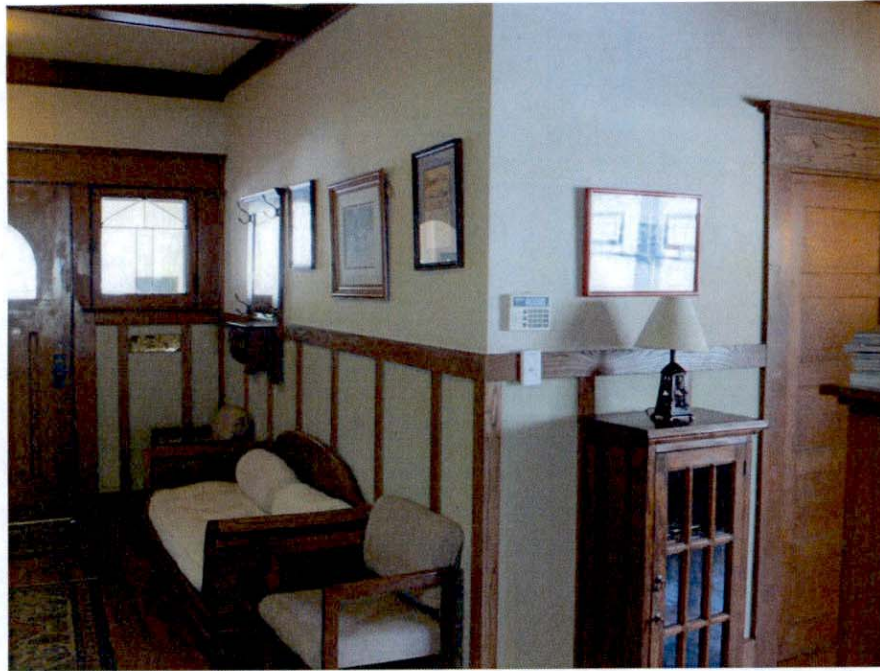
From a site visit on September 15, 2015, Architectural Historian Steven Treffers observed that nearly all the interior rooms and walls on the first floor have been removed and reconfigured to accommodate a commercial office use. This alteration has changed the spatial relationship of the interior spaces in that it no longer corresponds with the original architect’s residential floor plan design (Figures 16 and 17). Further, a kitchen at the northeast portion of the building has been substantially altered and reconfigured through the addition of new interior walls (Figure 18)

**Figure 16.** Looking northwest at the added enclosed office room at right. Fireplace is out of view directly to left.

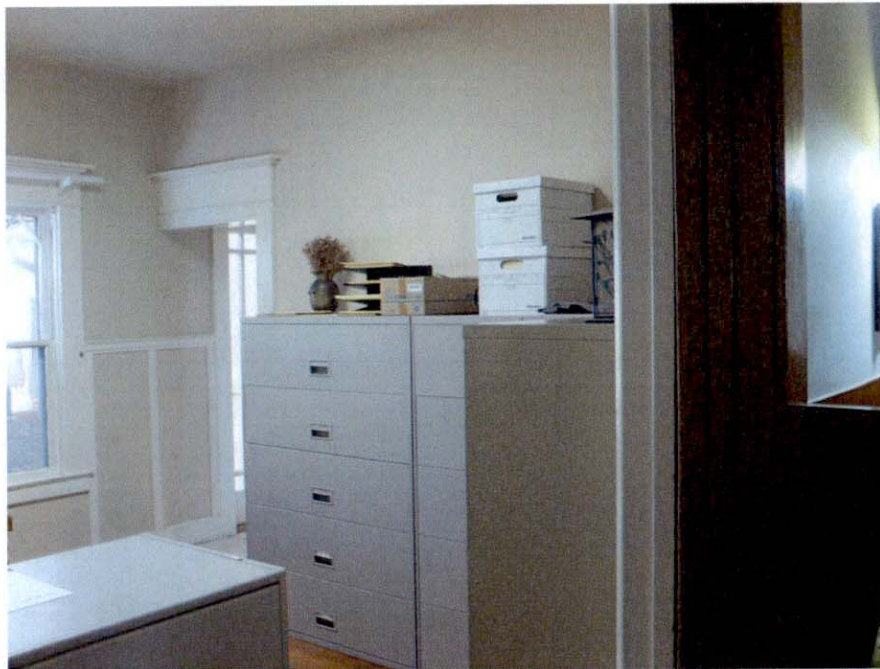
**Figure 17.** Looking northeast at an office room located to the north half of the building.

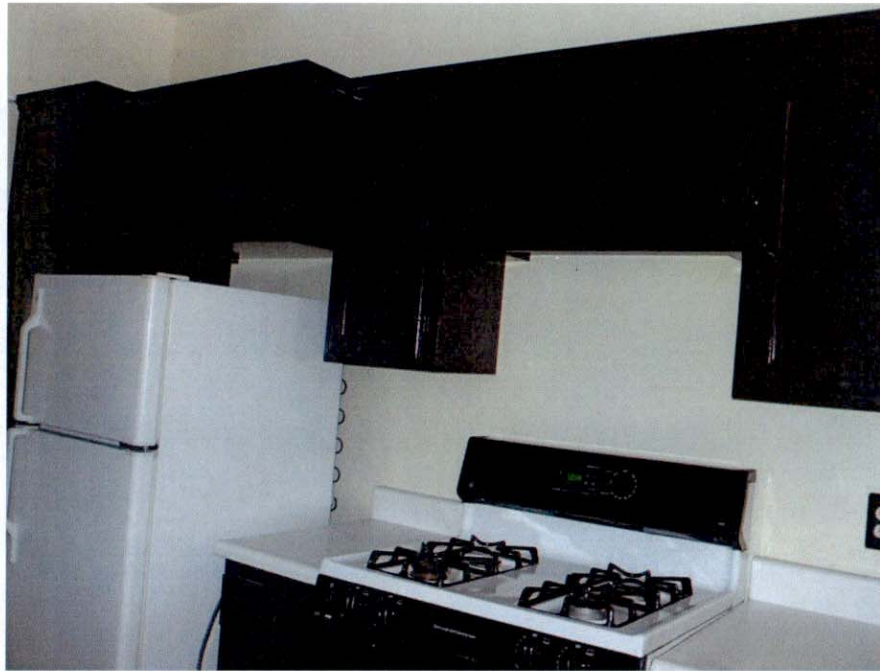
**Figure 18.** Looking northeast at the second-story kitchen area.
