May 3, 2016
W&G #S16180.00

FIELD INVESTIGATION REPORT

Pinney House
180 S. Euclid Avenue
Pasadena, CA 91101

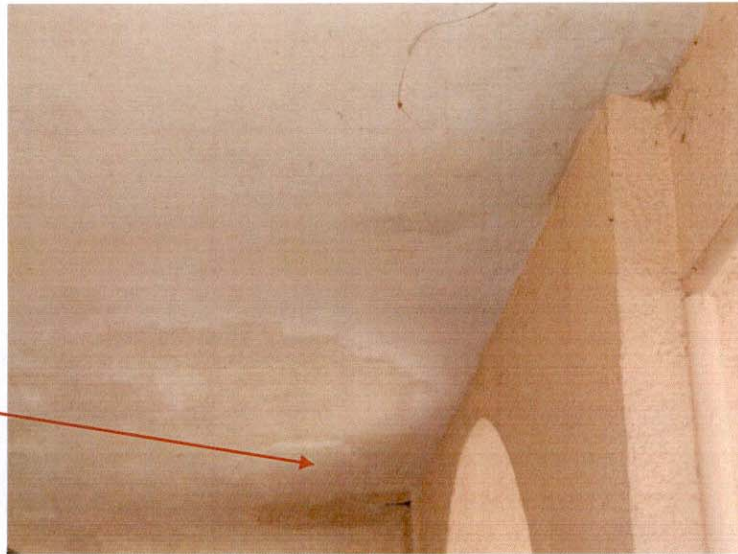
1. Exterior stucco walls and stucco soffits show a number of areas with substantial signs of damage, leakage, and moisture intrusion. Stucco has been poorly patched in a number of places (Figures 1-7).
2. Signs of leakage, moisture intrusion, water damage, and dry rot are evident in a number of locations at the basement walls, perimeter wood walls, and floor framing (Figures 8-11).

stains, moisture intrusion, and sagging

Figure 1: Damage to Soffit at Porch Entry (Looking South)

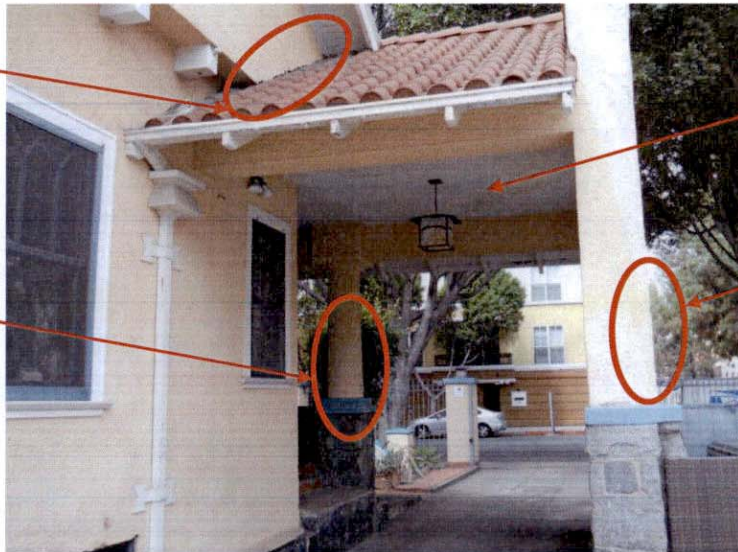
stains and sagging stucco

Figure 2: Damage at Entry Cover (Looking West)

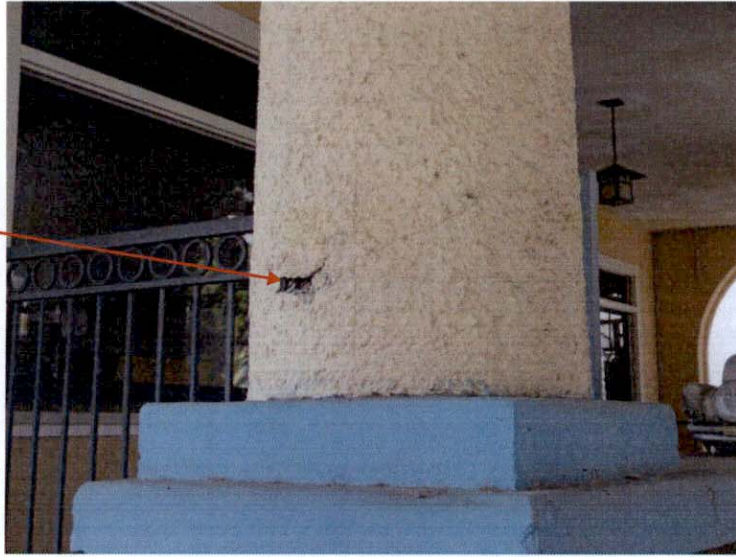
cracks and
spalling of
stucco

Figure 3: Cracks at Entry Column (Looking South)

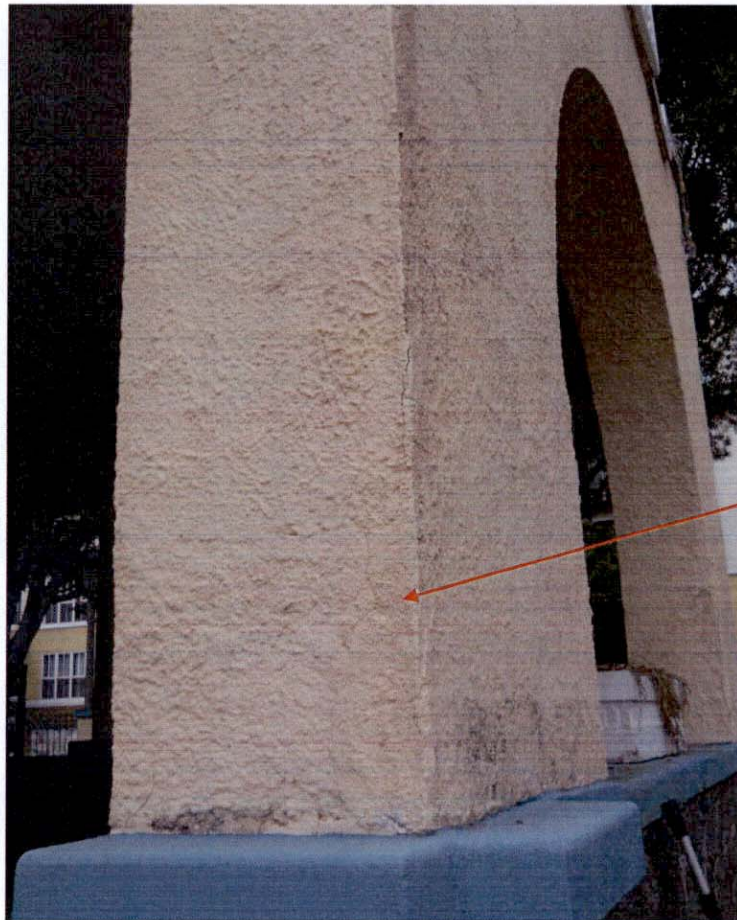
cracks and
patched stucco

Figure 4: Cracks at Entry Arch (Looking West)

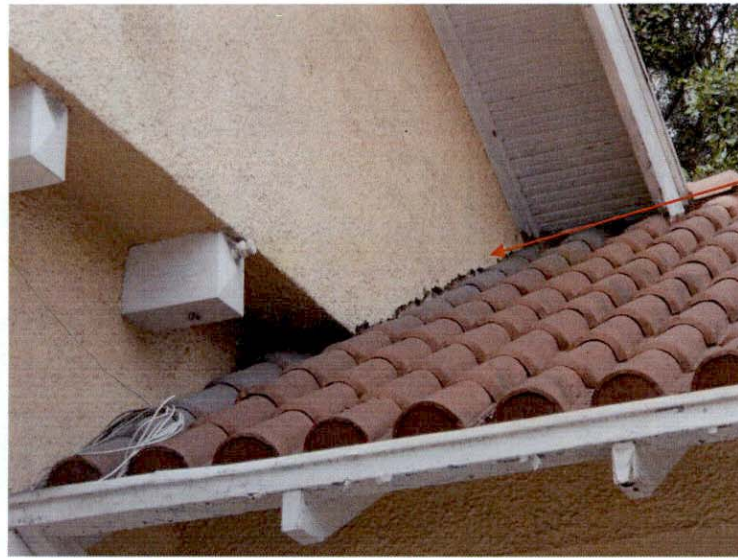
spalled stucco
at roof

Figure 5: Spalling at Entry Roof (Looking Southwest)

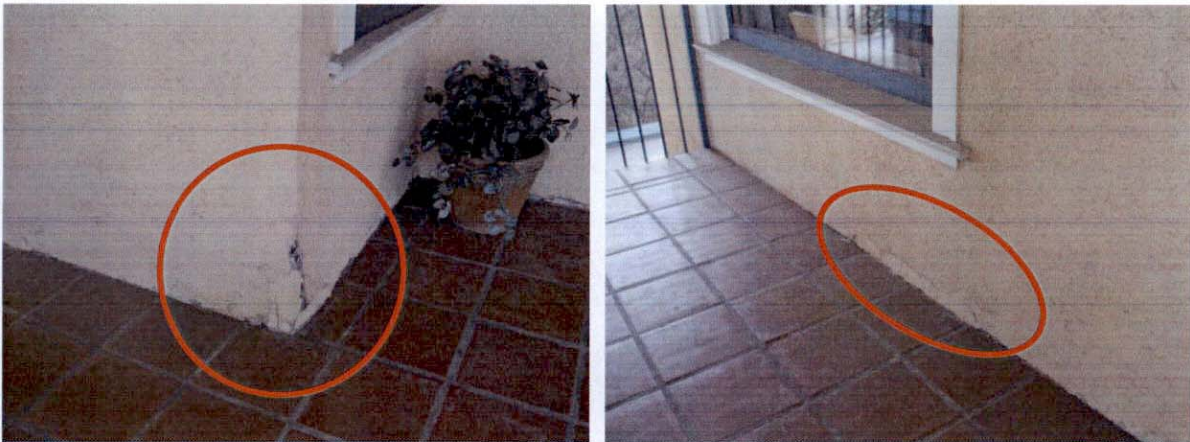
Figures 6 & 7: Damage at Porch (Looking East)

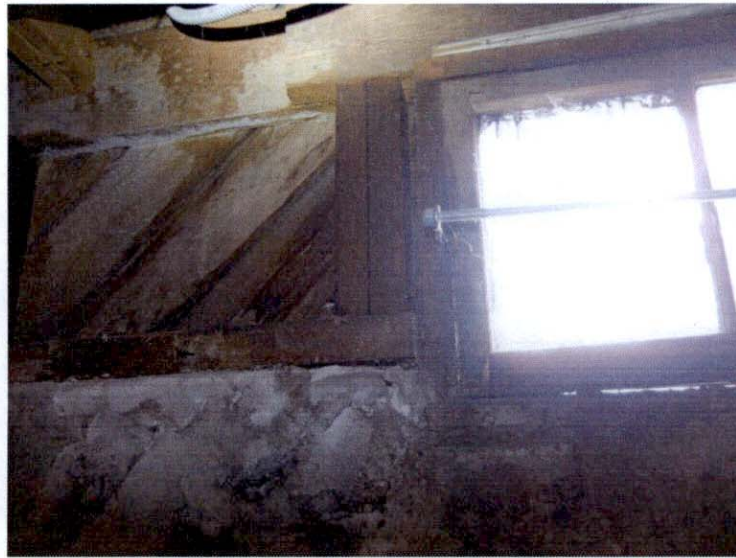
Figure 8: Moisture at Foundation (Looking North)

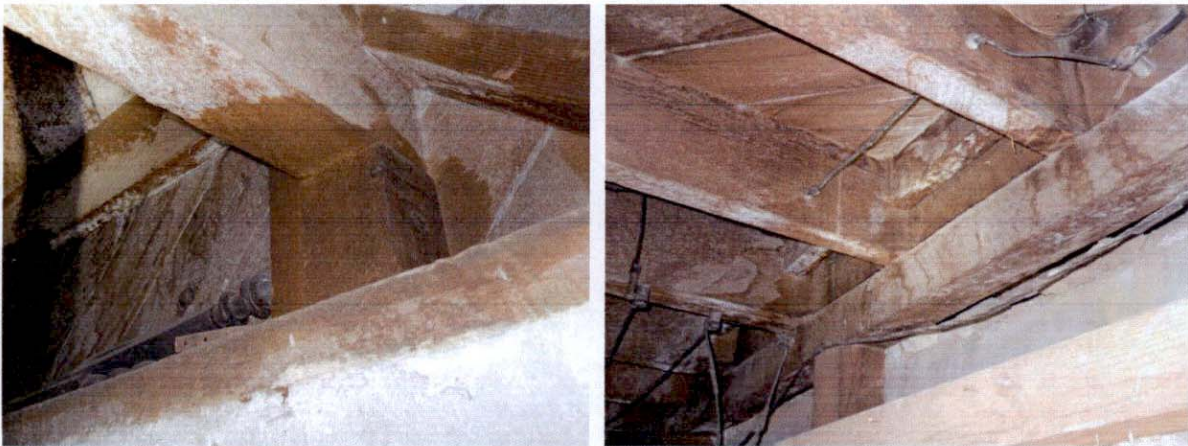
Figures 9 & 10: Moisture at Foundation (Looking West)

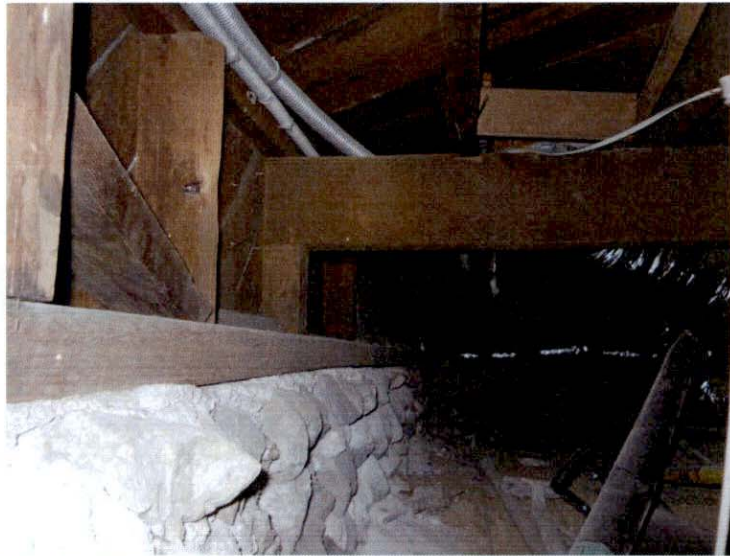
Figure 11: Typical Foundation Without Anchorage (Looking South)

Anchoring the structure to the foundation to reduce damage due to future earthquake episodes is critical. It is also recommended that the cut stone foundation be supplemented or replaced with a reinforced concrete continuous footing and stem wall for positive anchorage and lateral load path. The unreinforced brick chimney should also be positively anchored to the roof and floor diaphragms.

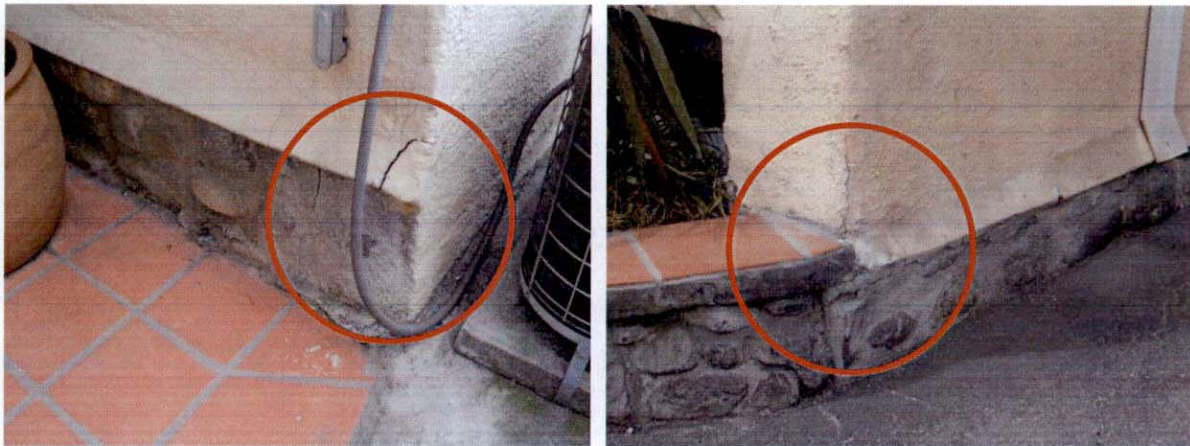
3. Cut stone and river rock foundations are unreinforced and cracked at corners as well as other locations. No positive anchorage to the foundation was observed (Figures 12-13).
4. Based on time of construction, the brick chimney is unreinforced (Figure 14).
5. The non-original exterior stair and walkway structure used to access attic living space is extremely distressed. The method of construction significantly impacted the original building systems and created a number of areas where moisture can enter the structure. Plywood sheathing, stair treads, stringers, and walkway framing has been poorly maintained and is subject to partial collapse or local failure (Figures 15-21).
6. No signs of settlement were observed.
7. Tile roofing materials were found to be non-original sheet metal.

Figures 12 & 13: Cracks at Foundation Corners (Looking Northwest & Southwest)

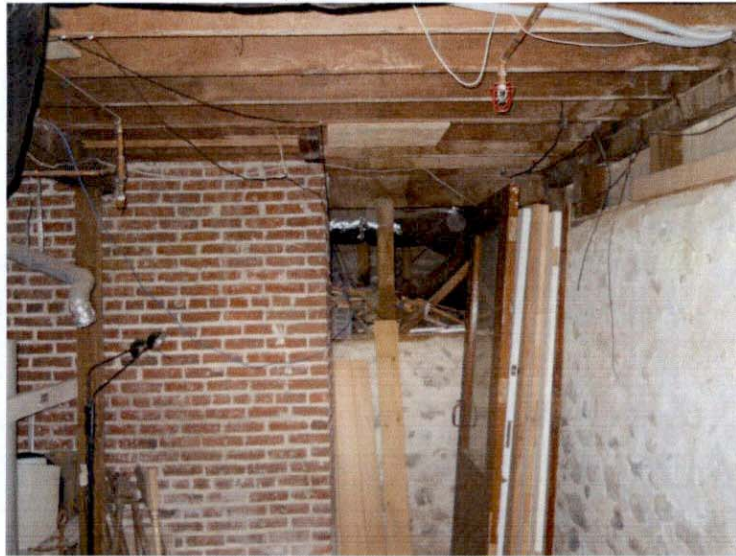
Figure 14: Brick Chimney at Foundation (Looking South)

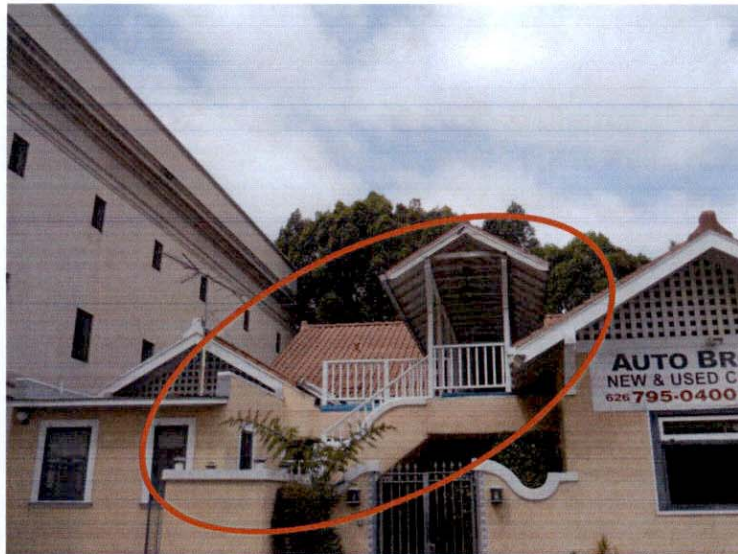
Figure 15: Non-Original Rear Stair and Walkway (Looking West)

It is our opinion that the exterior stair and walkway be removed or entirely replaced to prevent future collapse and deterioration of adjacent structures or structural elements.

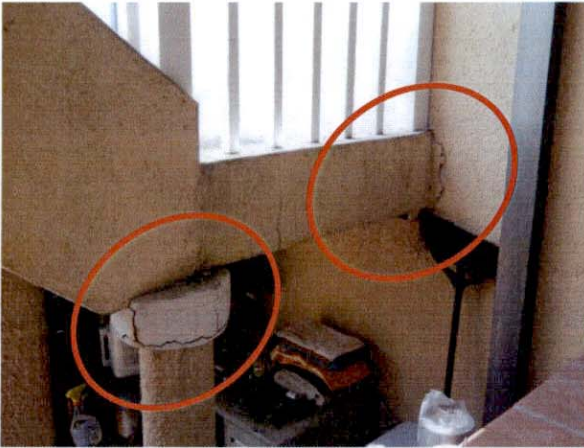
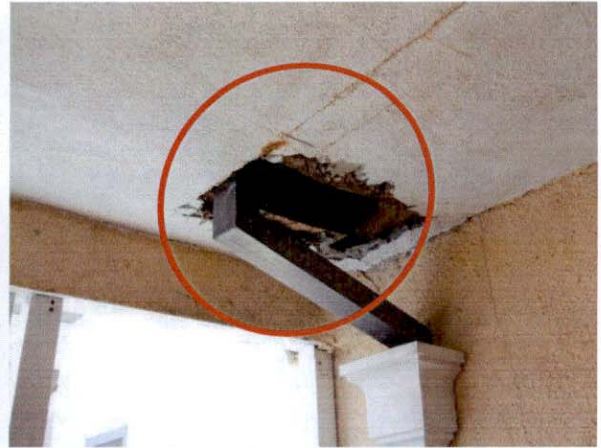
Figures 16 & 17: Damage at Rear Stair & Soffit (Looking East)

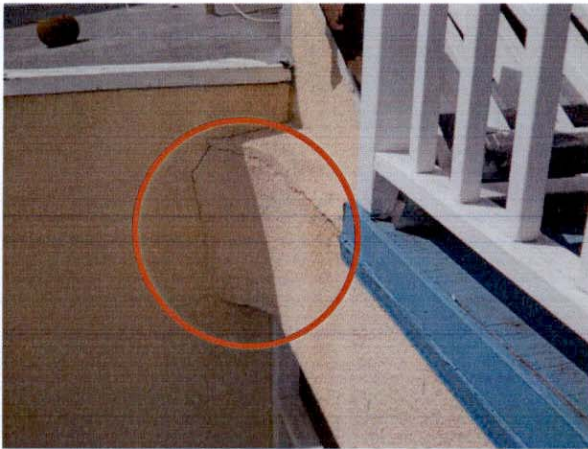
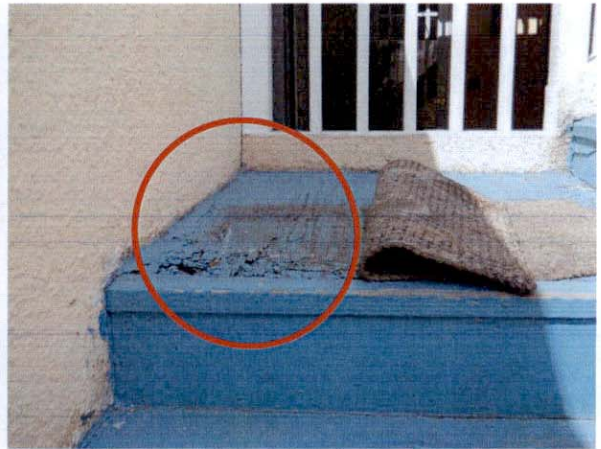
Figures 18 & 19: Damage at Rear Stair Landing & Walkway (Looking South & West)

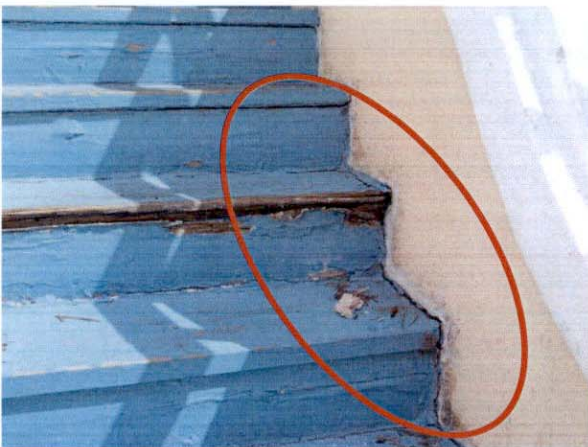
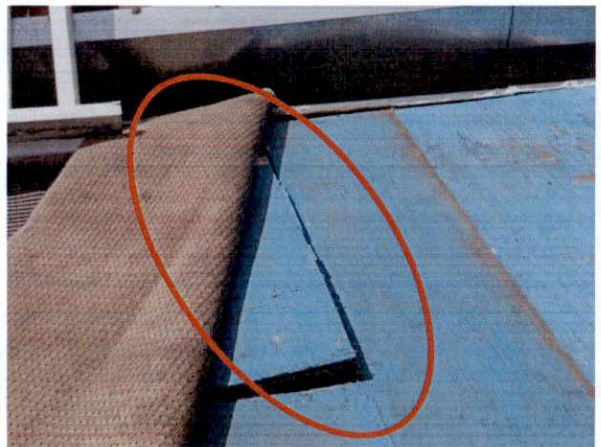
Figures 20 & 21: Damage at Rear Stair & Walkway (Looking North & South)

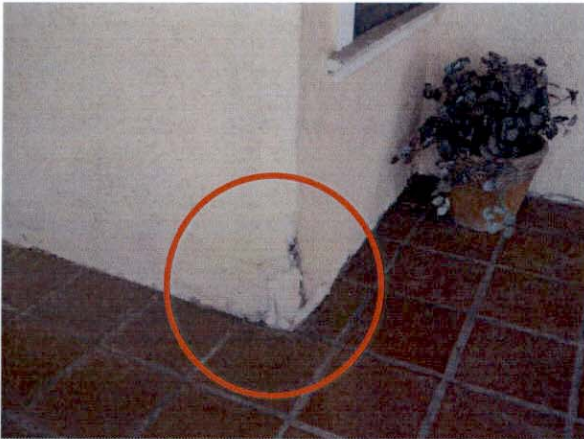
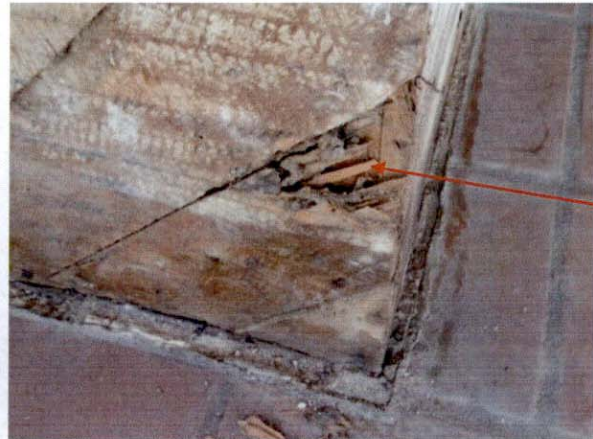
1. Significant termite damage observed at wall area exposed at porch entry (Figures 1-2).
2. Significant termite damage observed at soffit area exposed at porch entry (Figures 3-6).

Figures 1 & 2: Termite Damage to Wall Sheathing at Porch Entry (Looking East)

1. Non-original walkway, stairs, and courtyard canopy should be removed and/or replaced.
2. The exterior finish of the building should be removed to locate all areas of termite damage and areas of potential dry rot. Termite-damaged or dry rot diagonal sheathing and wood lath should be removed and replaced. Building should be treated for termites to avoid further damage to structural members.
3. A building mover should be consulted to evaluate relocating all or a portion of the building on site.

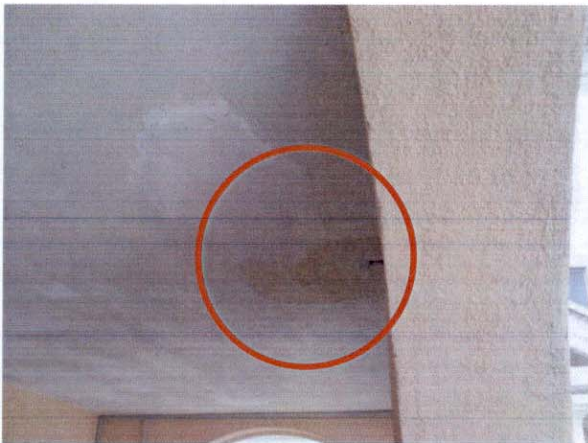
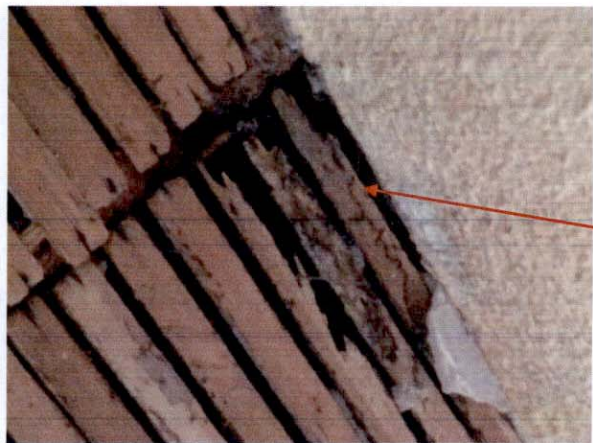
Figures 3 & 4: Termite Damage to Wood Lath at Porch Entry Soffit

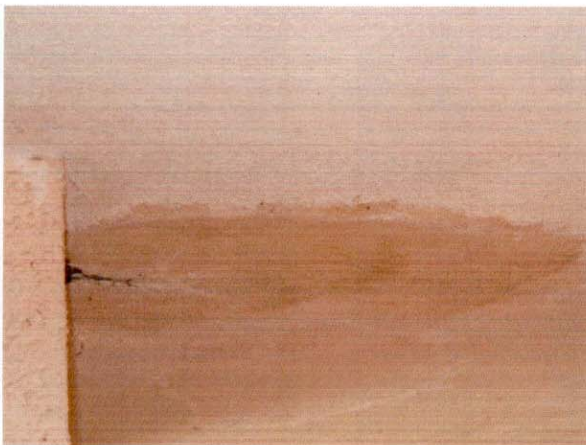
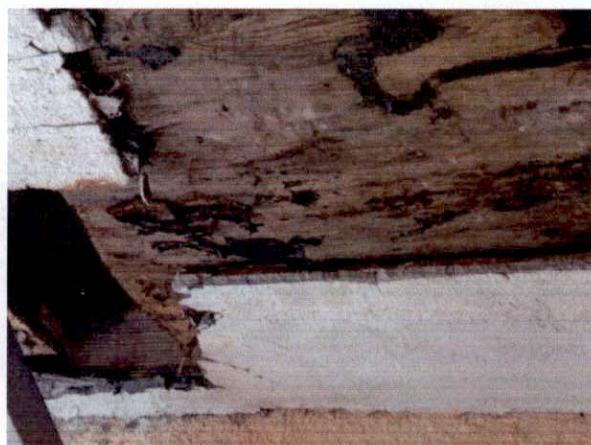
Figures 5 & 6: Termite Damage to Porch Entry Soffit

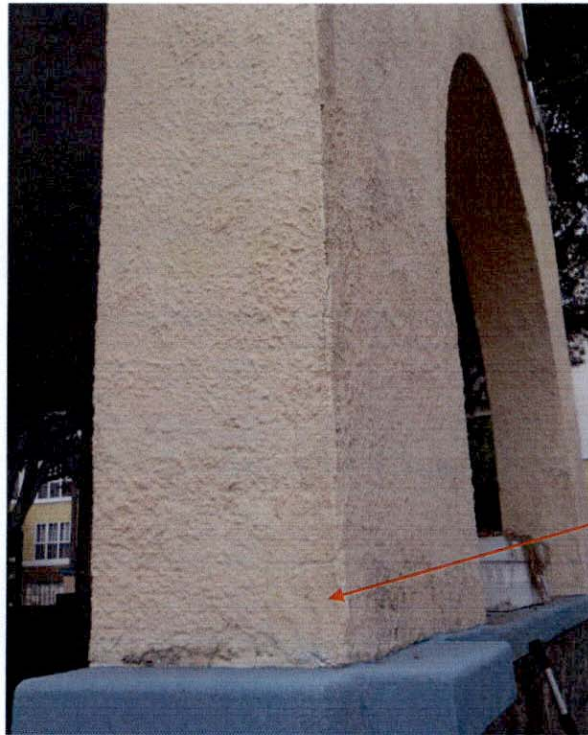
3. Significant termite damage observed at arch area exposed at porch entry (Figures 7-9).
4. Severe water damage and dry rot at non-original walkway, stairs, and courtyard canopy was observed (Figures 16-22).

cracks and
patched stucco

Figure 7: Cracks at Entry Arch (Looking West)

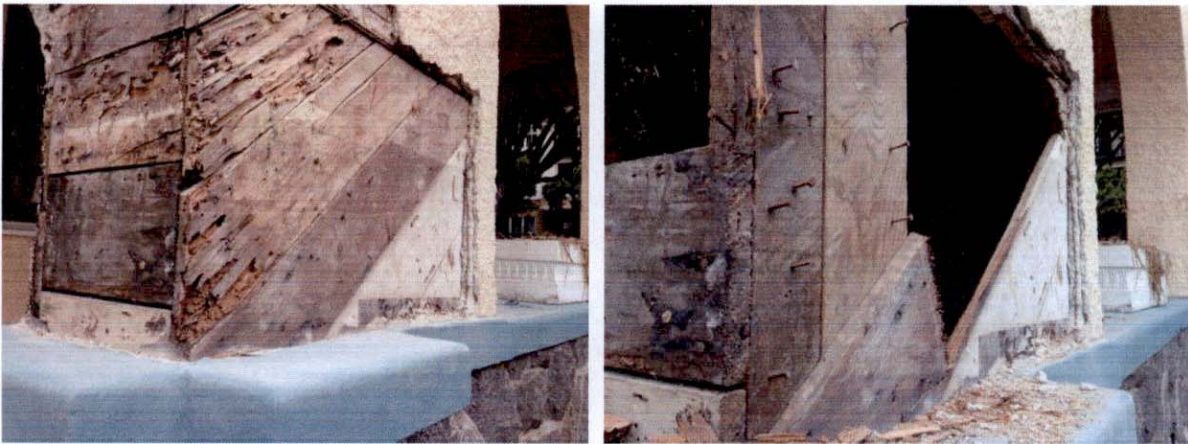
Figures 8 & 9: Termite Damage at Entry Arch (Looking West)

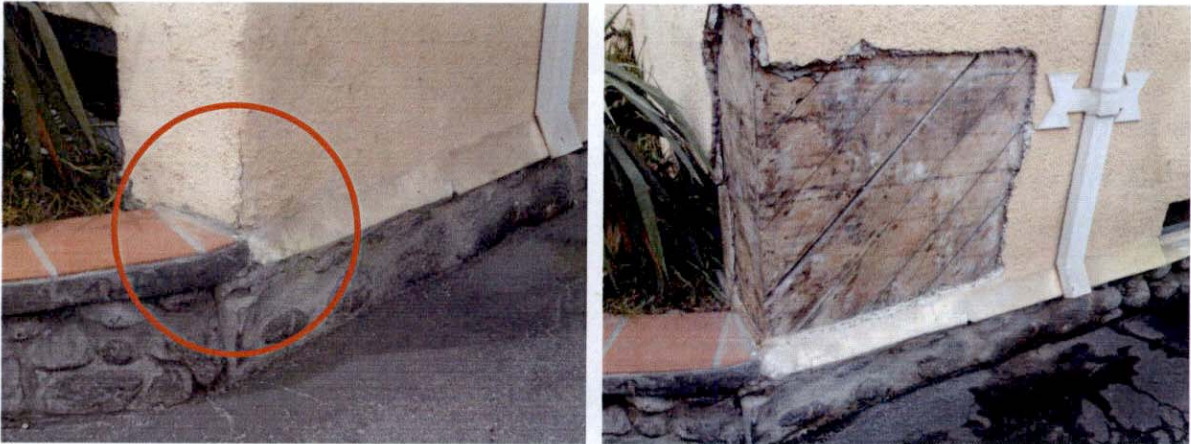
Figures 14 & 15: Crack at Foundation Corner (Looking Southwest)

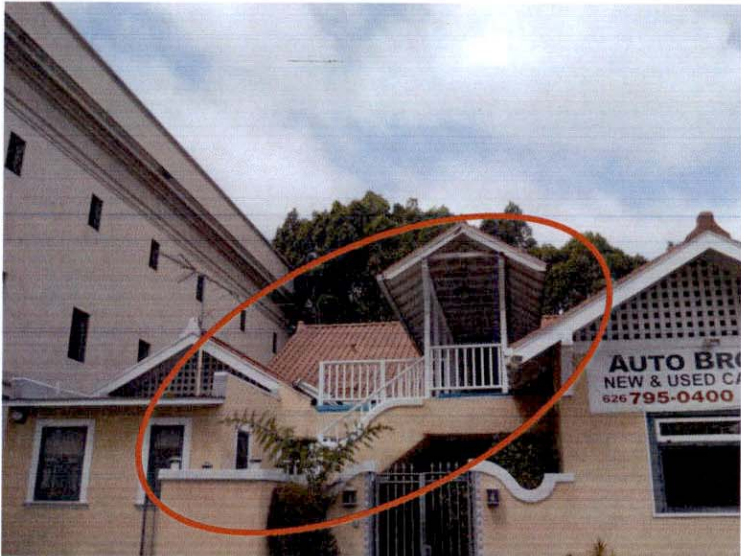
Figure 16: Non-Original Rear Stair and Walkway (Looking West)

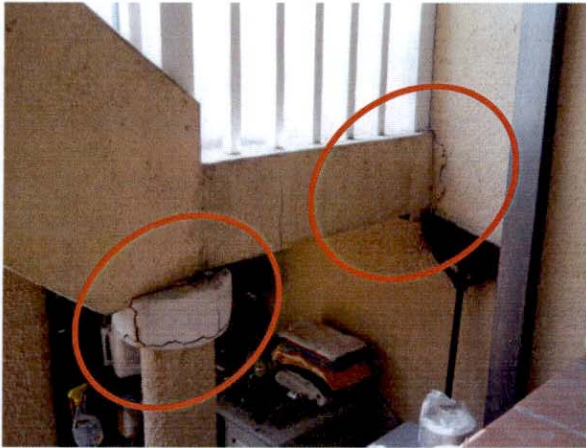
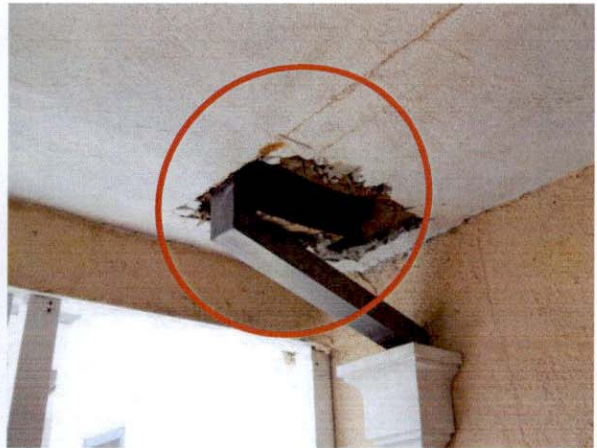
Figures 17 & 18: Damage at Rear Stair & Soffit (Looking East)

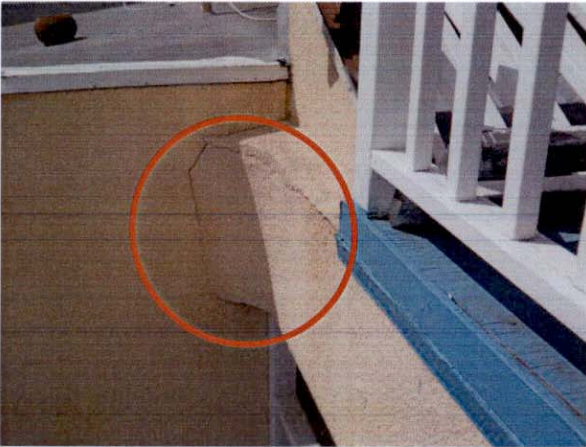
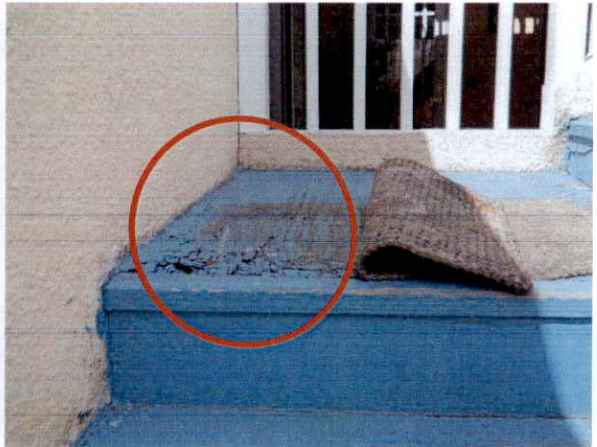
Figures 19 & 20: Damage at Rear Stair Landing & Walkway (Looking South & West)

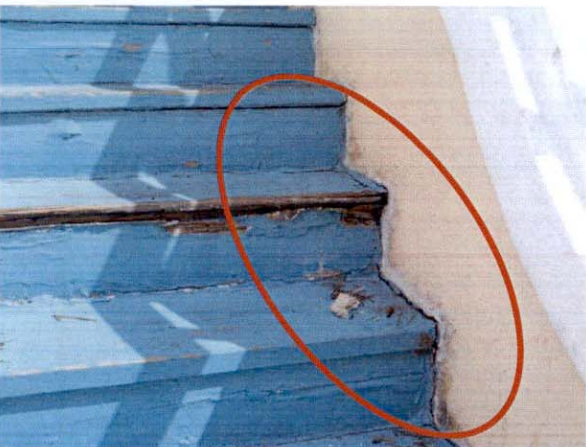
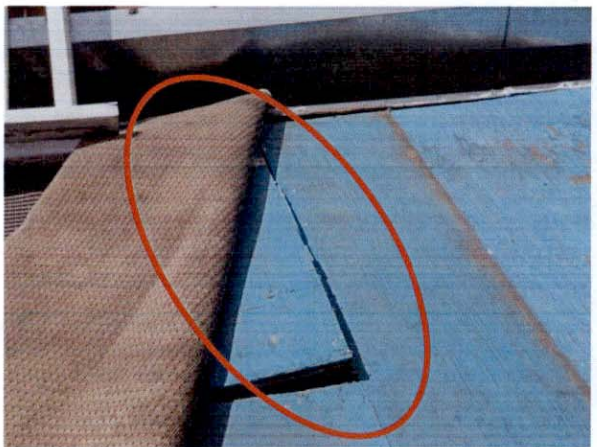
Figures 21 & 22: Damage at Rear Stair & Walkway (Looking North & South)
