**RE: NOTICE OF DECISION Application for Private Tree Removal  
366 South Mentor – PLN2006-00617**

Staff Use  
**Tree Evaluation Form**

Site Address: 366 S. Mentor Avenue Cross Street: Del Mar  
Zoning Designation: N/A Parcel Number: N/A  
Activity/Case Number: \_\_\_\_\_ Date of Inspection: 11-21-06  
Inspector: TMG  
ASCA/ISA Certified Arborist #: \_\_\_\_\_ Expiration Date: \_\_\_\_\_

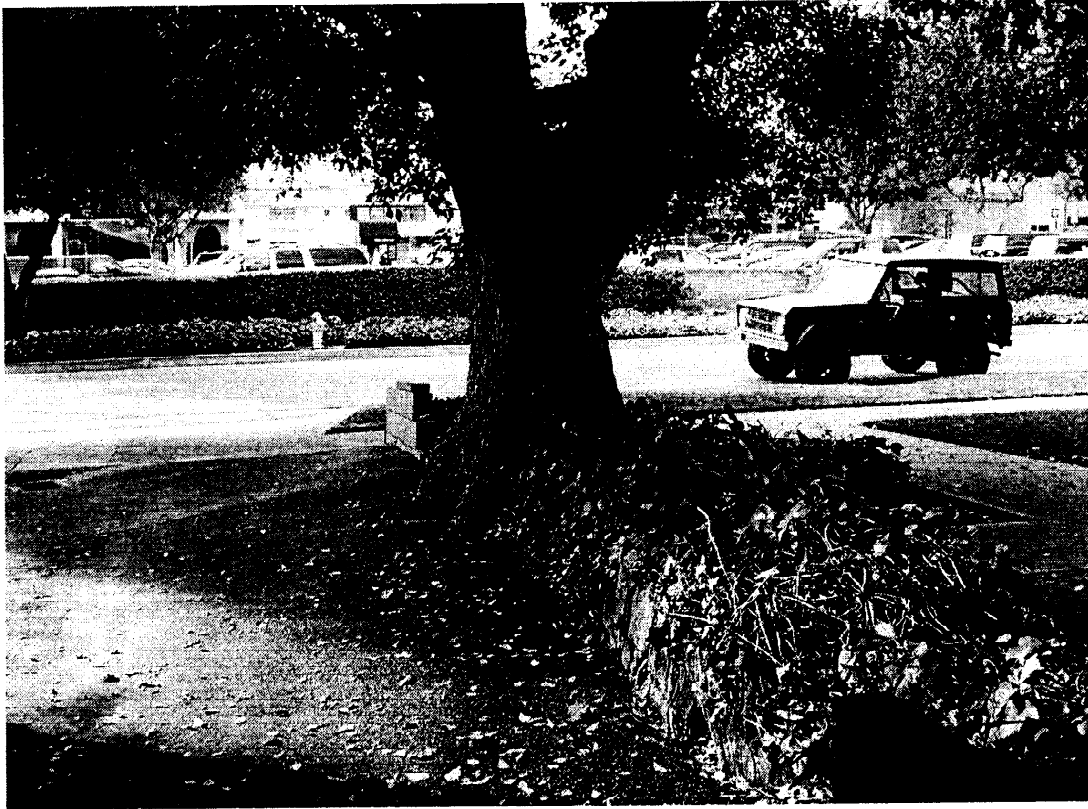
Conversely, the tree is causing significant uplift to the neighboring driveway and has caused the destruction of a portion of a low boundary wall constructed of cinder block. The tree trunk reduces the usable portion of the adjacent driveway. This tree is just over three feet in diameter but camphor trees may reach diameters in excess of six feet. The continued growth of this tree will further impact the adjacent driveway and boundary wall. In addition, complete repairs to the adjacent driveway would require significant root removal and could compromise the health and stability of the tree.

Photo illustrating driveway and wall impacts.

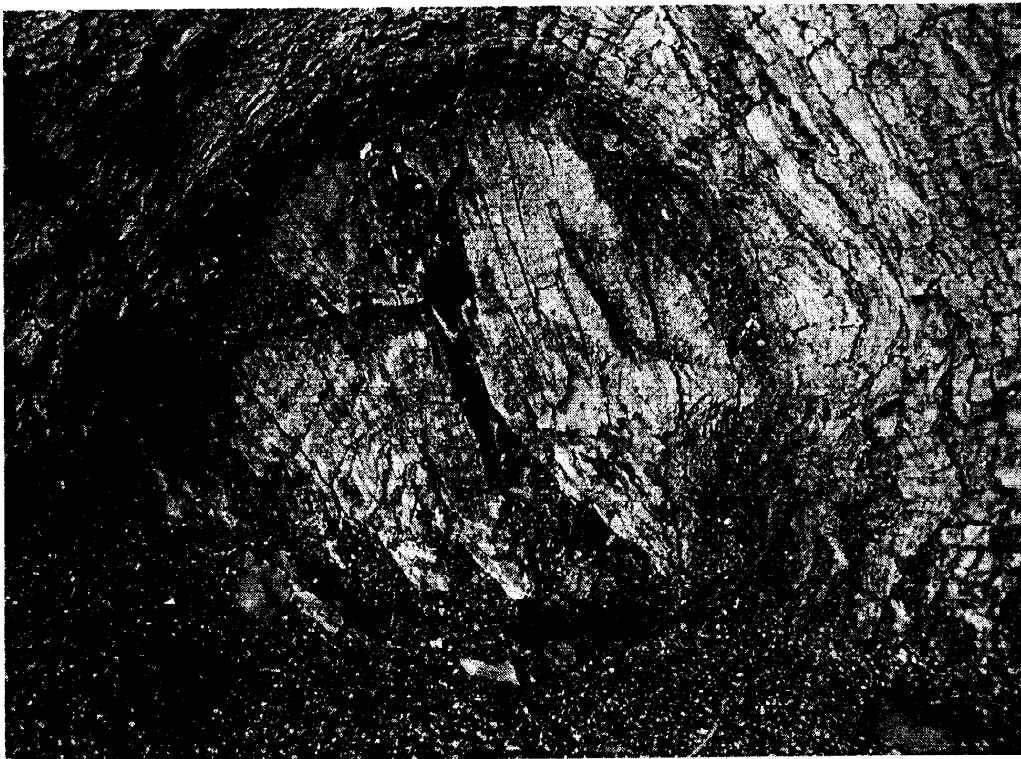
Location & Extent of Decay: Decay noted in buttress where a buttress root had been historically removed. Additional decay noted in pruned branches indicating that there may be significant decay in the trunk of the tree. Termites are also noted in the buttress cut.

Pests or Diseases: Termites observed in the buttress cut and other exposed wood.

Photo illustrating buttress decay .
