# Assisted Living Building

Building 32

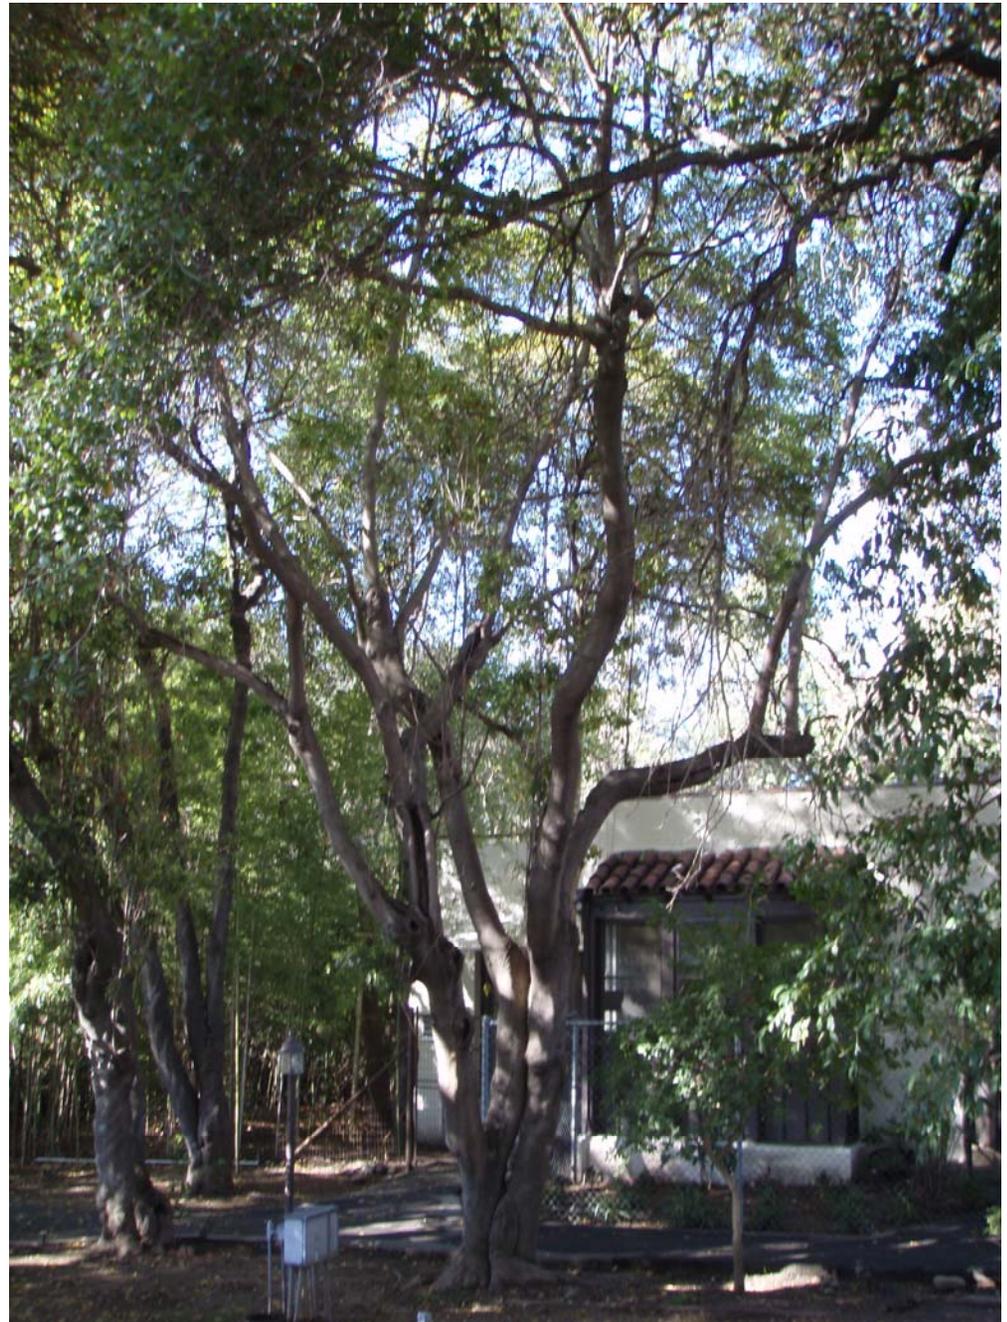
Tree Number: 521

This non-native species is 35' high with a North-South spread of 25' and a East-West spread of 40'. It is 20.5" in diameter; trees of this type are protected when they reach 12".

A portion of the two story assisted living facility would need to be removed in order to preserve this tree.

Need to remove to move historic structures.

Staff Recommendation: Remove

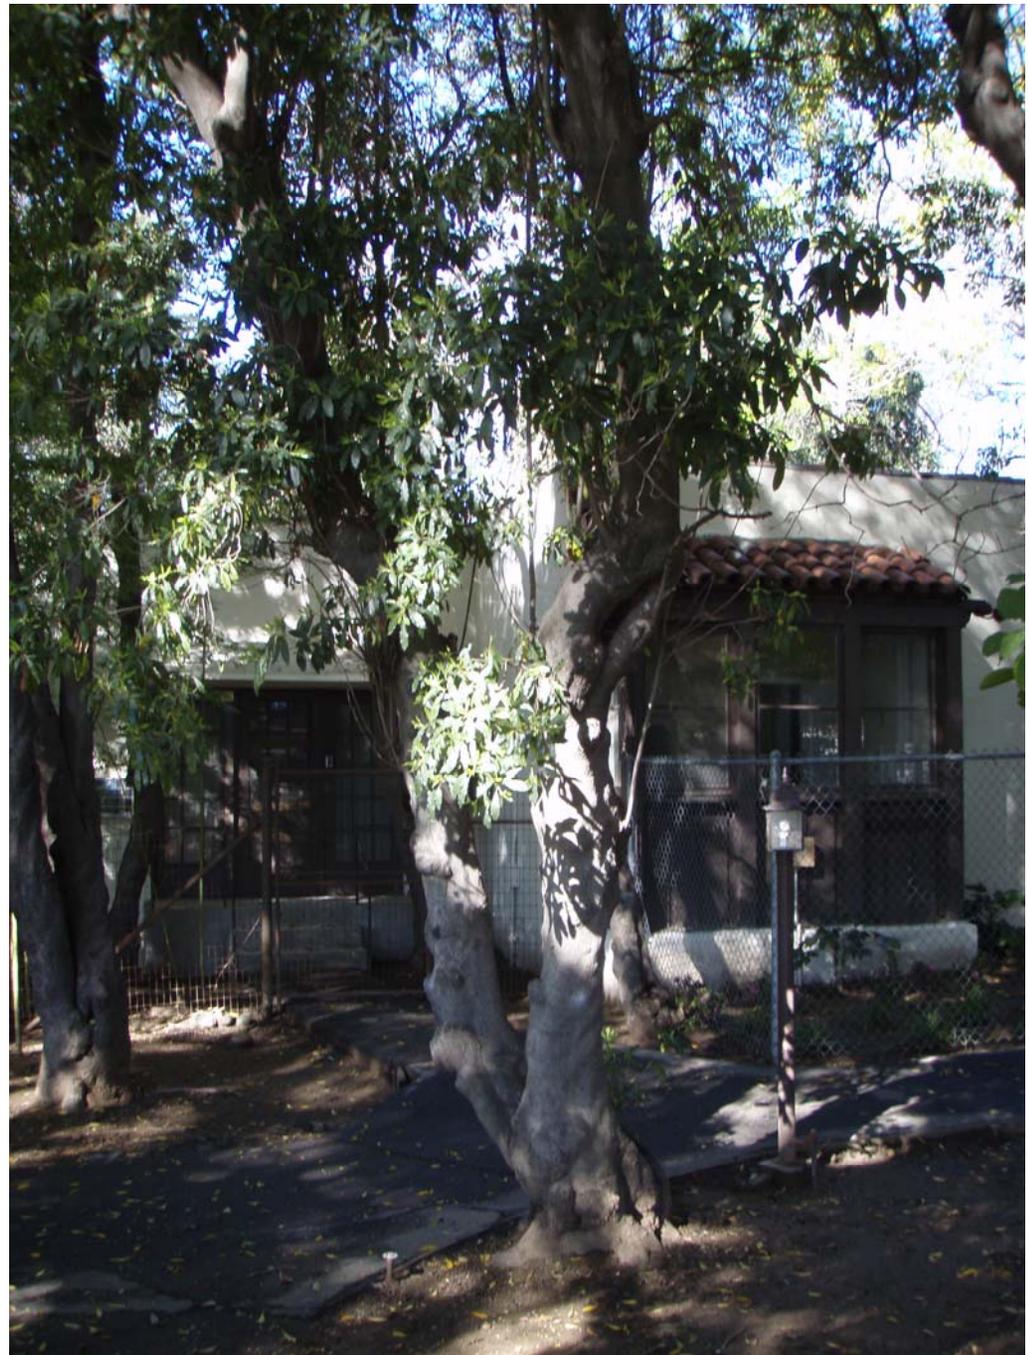
Tree Number: 522

This non-native species is 25' high with a North-South spread of 20' and a East-West spread of 20'. It is 14.7" in diameter; trees of this type are protected when they reach 12".

A portion of the two story assisted living facility would need to be removed in order to preserve this tree.

Need to remove to move historic structures.

Staff Recommendation: Remove

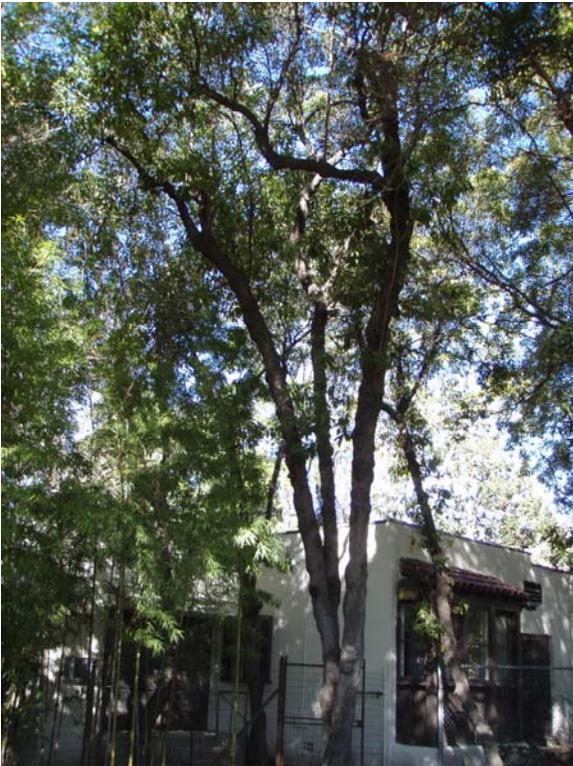
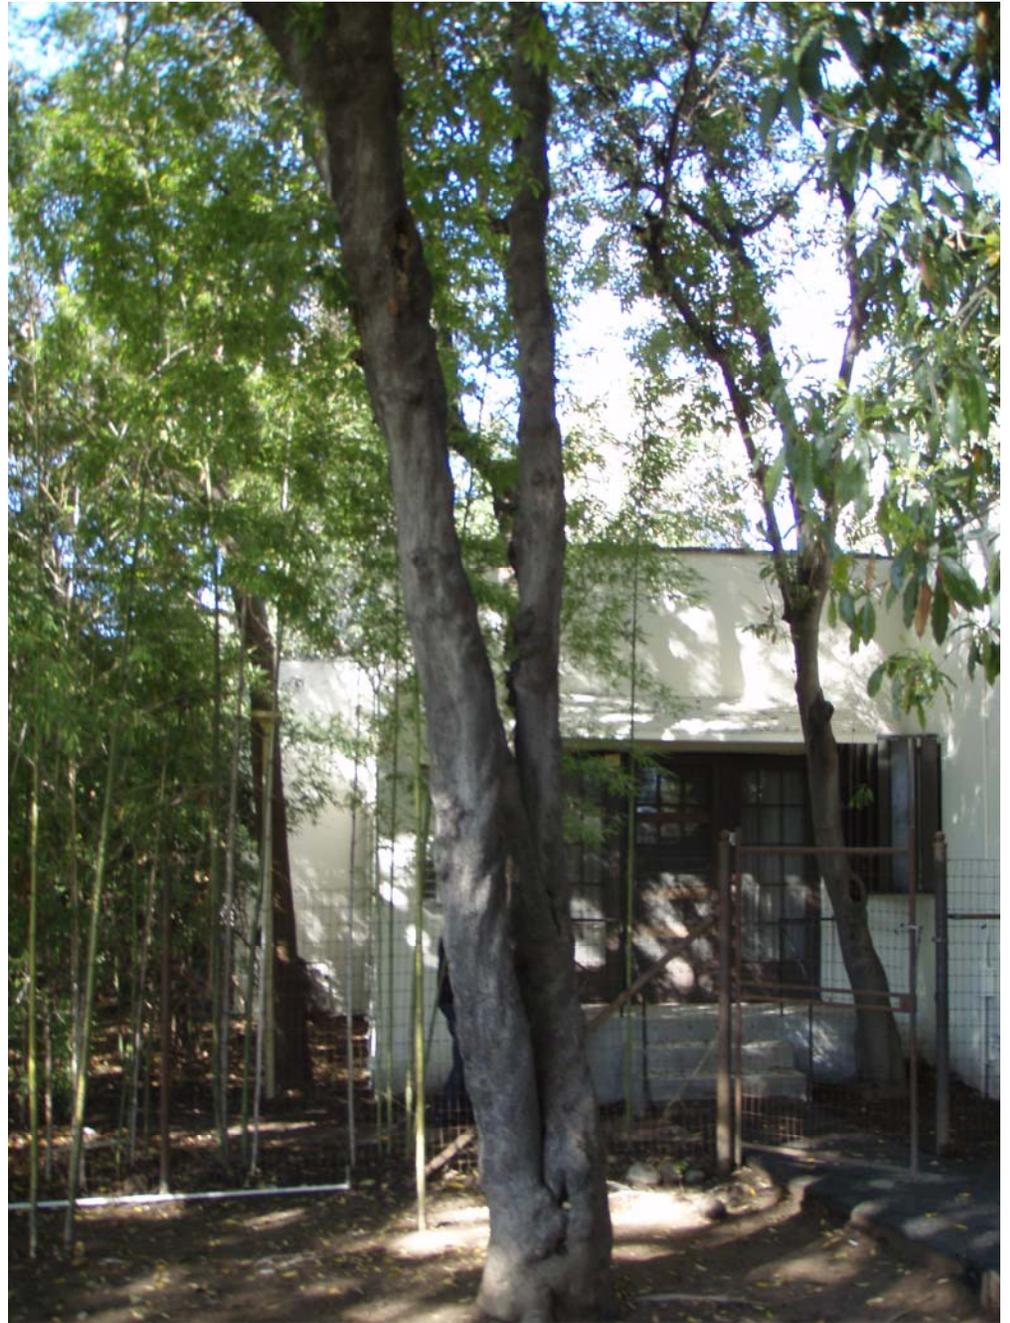
Tree Number: 526

Staff Recommendation: Remove  
Need to remove to move historic structures.

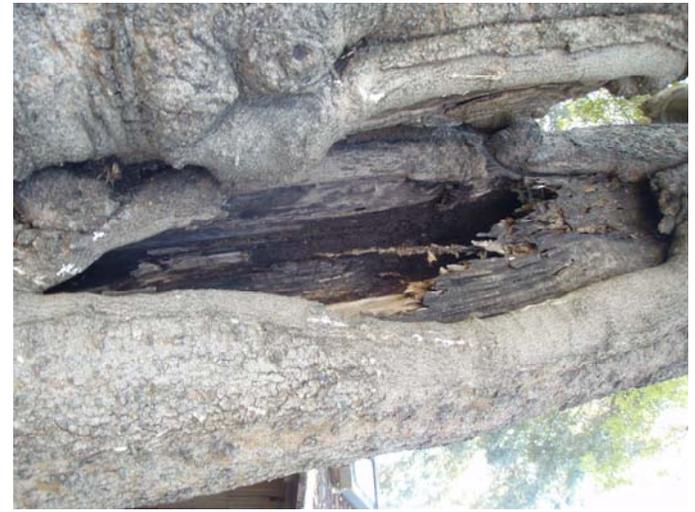
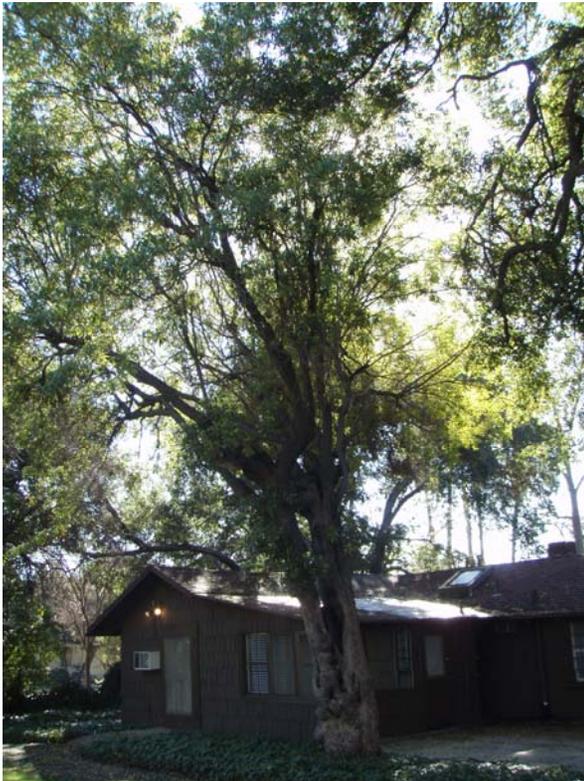
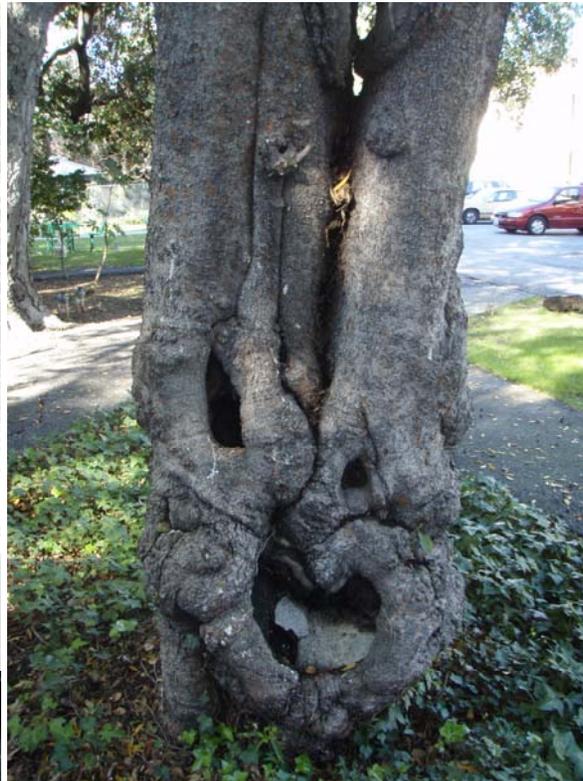
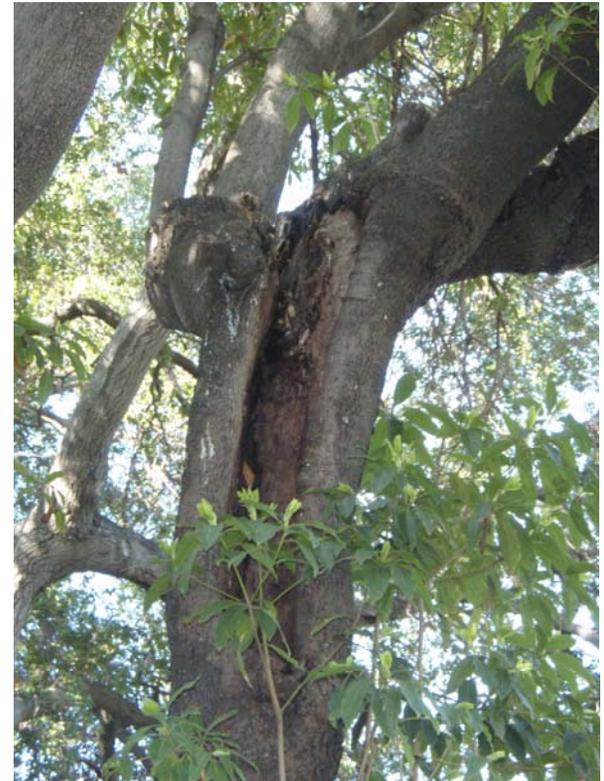
Tree Number: 519

Staff Recommendation:  
Remove – damaged

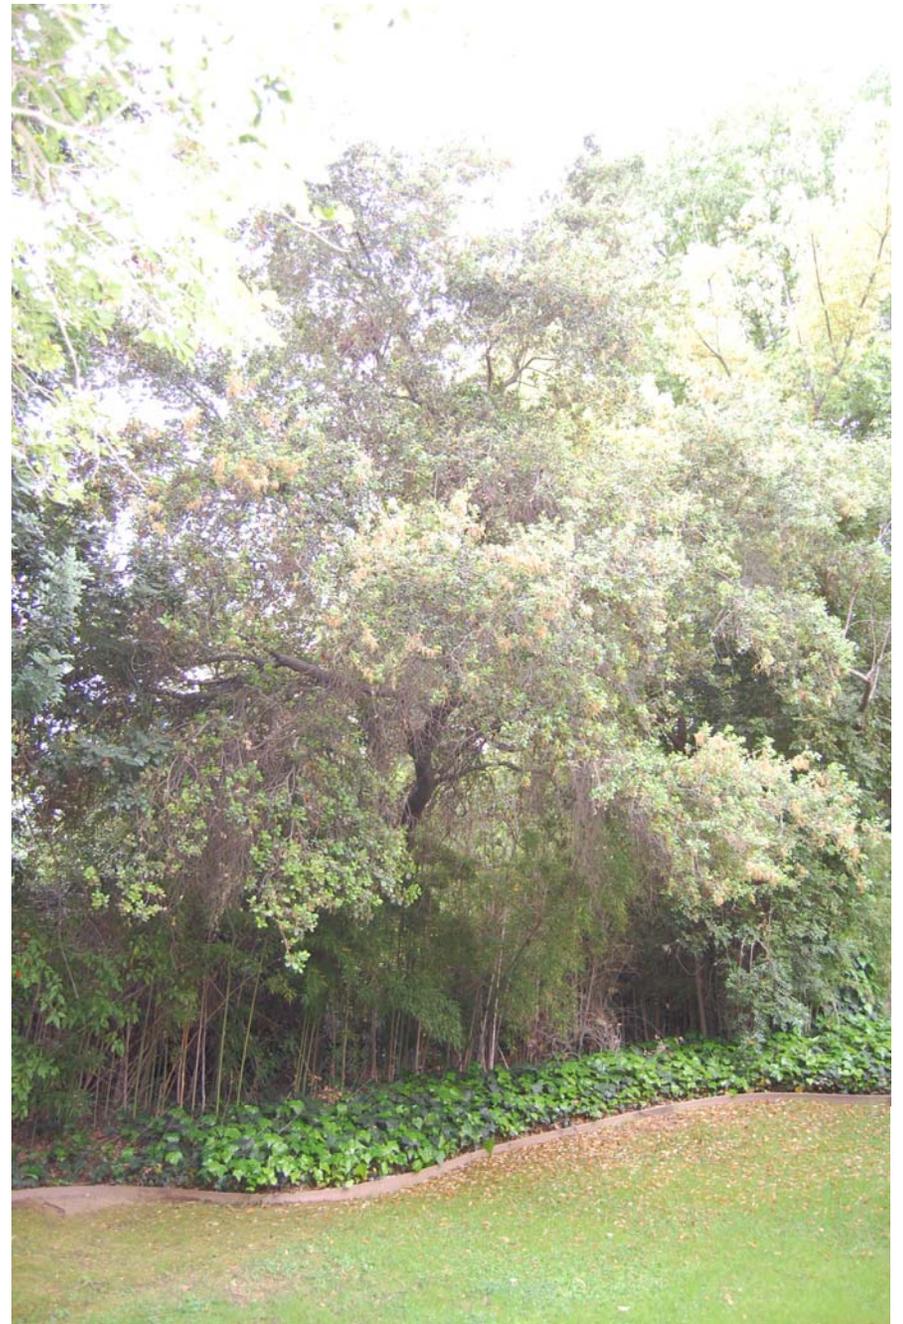
Tree Number: 538

Directly in the middle of a two  
story Bldg.

Staff Recommendation: Remove

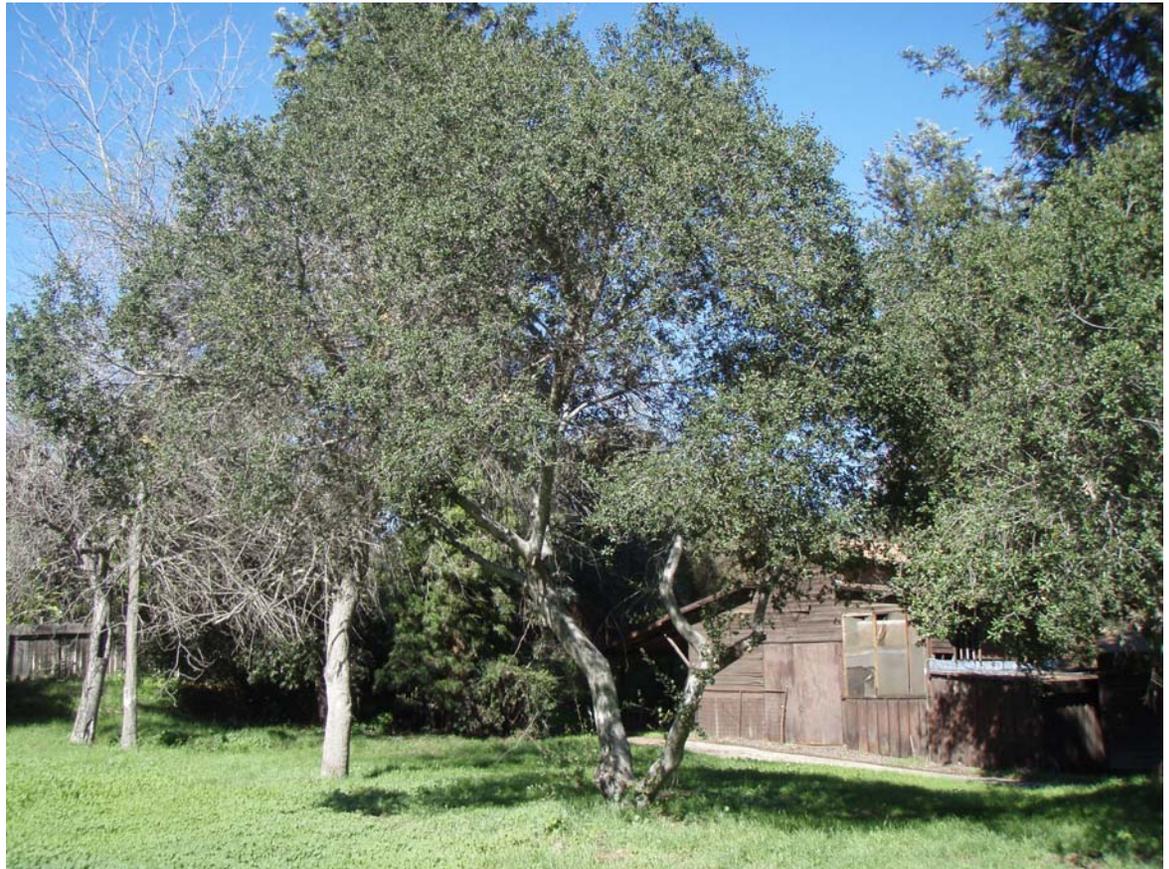
Tree Number: 484

Directly in the path of the proposed parking structure.

Surrounding trees are slated for removal given declining health.

Remove.

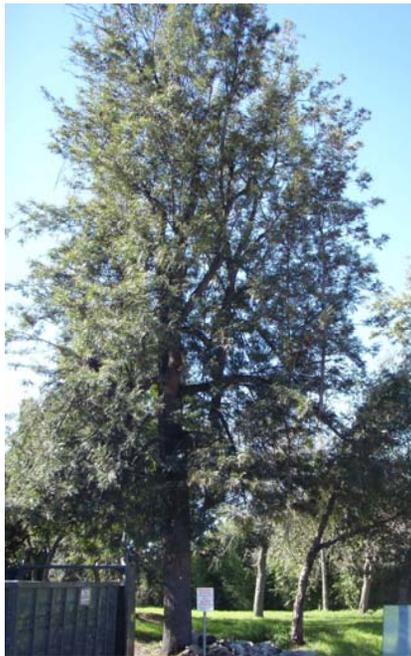
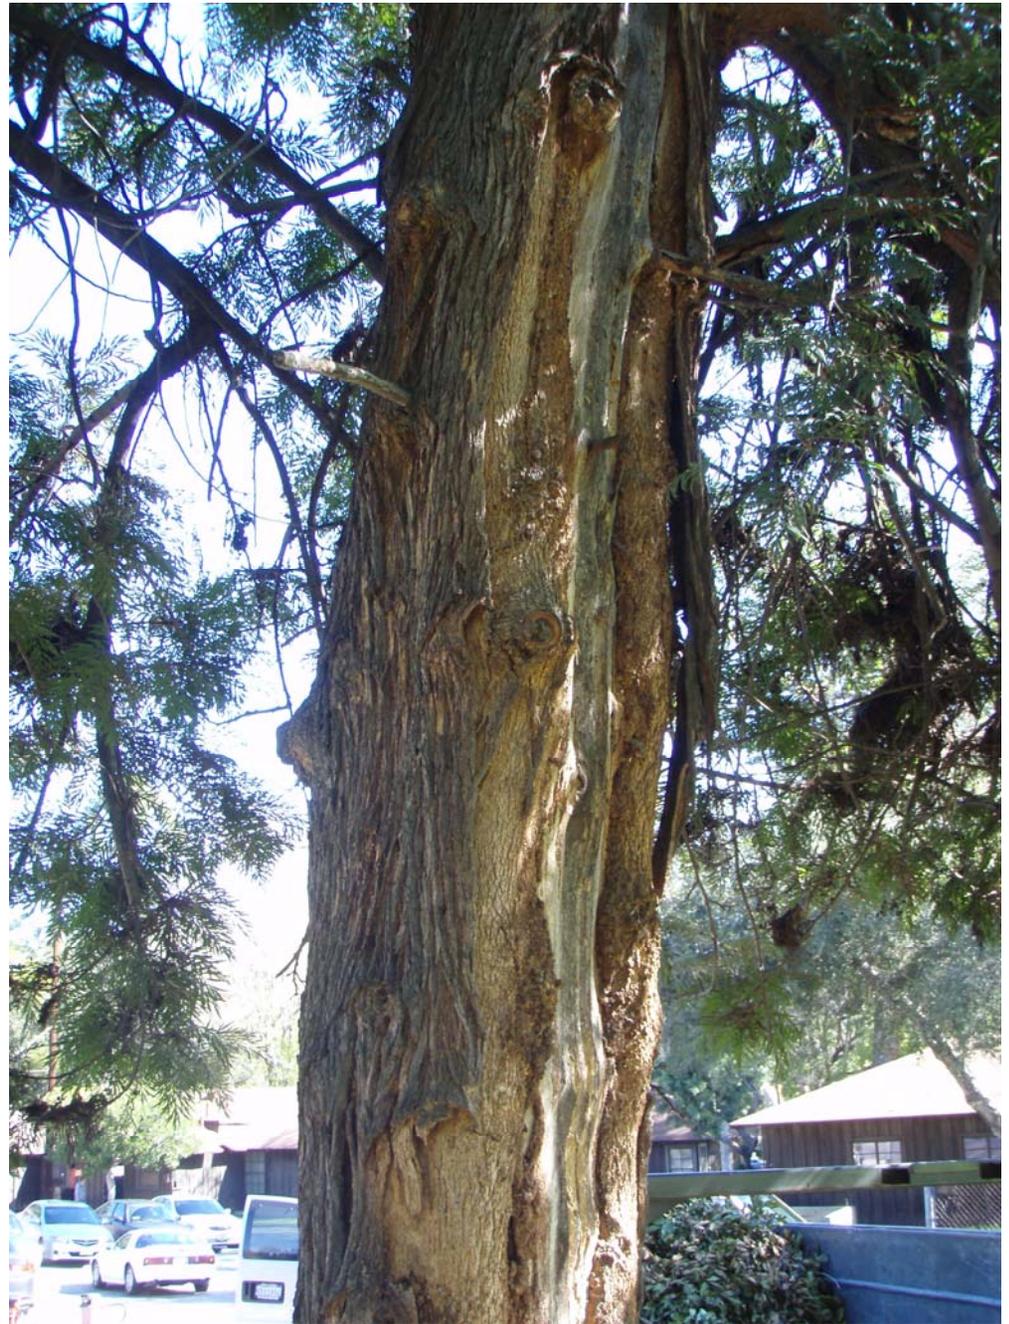
Tree Number: 487

Scar allows for termite infestation. Poor long term viability as heartwood deteriorates.

Staff Recommendation:  
Remove.

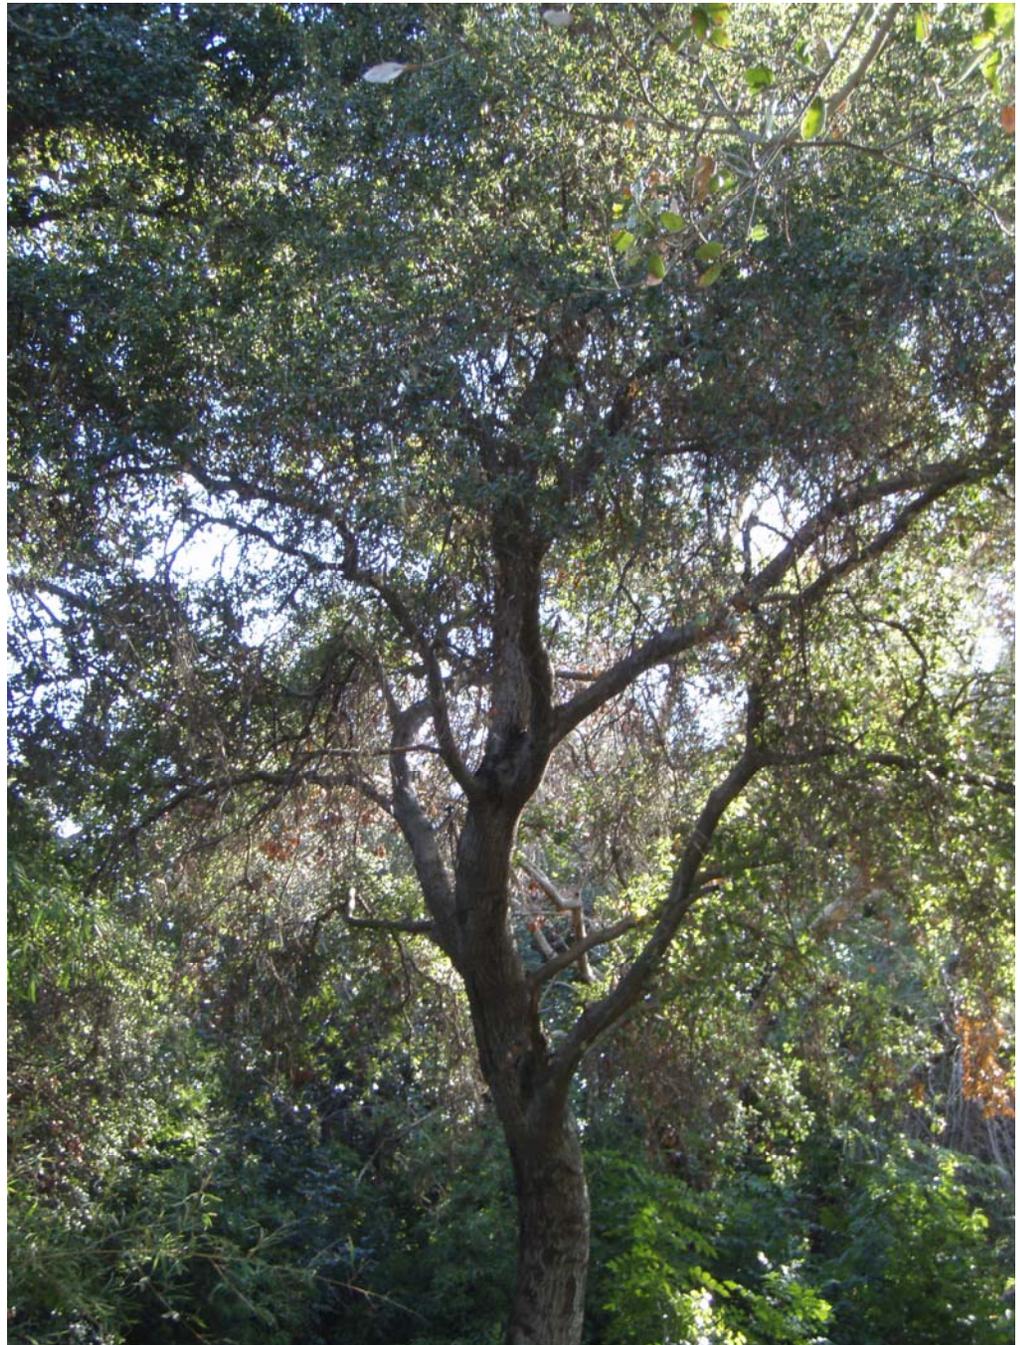
Tree Number: 374

Staff Recommendation: Remove  
Tall, good structure.

Unfortunate location in the middle of required 20' fire access road.

Preservation of this tree may require removal of similar Oak 378.

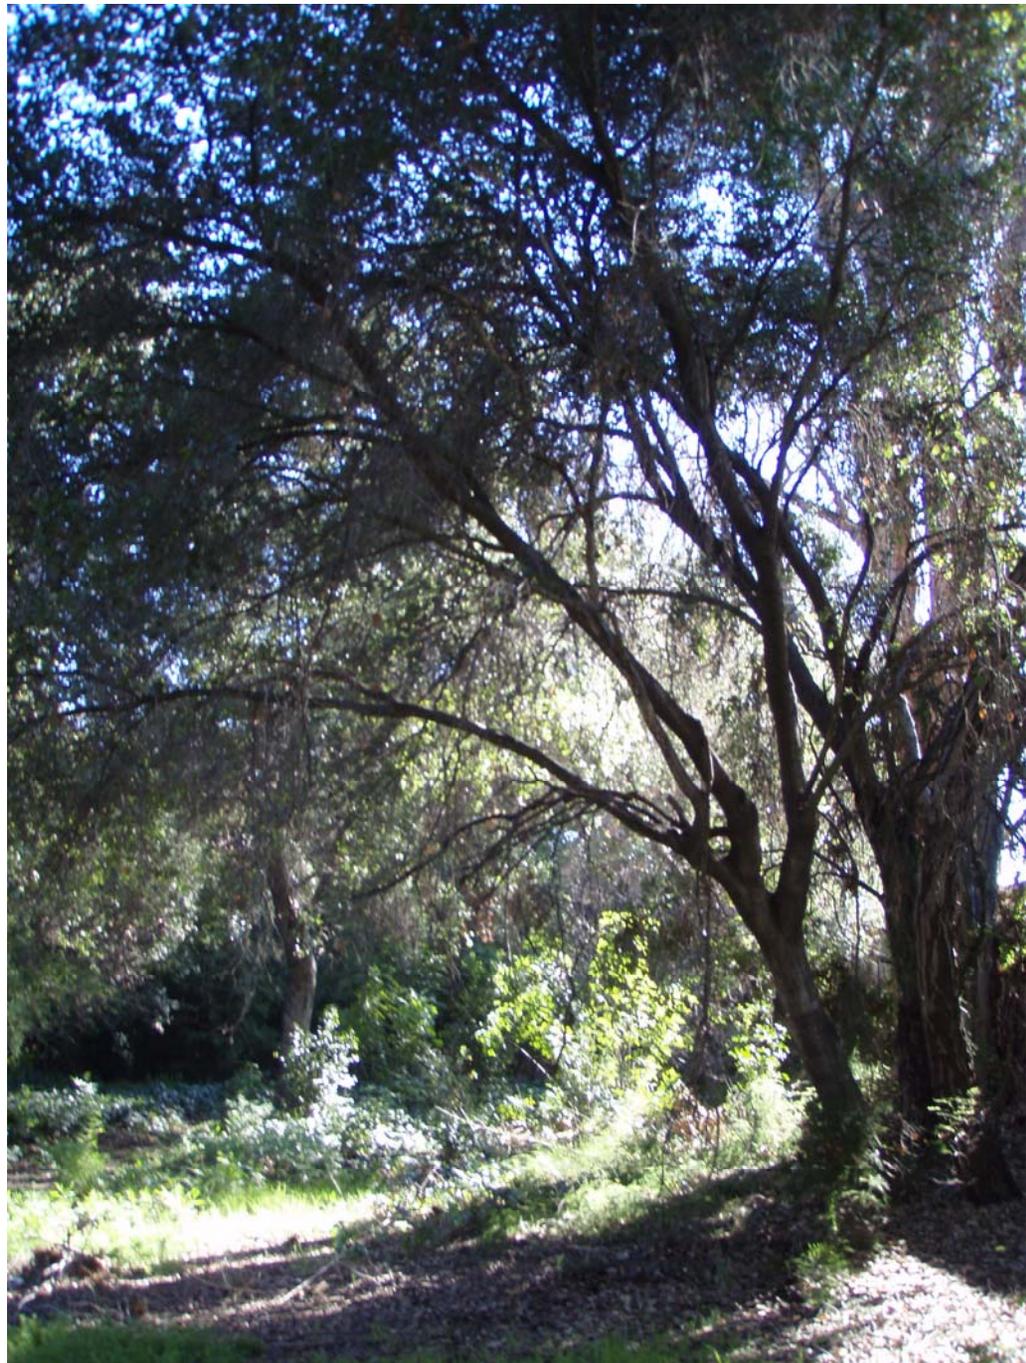
Tree Number: 369

Staff Recommendation: Remove.  
Leaning and crowded.

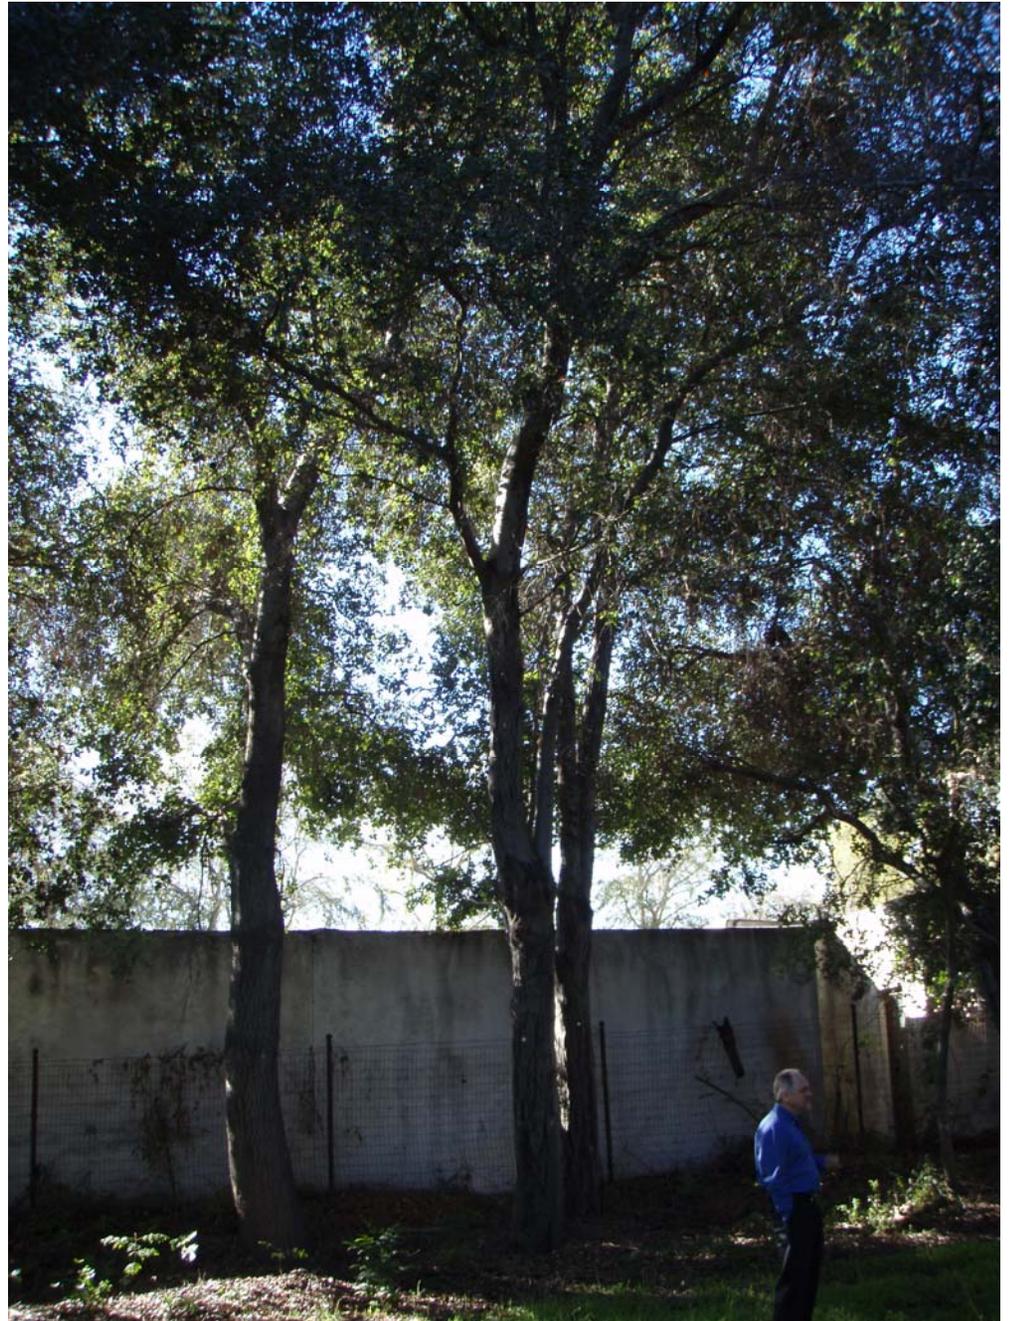
Tree Number: 366

Staff Recommendation: Remove.  
Crowded and leaning.

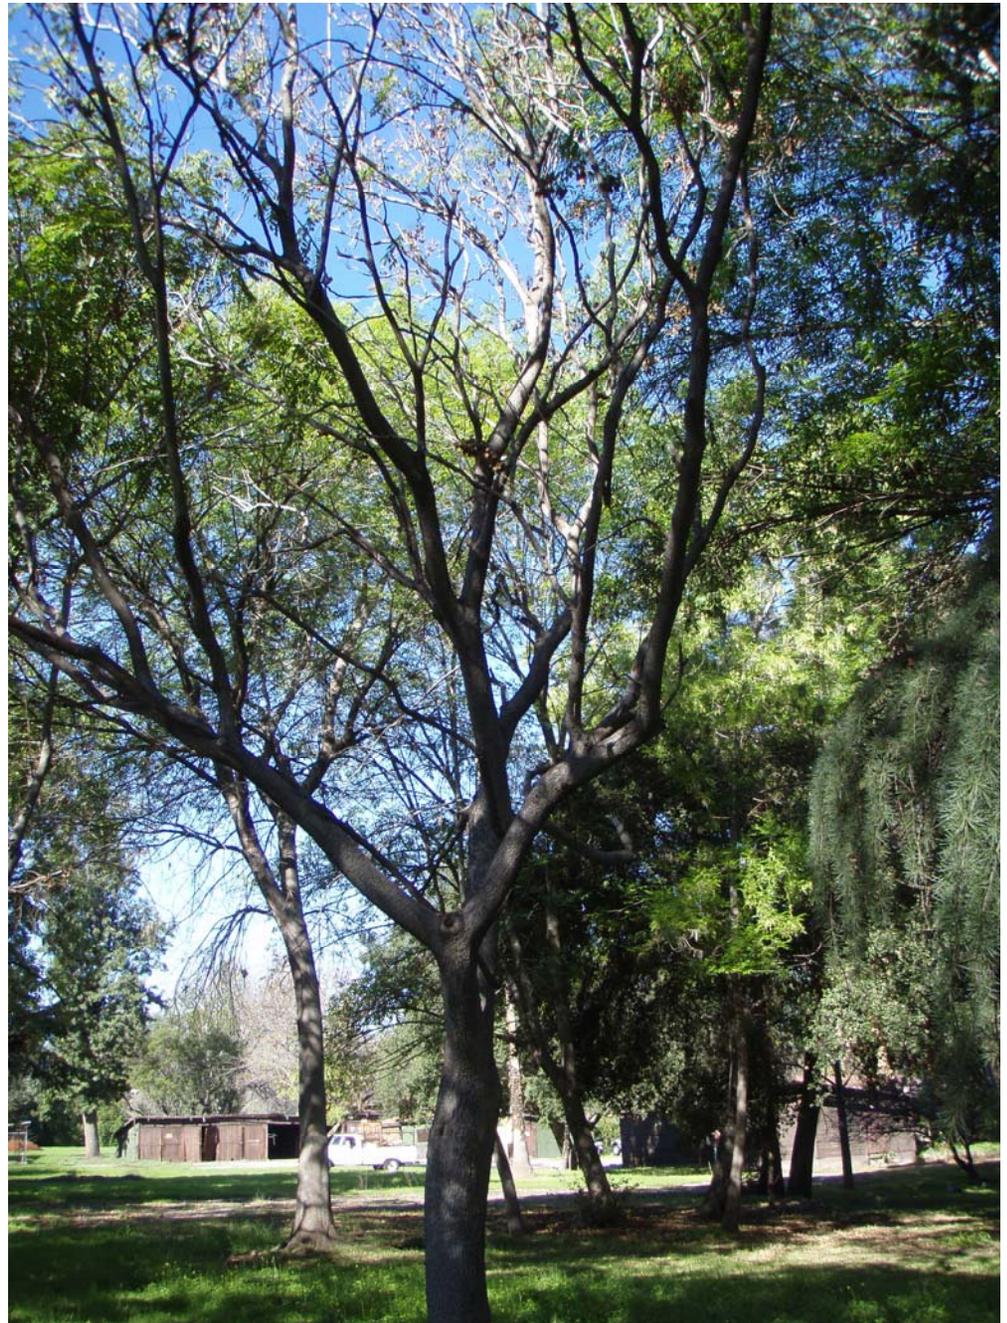
Tree Number: 348

Removal will allow for retention of an oak tree (346) and provision of a required fire access road.

This specimen is still young. The trunk is 16" inches, these trees are protected at 15".

Staff Recommendation: Remove

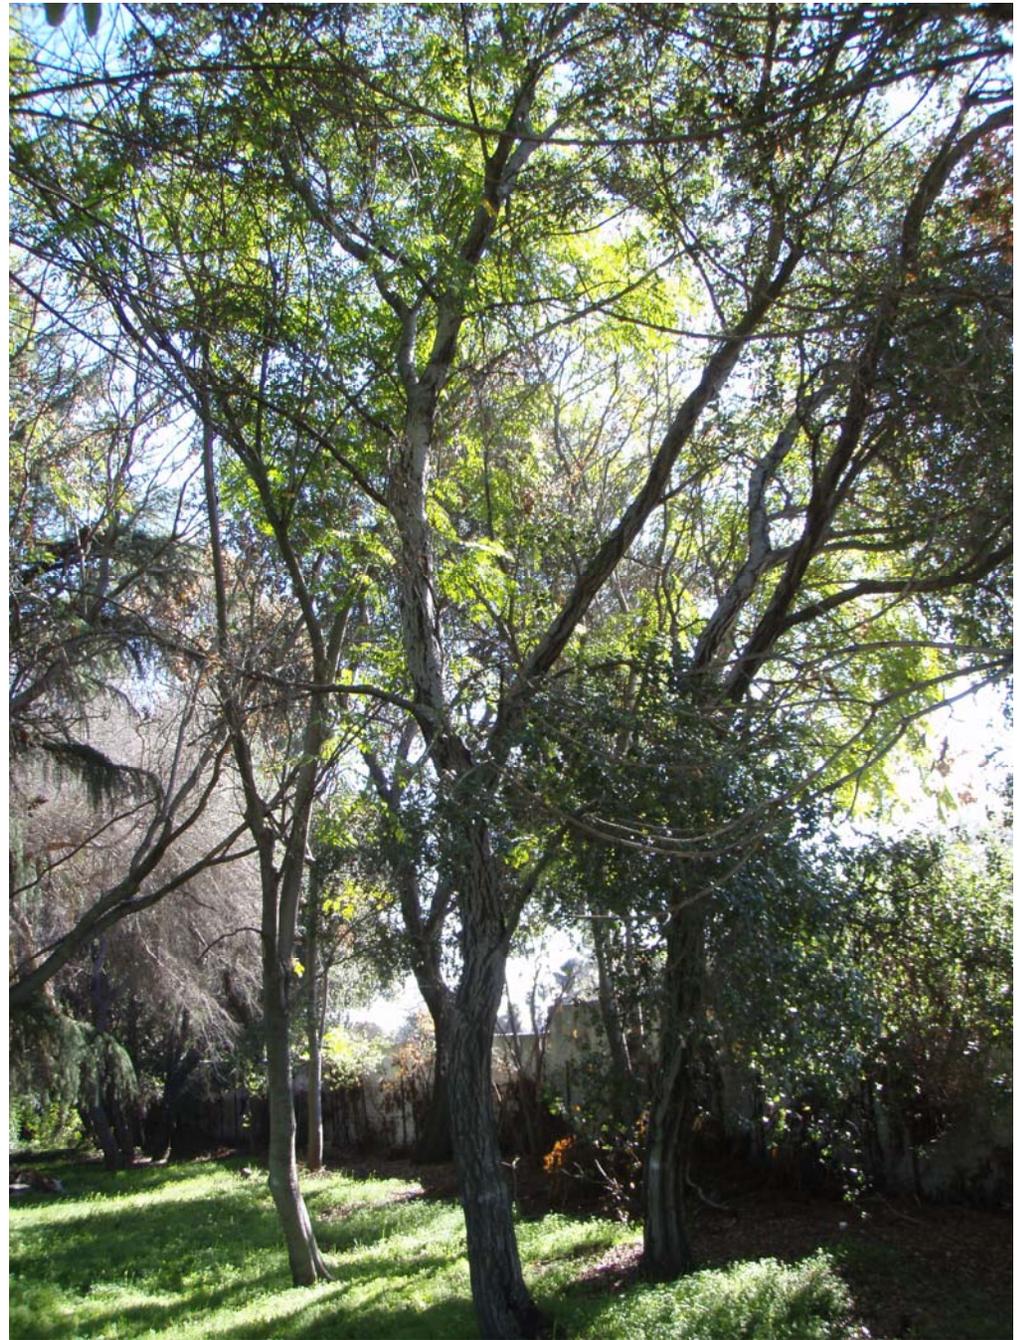
Tree Number: 345

Competing with an Oak and in a  
required fire road.

Staff Recommendation: Remove.

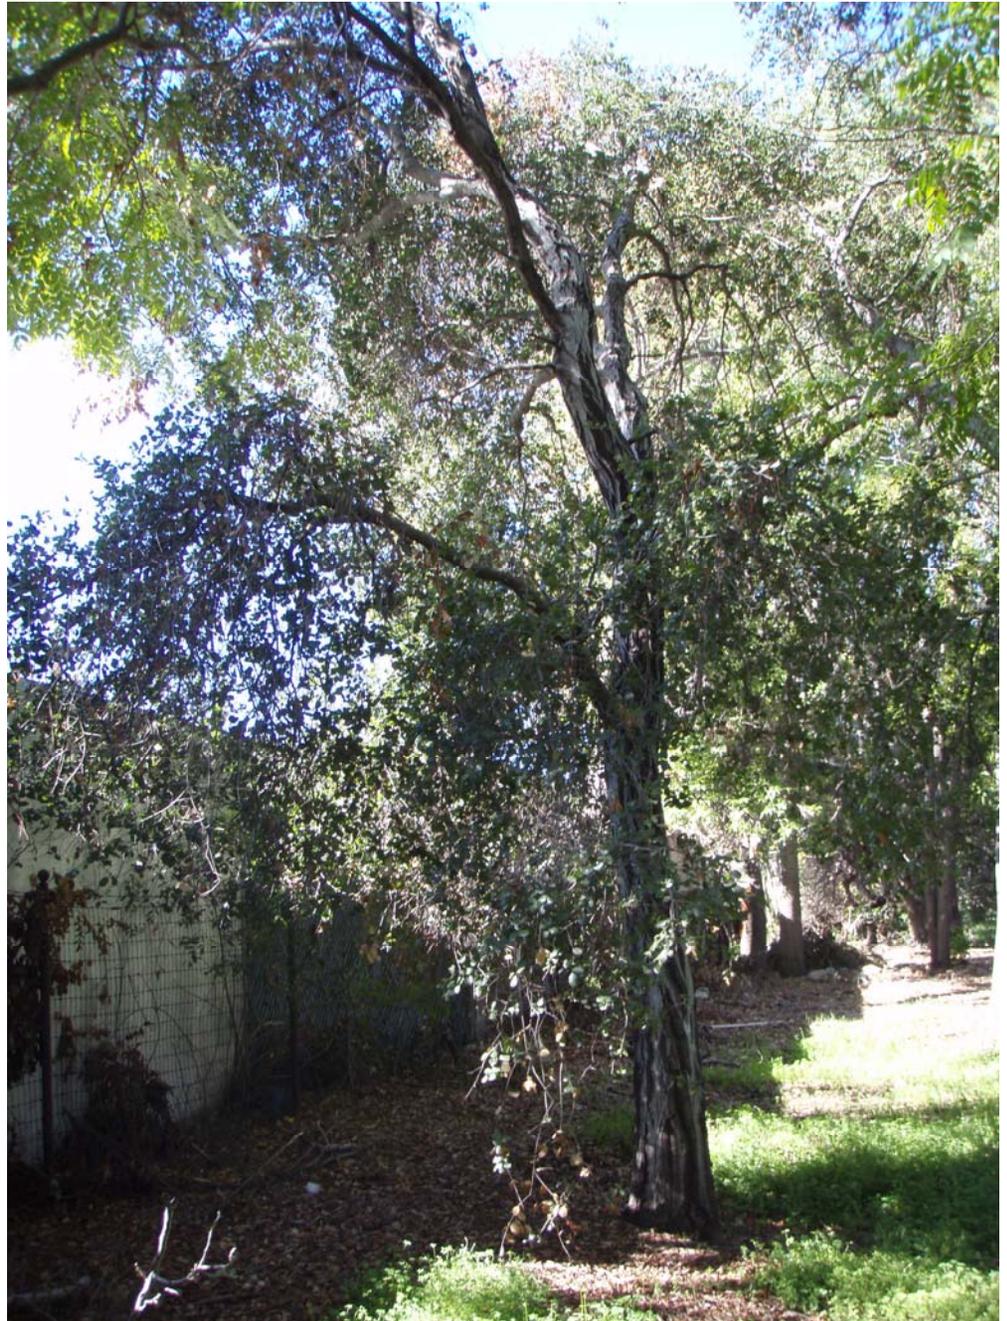
Tree Number: 346

May require modifications to the fire road.

Staff Recommendation: Retain

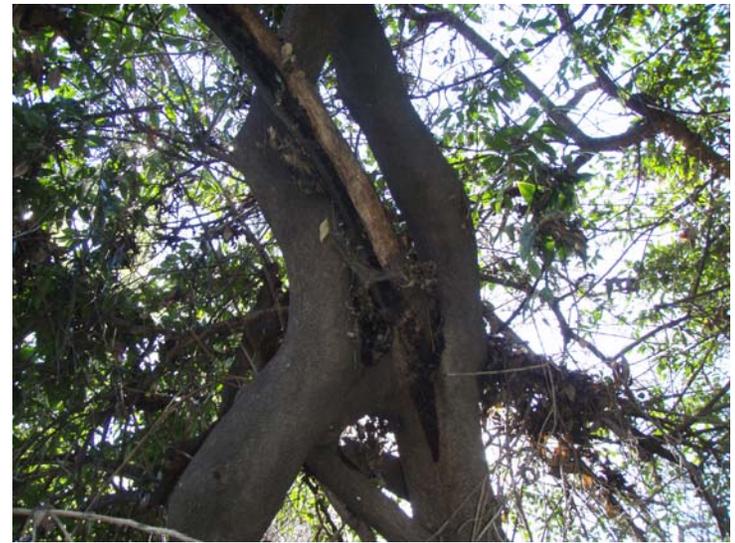
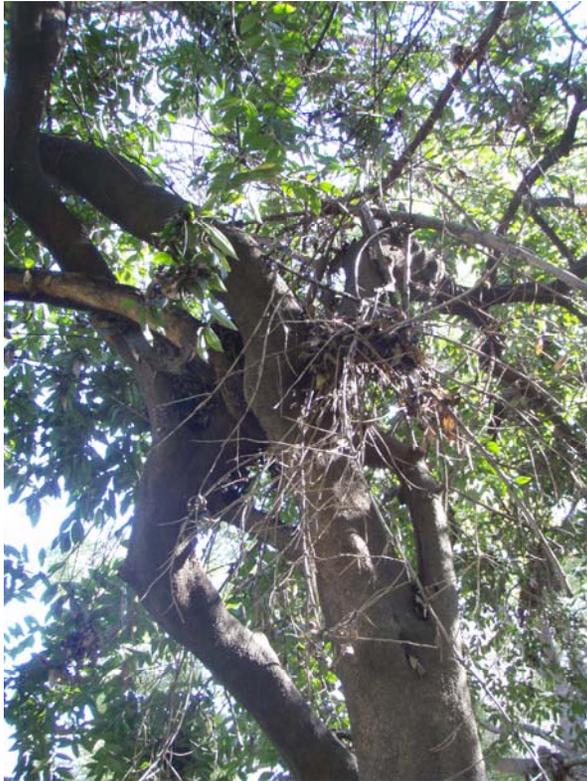
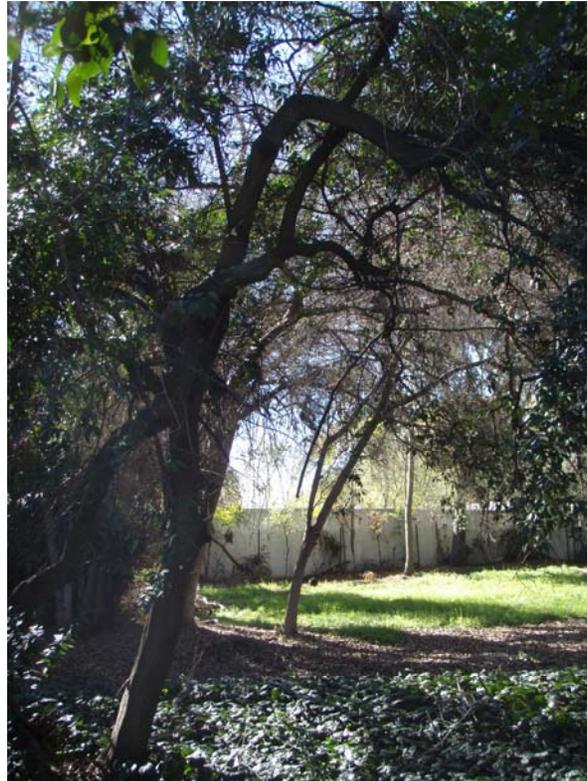
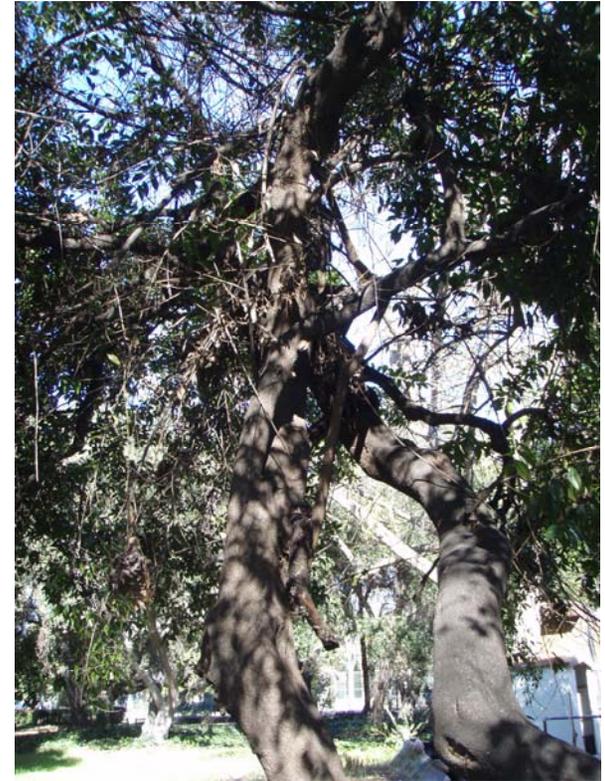
Tree Number: 354

Staff Recommendation: Remove.  
Very poor structure.

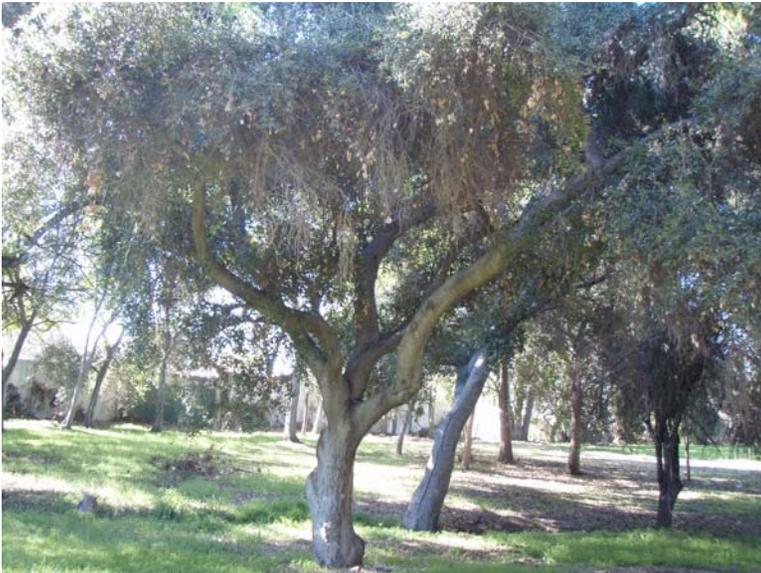
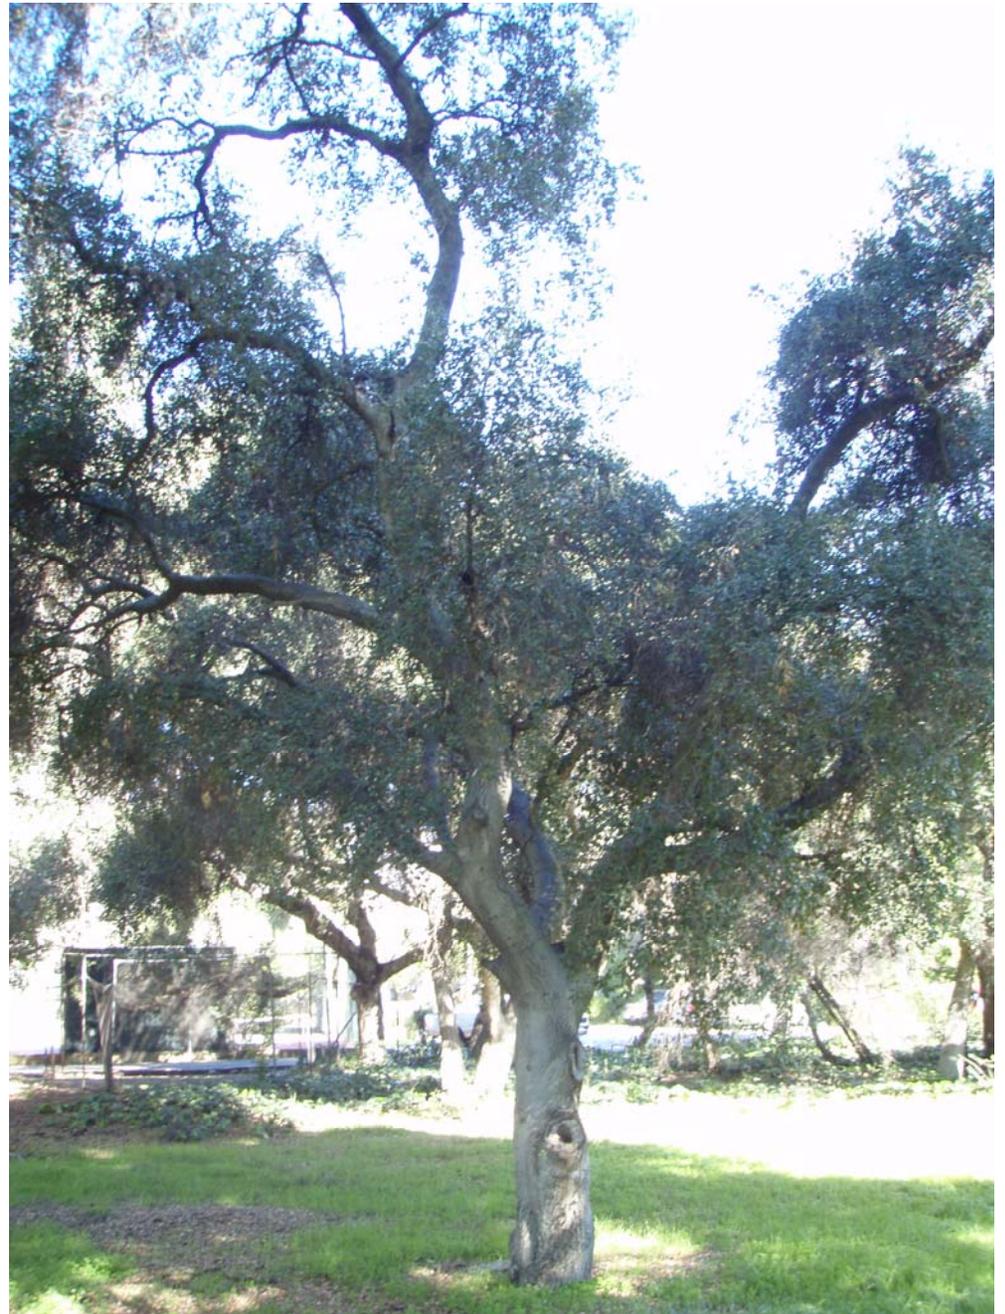
Tree Number: 334

This tree is in the middle of a proposed parking garage and the lobby/dining area of the independent living facility.

Staff Recommendation: Remove
