# Assisted Living Building

Building 32

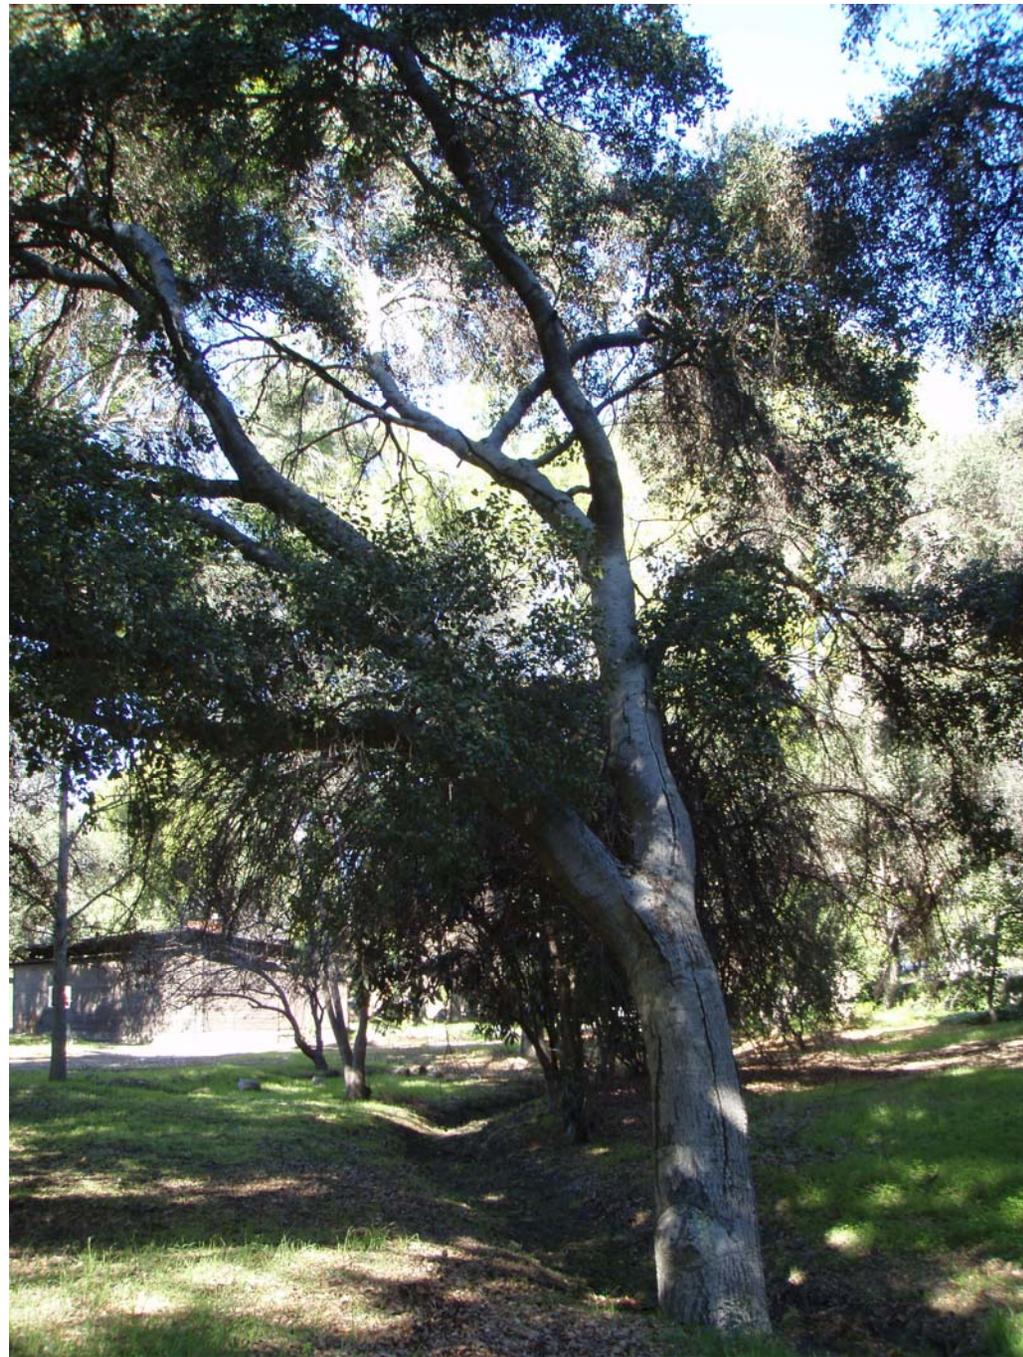
Tree Number: 333

Location in the middle of the lobby and leaning toward the two story portion of the building.

Staff Recommendation: Remove.

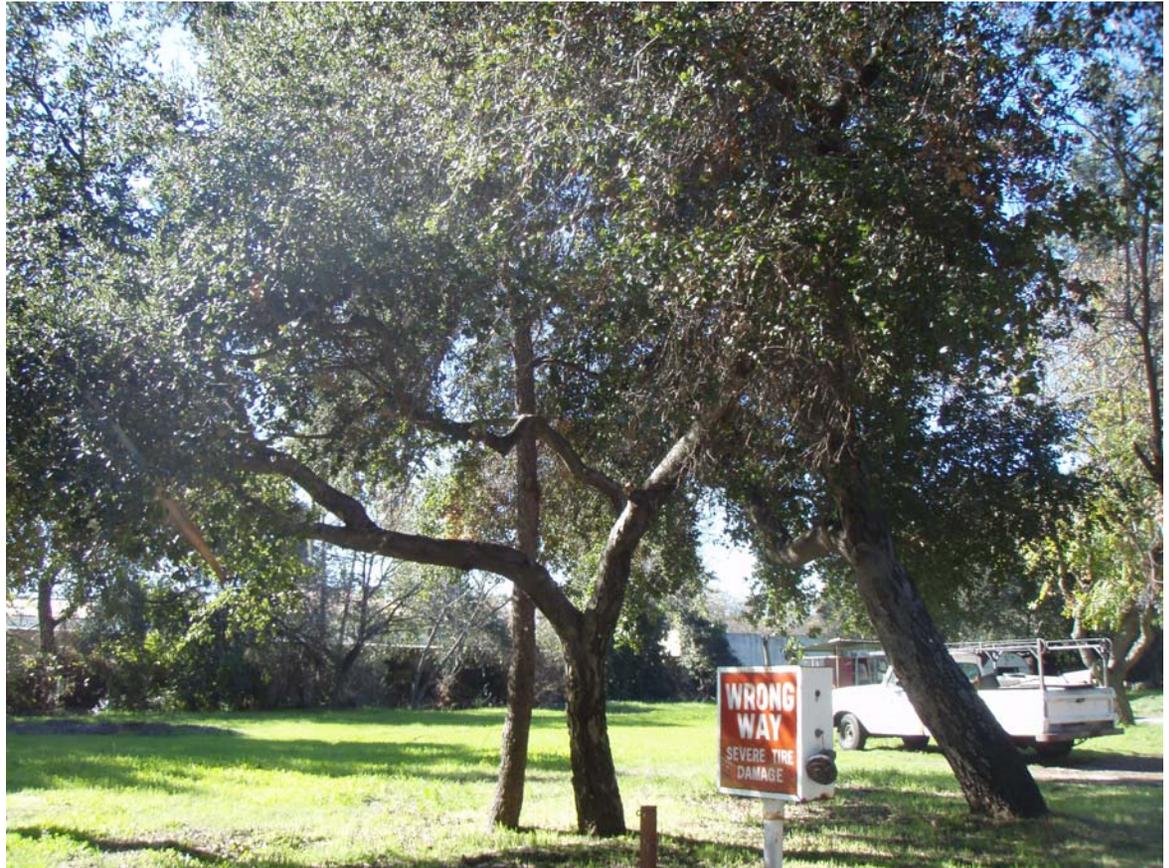
Tree Number: 428

Staff Recommendation: Remove.  
In the middle of the two story  
portion of the building.

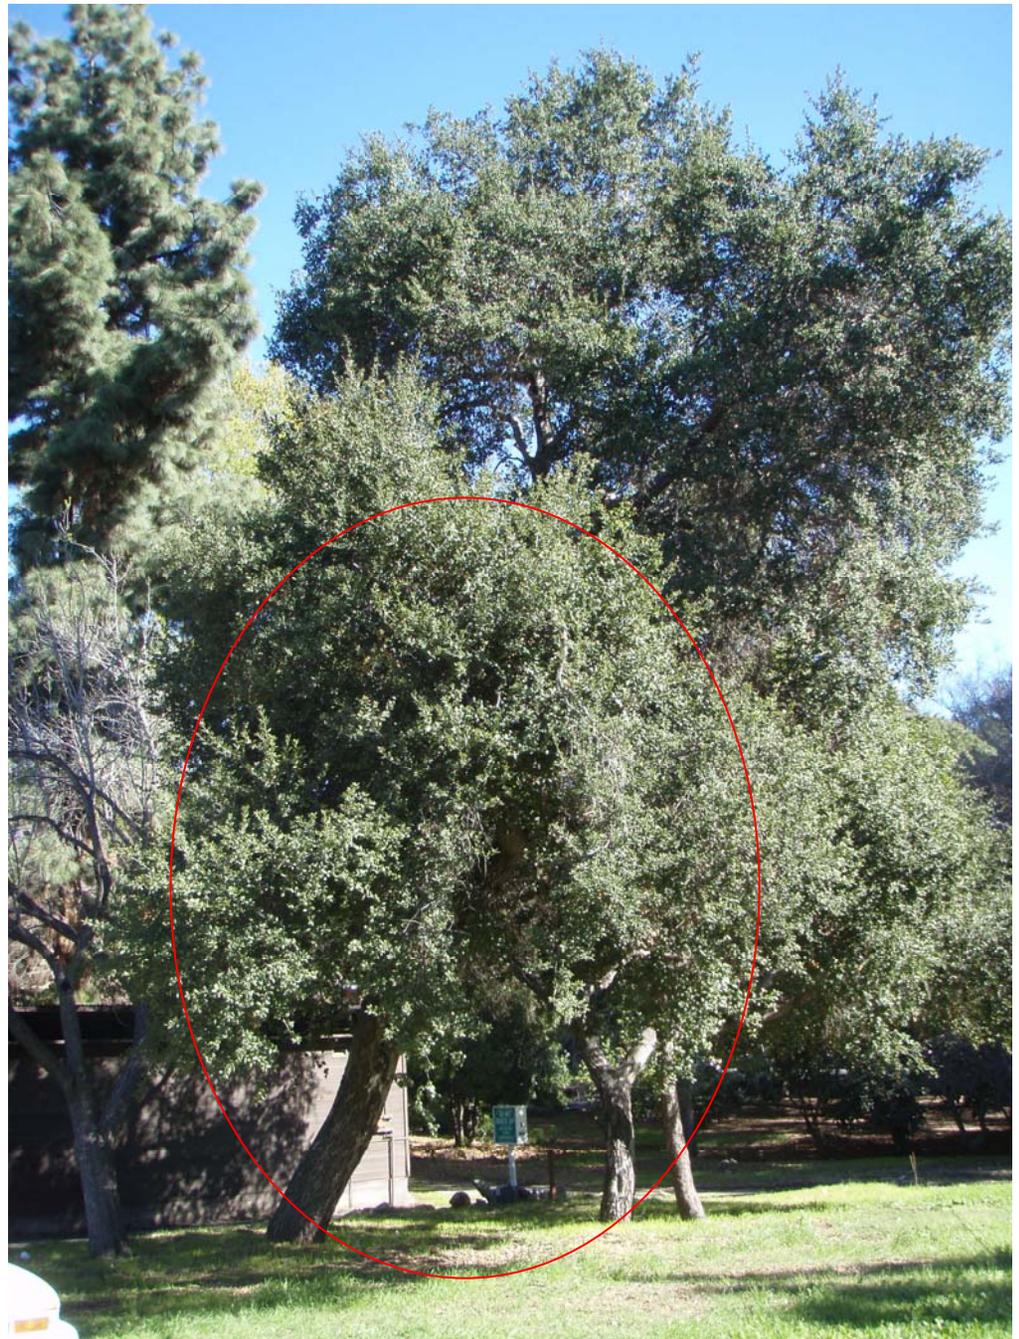
Tree Number: 429

Staff Recommendation: Remove. Directly adjacent to 428. In the middle of the 2 story portion of the building.

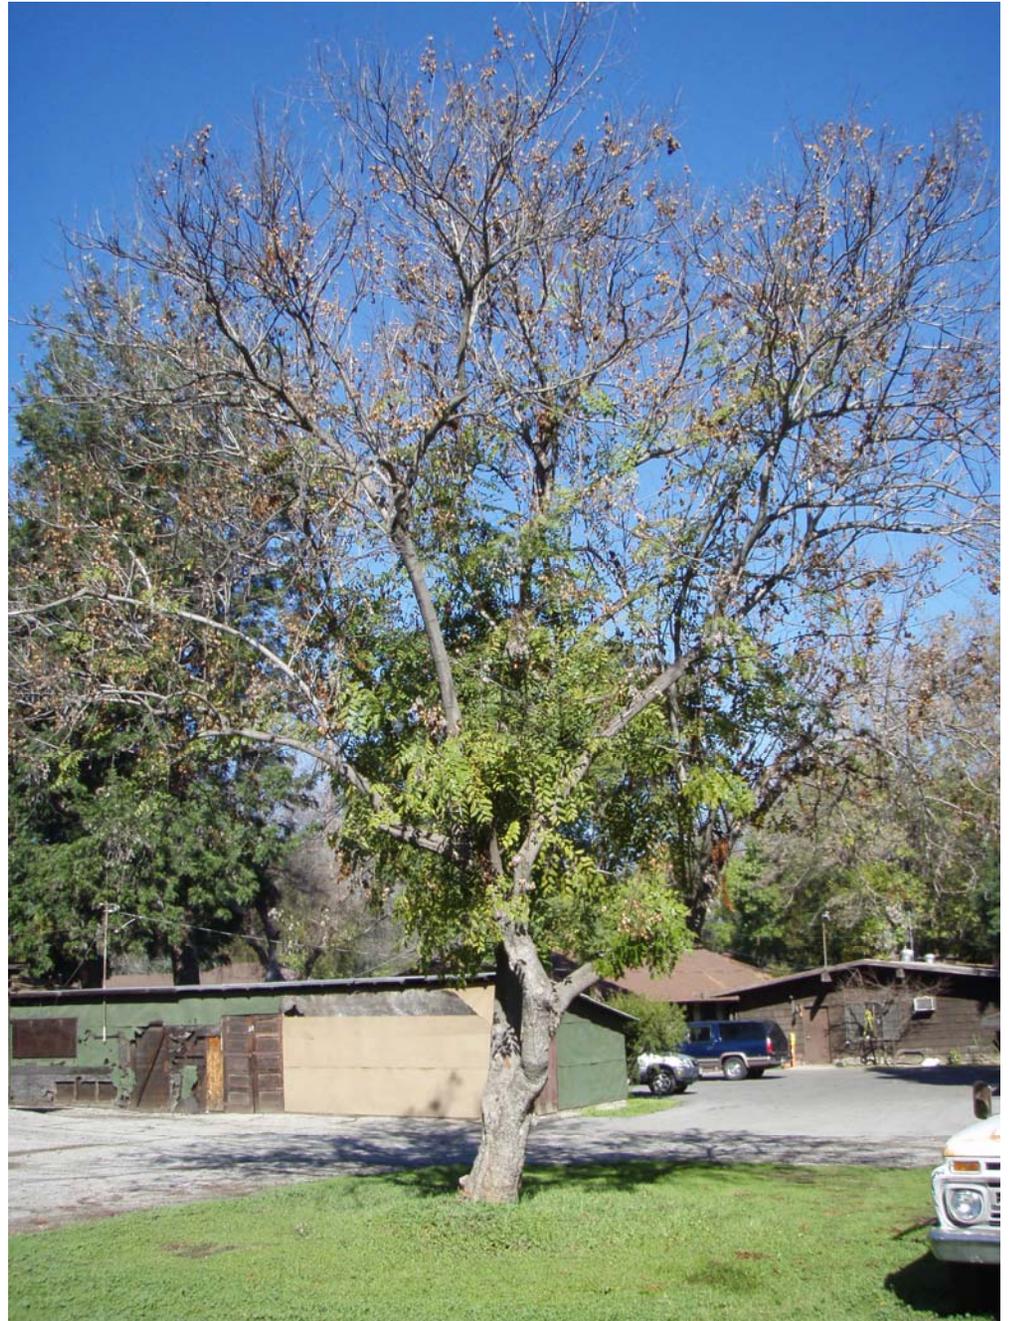
Tree Number: 431

Staff Recommendation: Remove.  
Fast growing, non-native tree in the middle of the three story portion of the building.

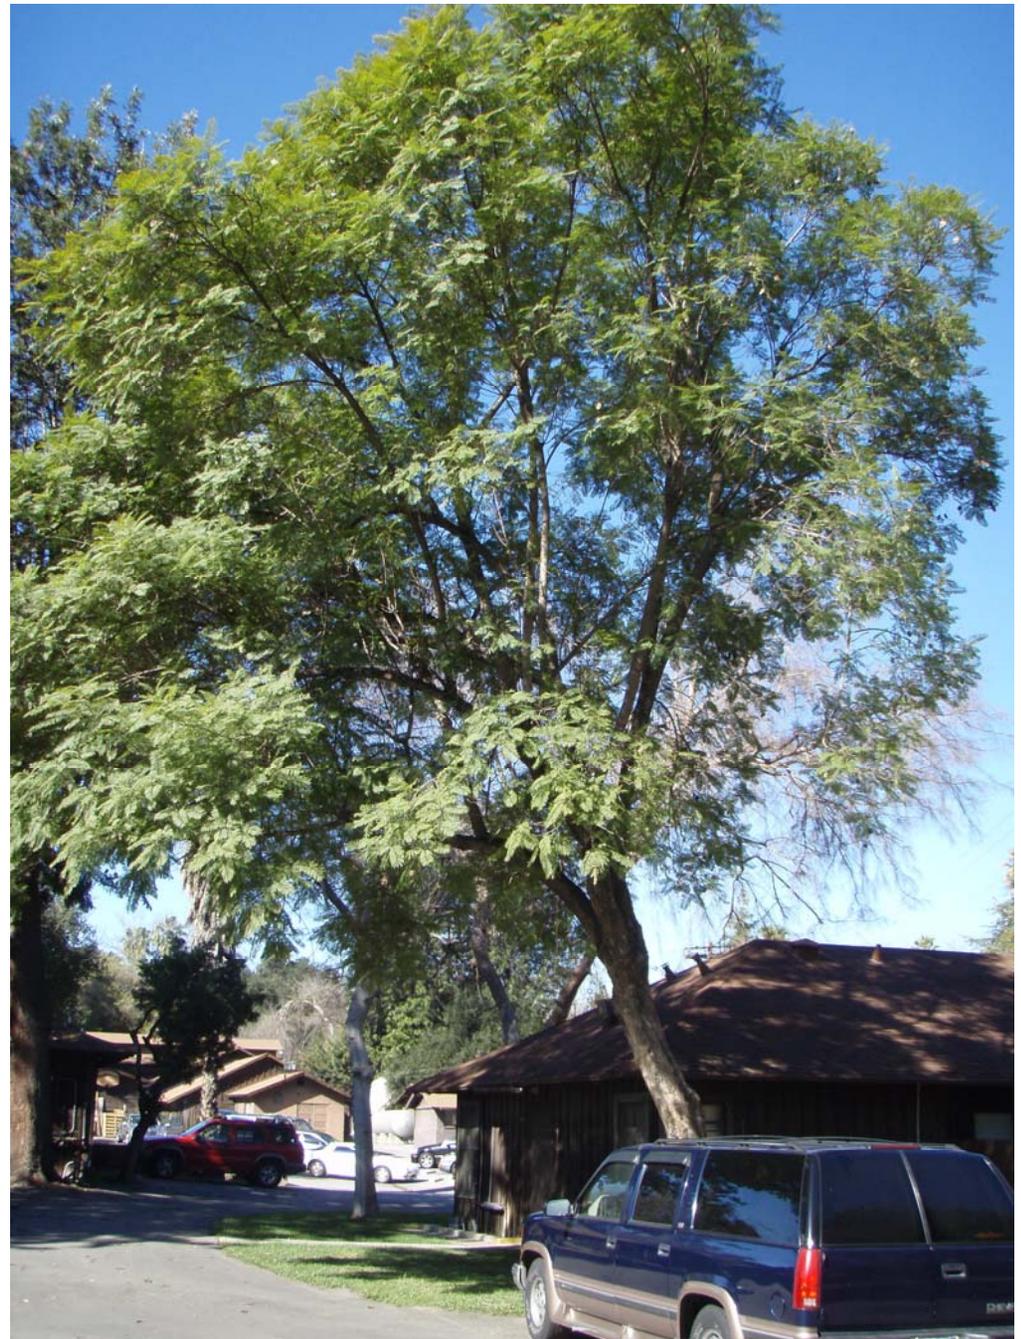
Tree Number: 419

This portion of the three story independent living facility would need to be removed in order to preserve this tree.

The tree's diameter is 15".  
These trees are protected when they reach 13" in diameter.

Jacaranda trees are fast growing species.

Staff Recommendation:  
Remove.

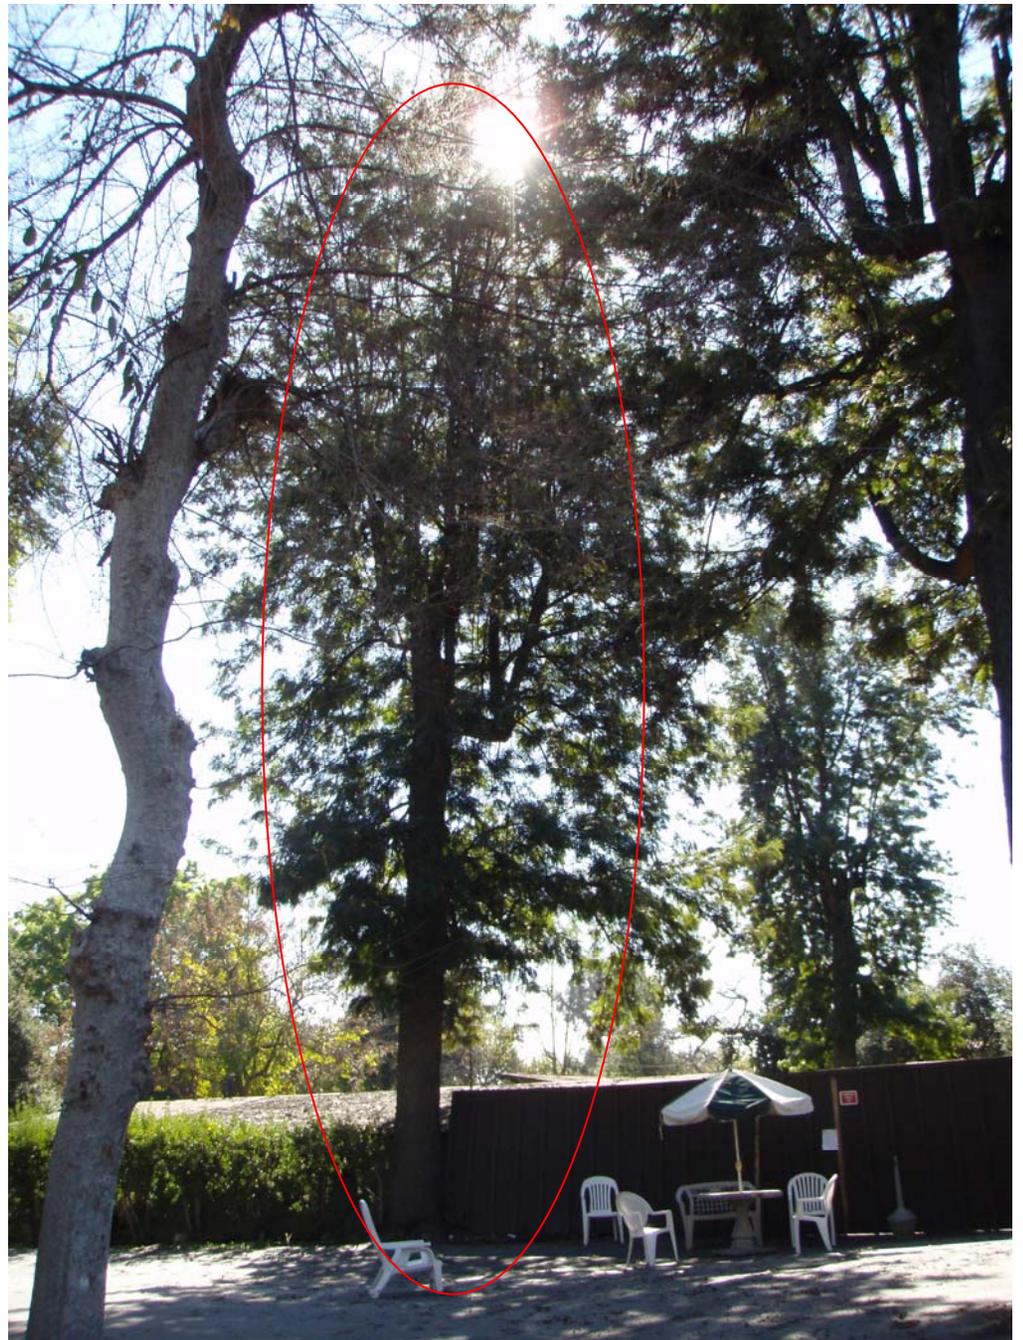
Tree Number: 420

This portion of the three story independent living facility would need to be removed in order to preserve this tree.

Staff Recommendation: Remove

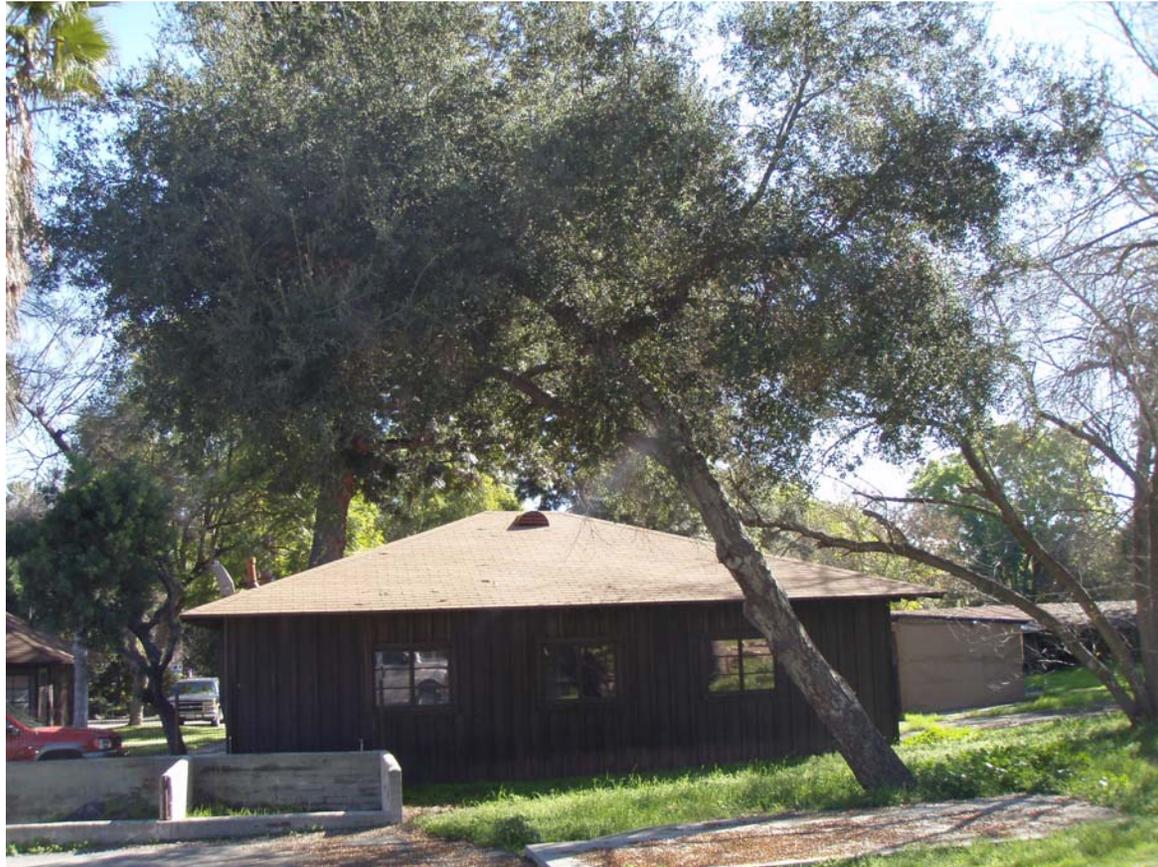
Tree Number: 494

In the middle of planned  
fire road.

Drastically leaning to the  
north.

Staff Recommendation:  
Remove

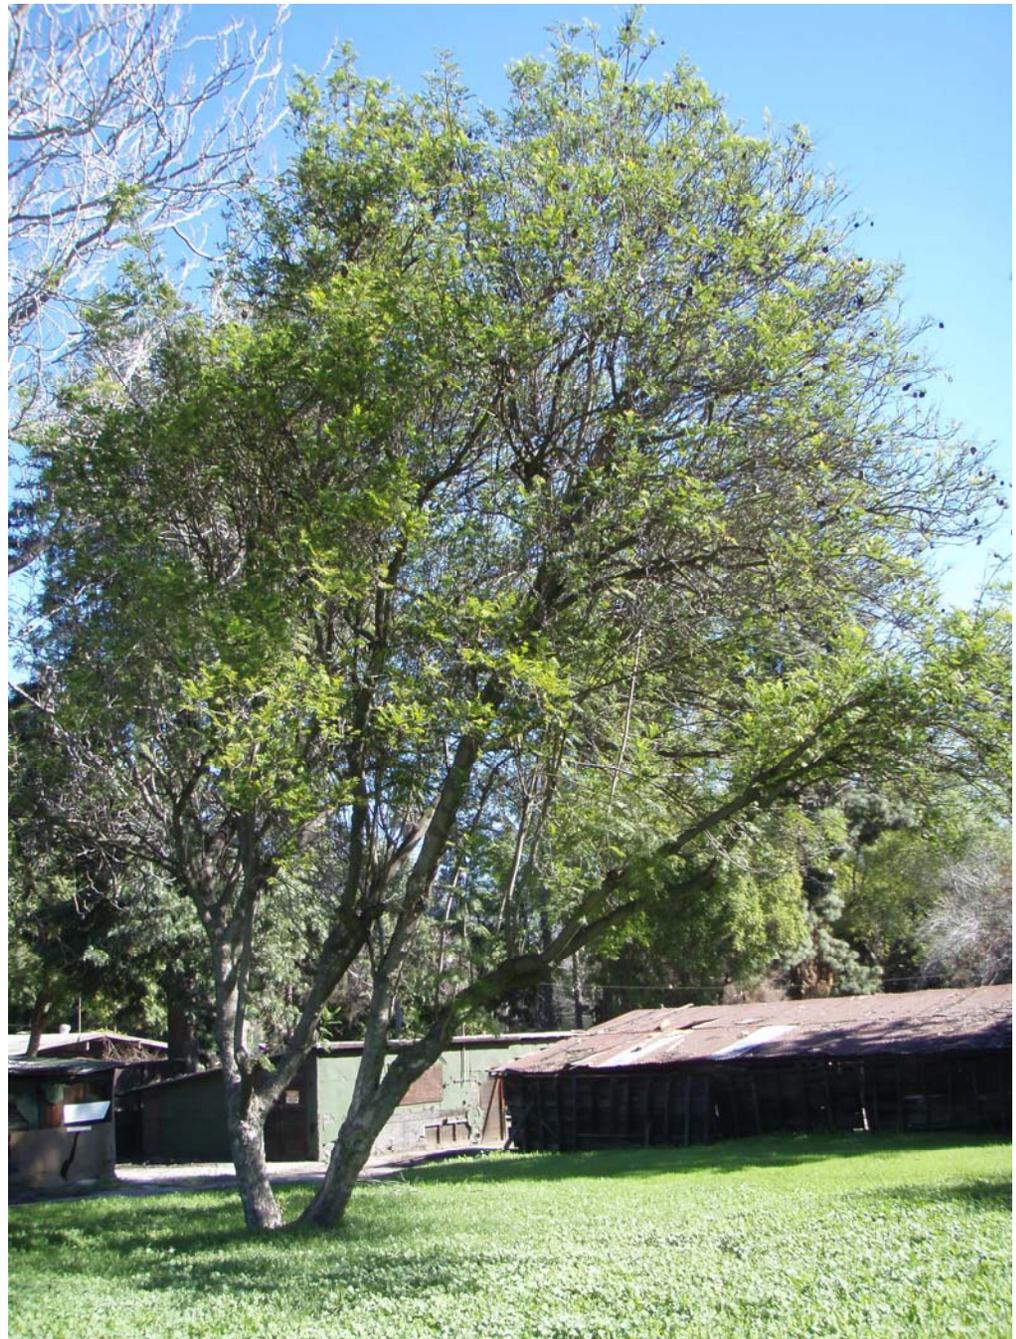
Tree Number: 444

This portion of the three story independent living facility would need to be removed in order to preserve this tree.

Staff Recommendation: Remove

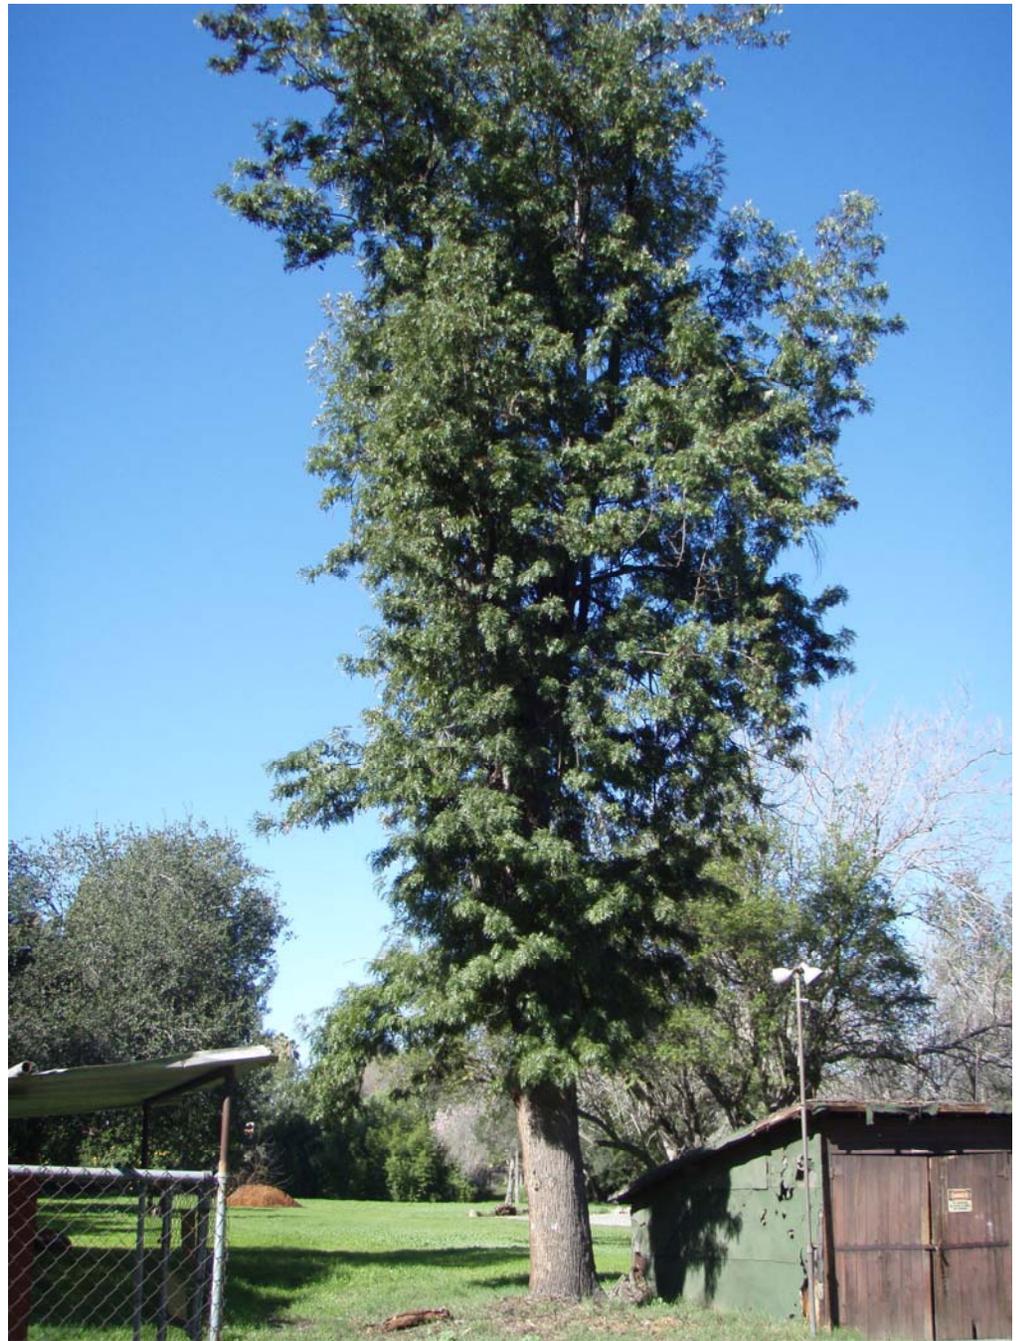
Tree Number: 439

Topped.

Very poor structure.

Staff Recommendation: Remove.

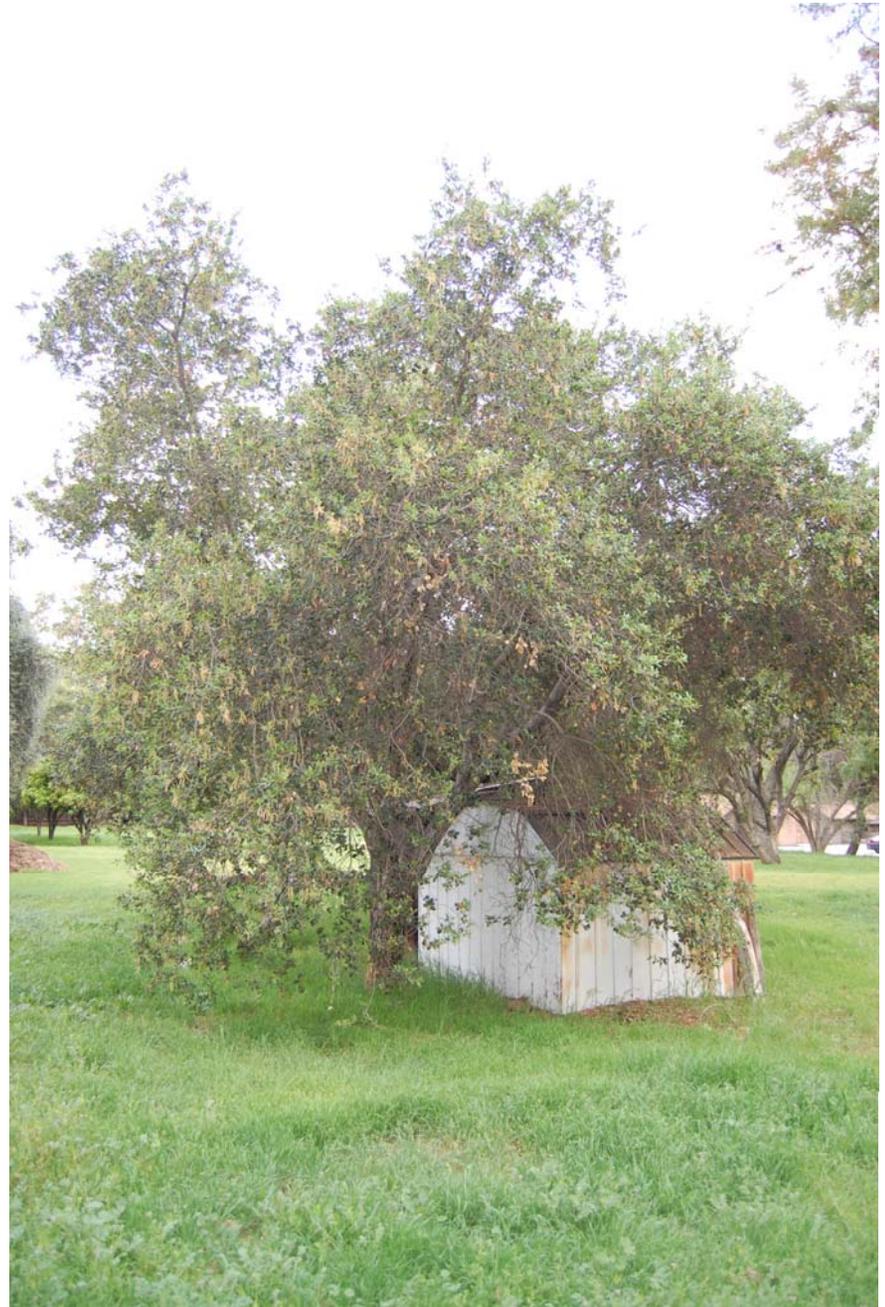
Tree Number: 440

Fire access road requires 14' vertical clearance. The tree's canopy is low and would require significant trimming.

Preserving this tree would place the fire road closer to tree 441, a protected Oak of greater significance.

Staff Recommendation:  
Remove.

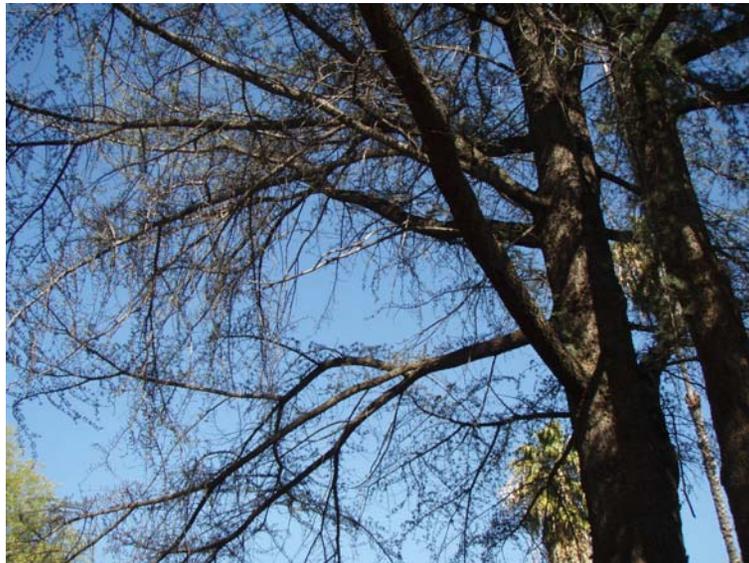
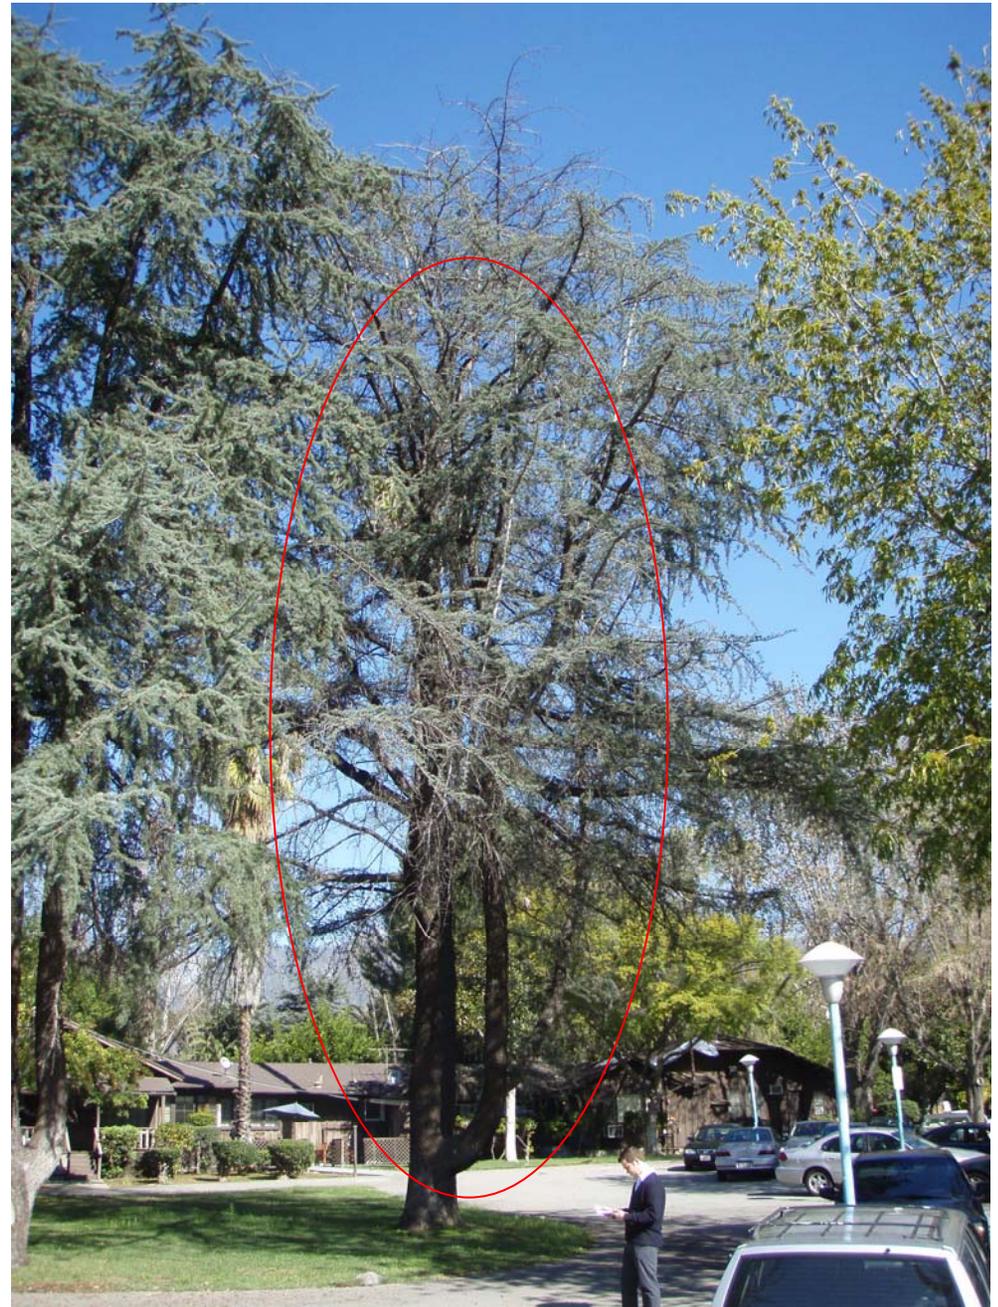
Tree Number: 587

Tree is in poor health and is not likely to survive.

Staff Recommendation: Remove

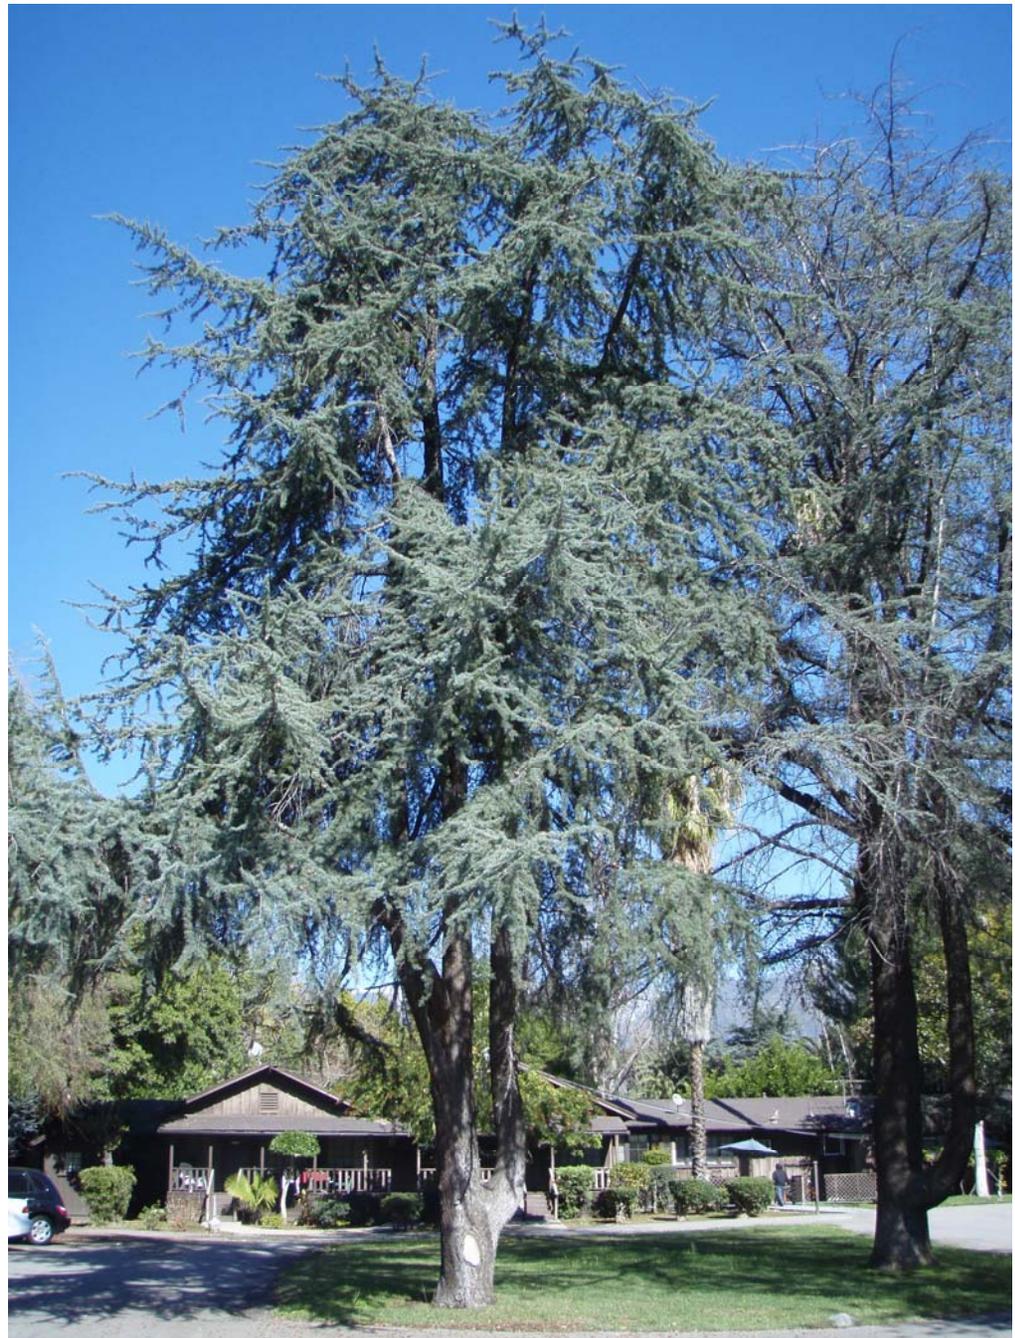
Tree Number: 588

Adjacent tree is in poor health.

This tree could be similarly susceptible.

Retention would require major building reconfiguration, for one tree.

Staff Recommendation: Remove

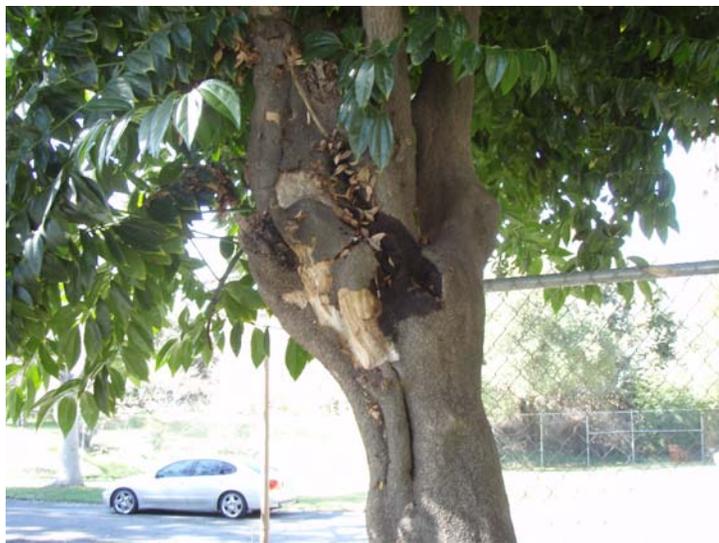
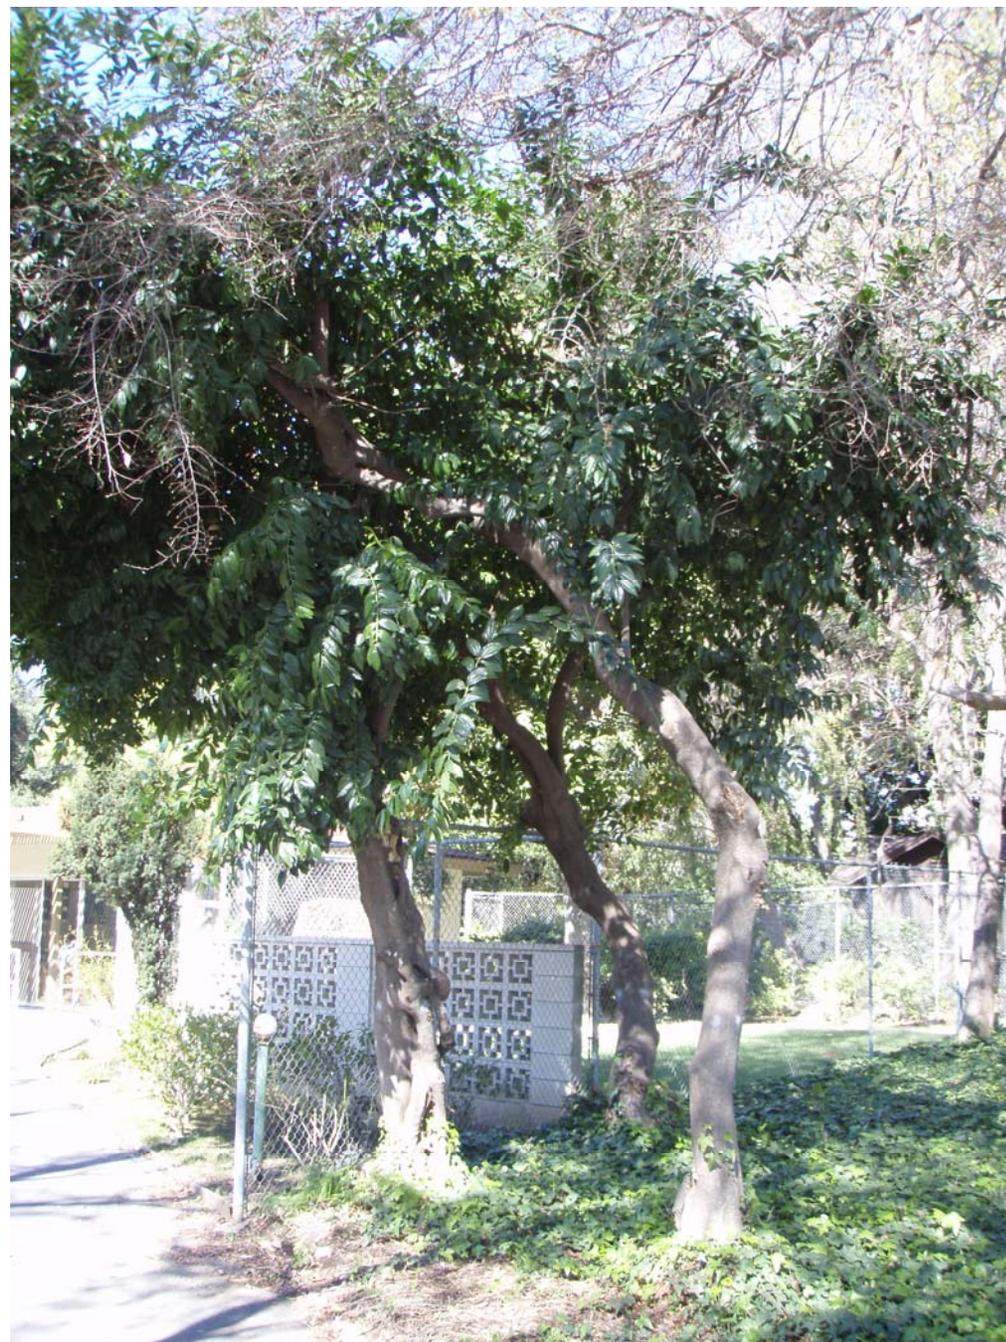
Tree Number: 579

Very poor structure

Staff Recommendation: Remove

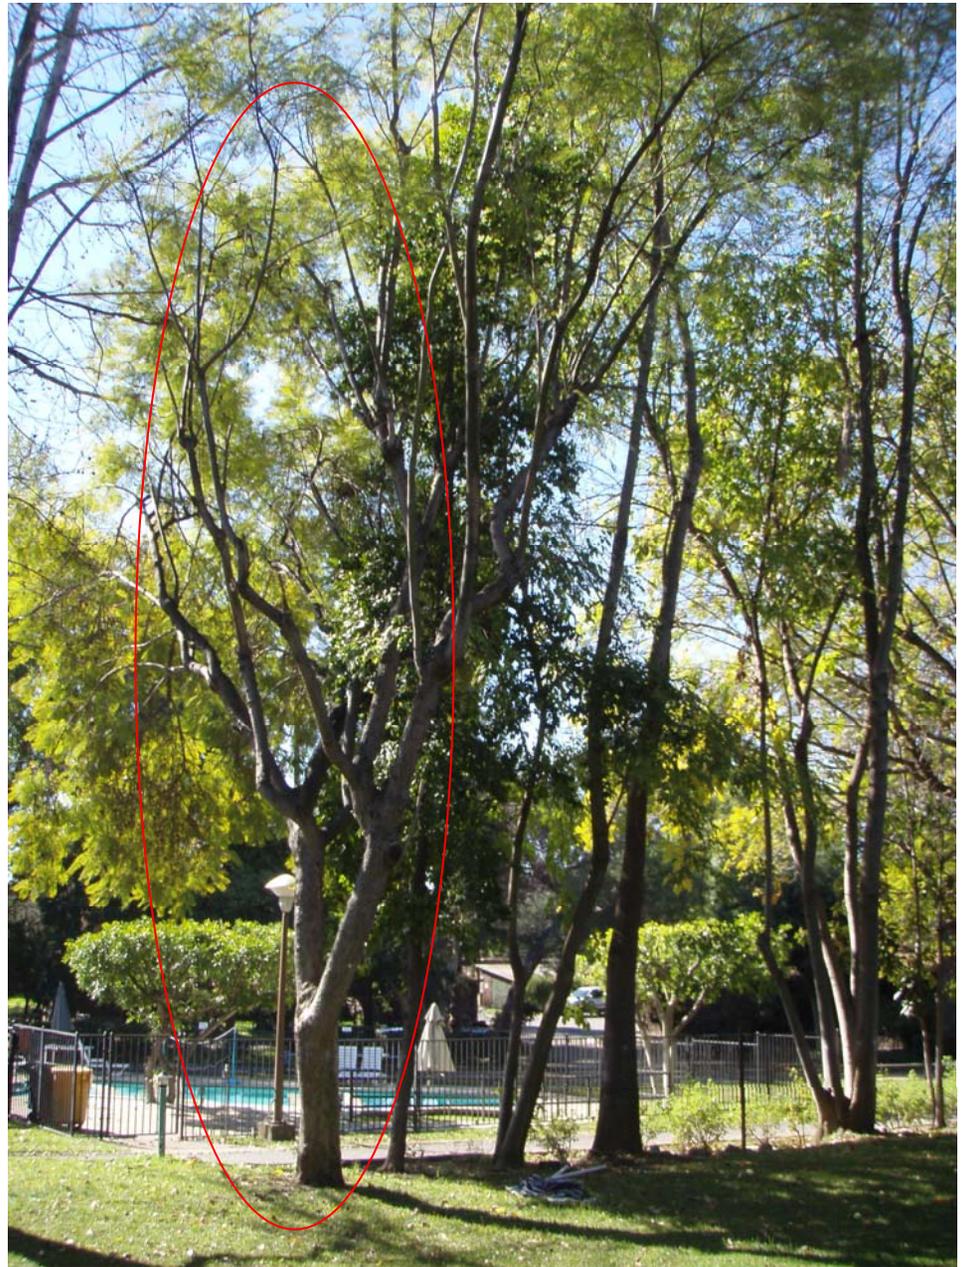
Tree Number: 93

Will require modifications to Bldg 36, north of the pool.

Staff Recommendation: Retain

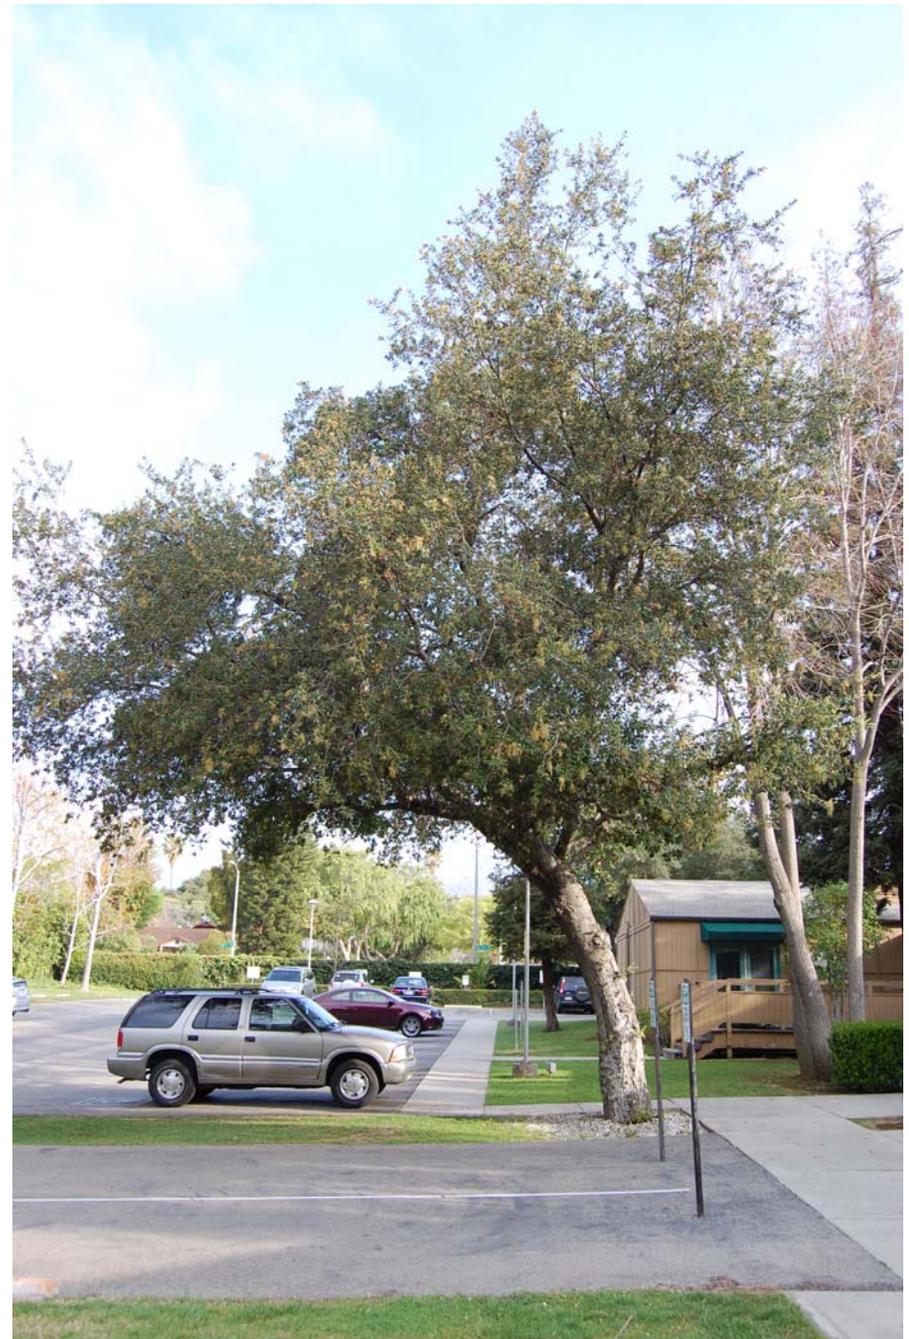
Tree Number: 641

Good form and health.

Would require building 37 to be moved to the east, or the building would have to be reduced in size.

Staff Recommendation: Remove

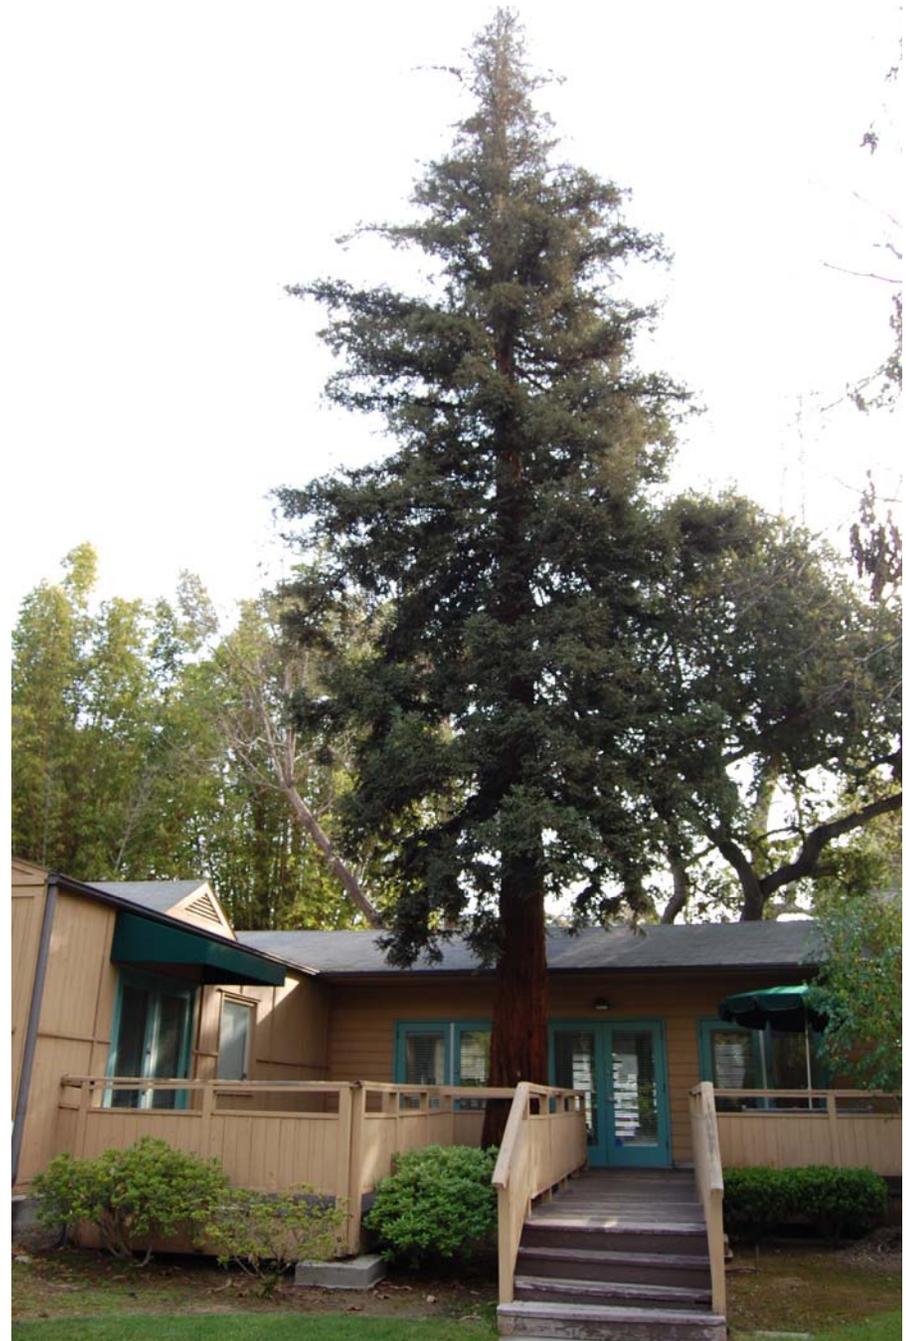
Tree Number: 643

In the middle of a two story office building.

Not likely to survive due to climate.

Other redwoods on the site have died.

Staff Recommendation: Remove

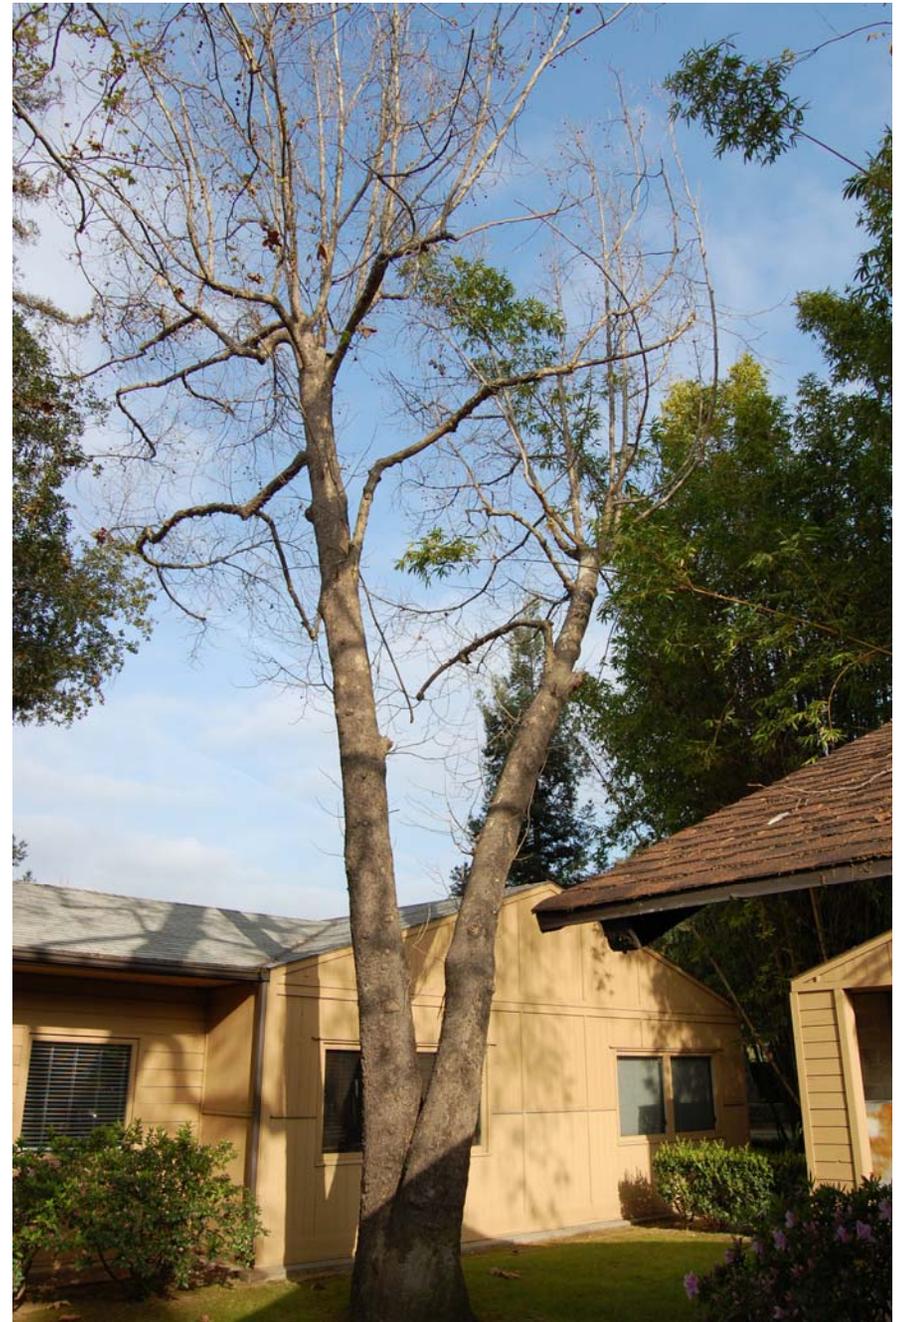
Tree Number: 648

Tree is leaning over the existing  
one story building.

Co-dominant stems are likely to  
fail over time. Could cause  
serious damage to new  
construction.

Remove.
