# Assisted Living Building

Building 32

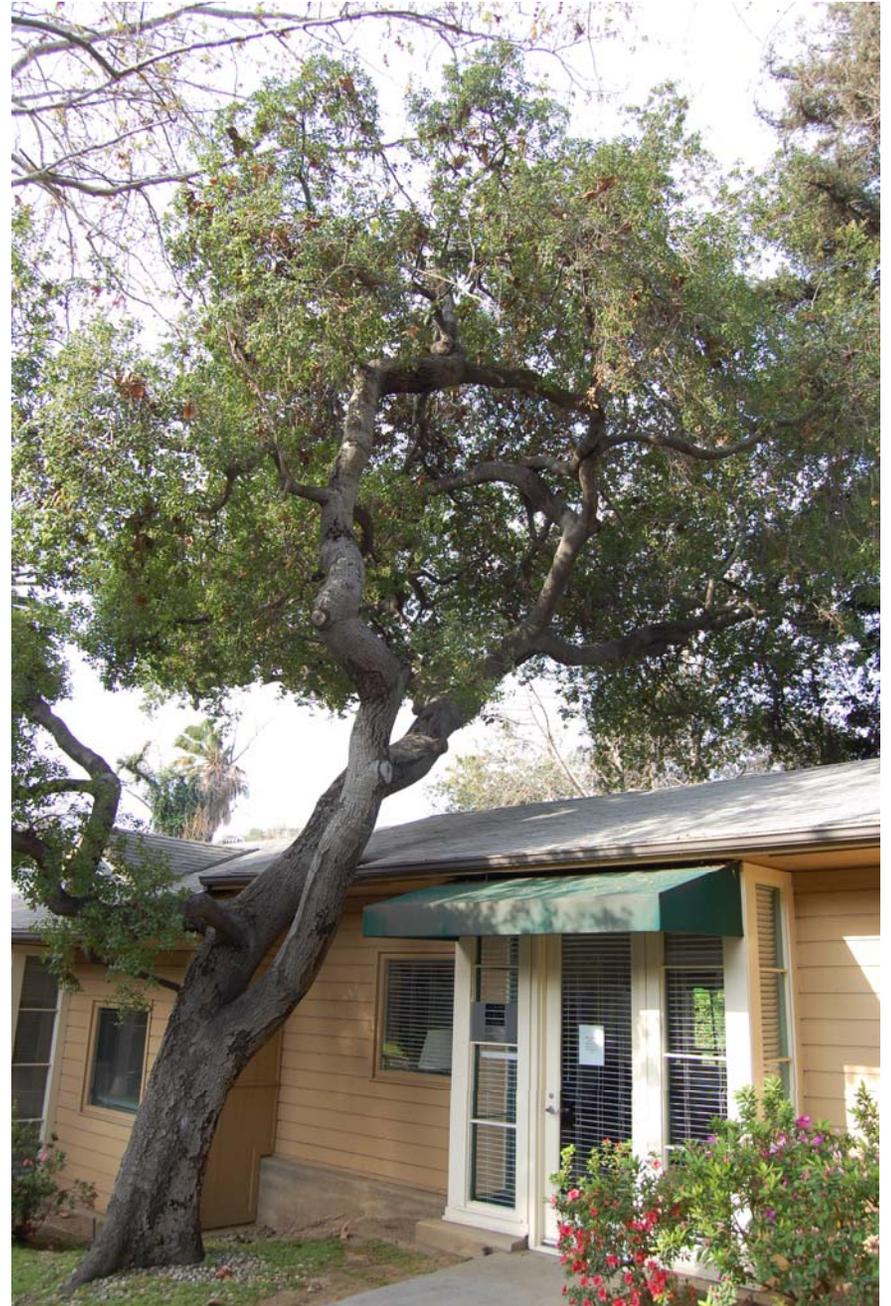
Tree Number: 649

The tree has poor structure and leans over nearly 90% of the structure.

Retention of the tree would require major design changes.

The Master Plan calls for a two story structure here.

Staff Recommendation: Remove

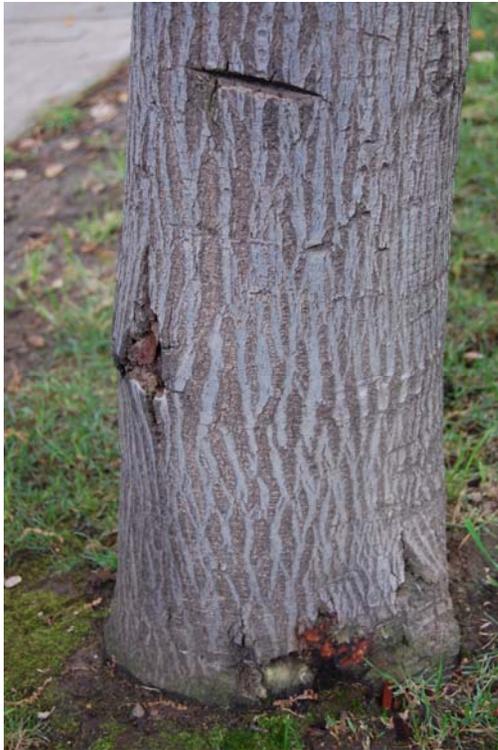
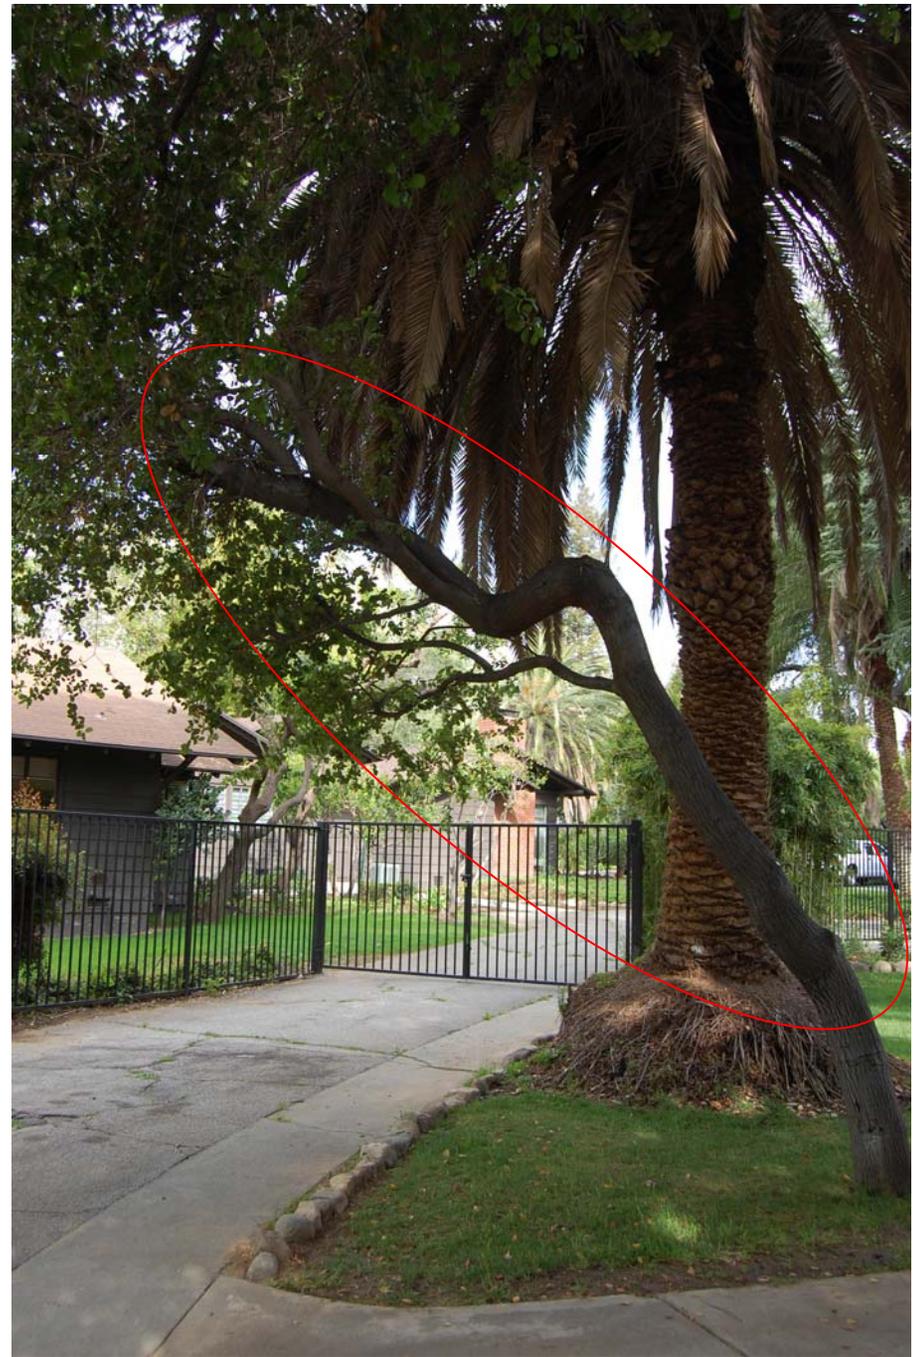
Tree Number: 726

Leaning. Poor Structure.  
Topped. Damage to trunk.

Staff Recommendation: Remove

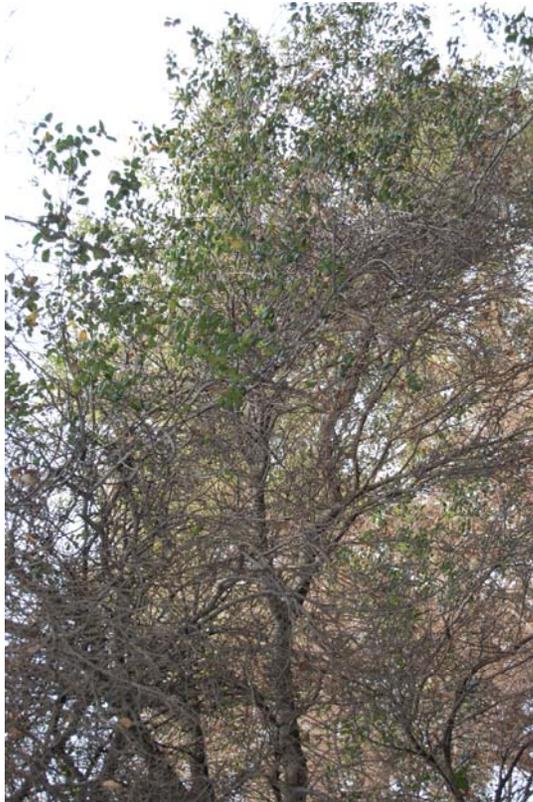
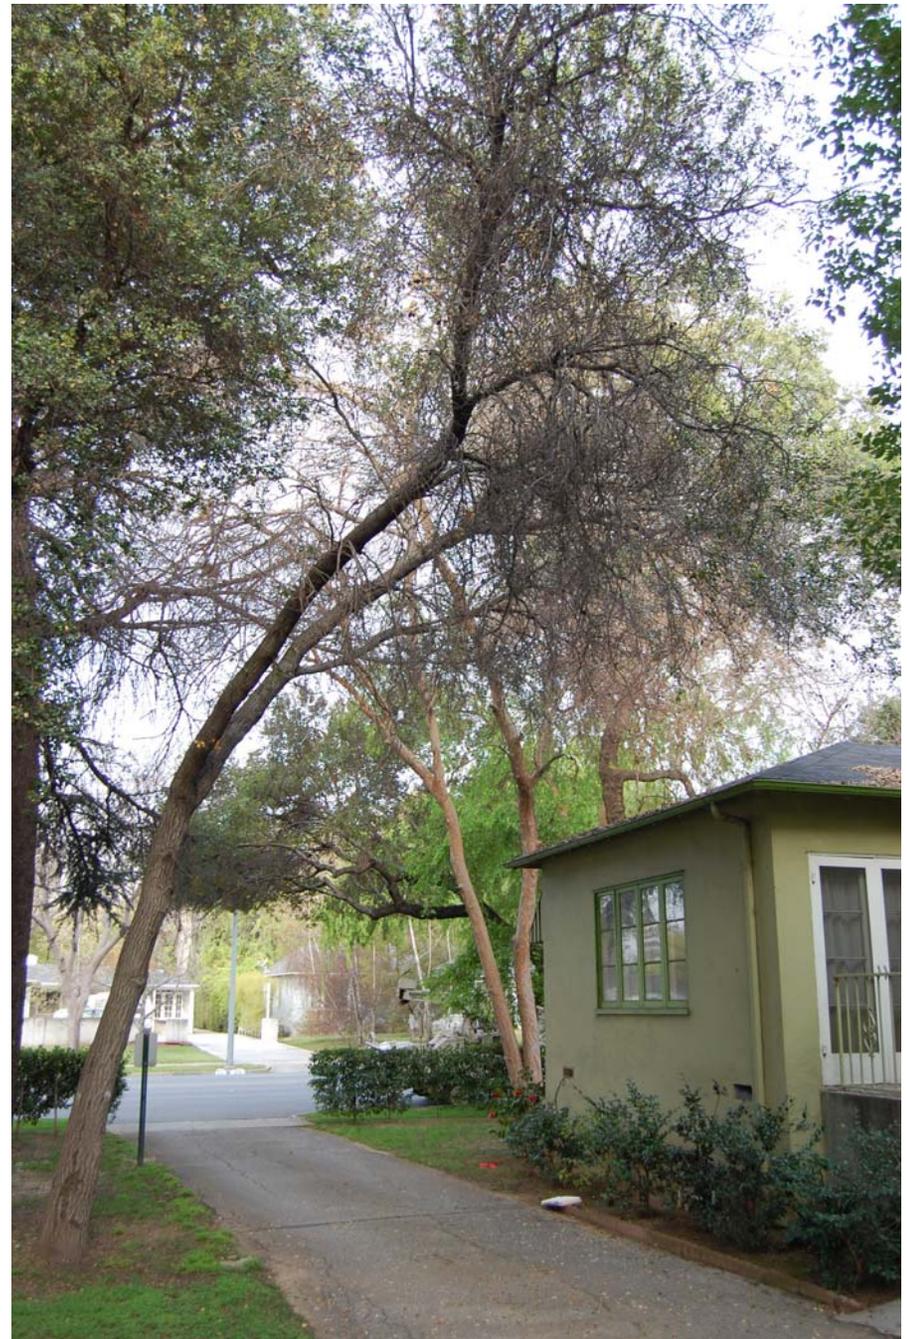
Tree Number: 940

Staff Recommendation: Remove  
Very poor health. No leaves.

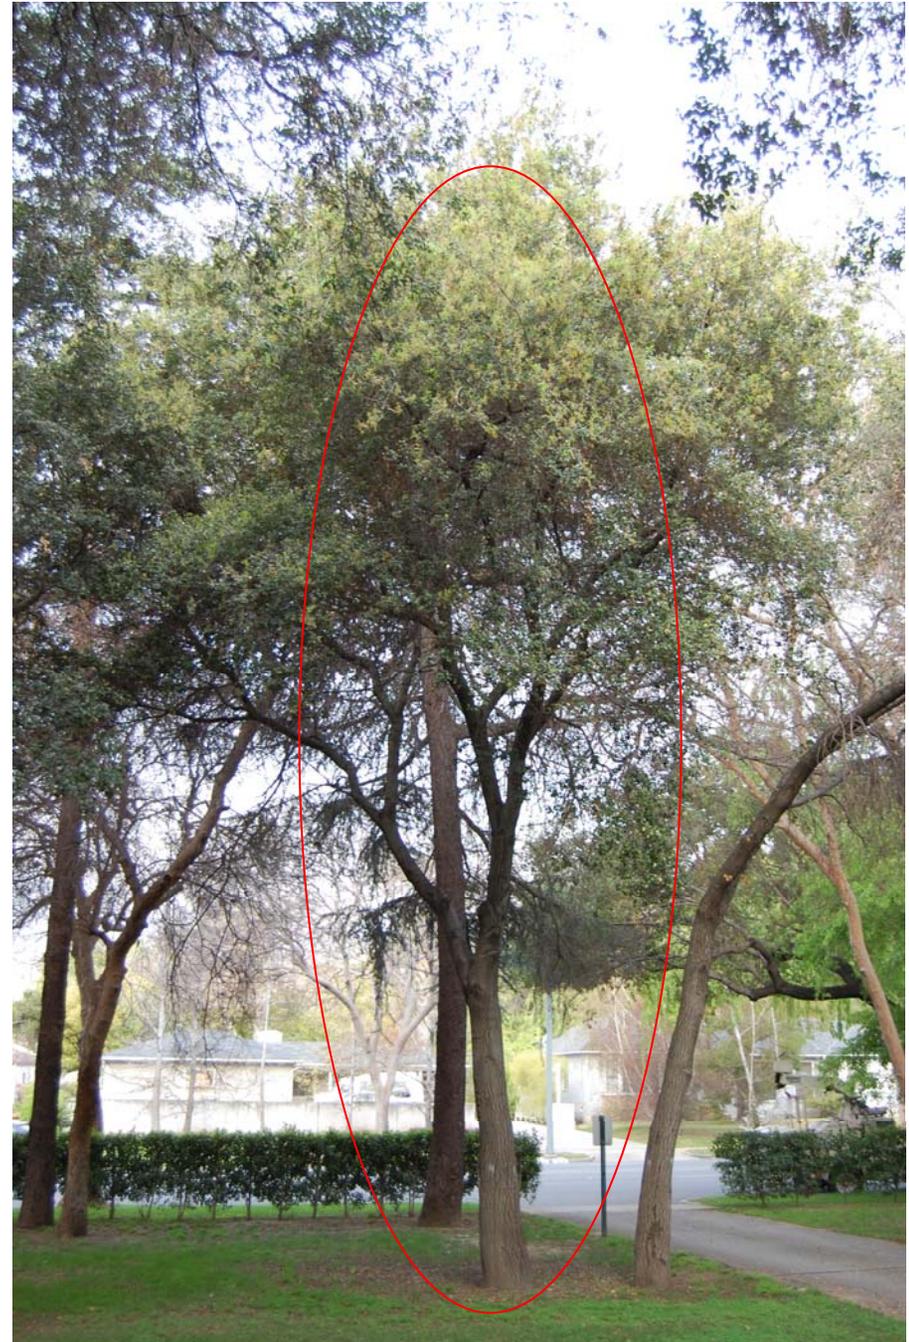
Tree Number: 941

Preservation of this tree would require the loss of an independent living unit.

The tree is 12" in diameter; trees of this type are preserved when they reach 8" in diameter. The tree is 35' high with a spread of about 25'.

Staff Recommendation:  
Remove.

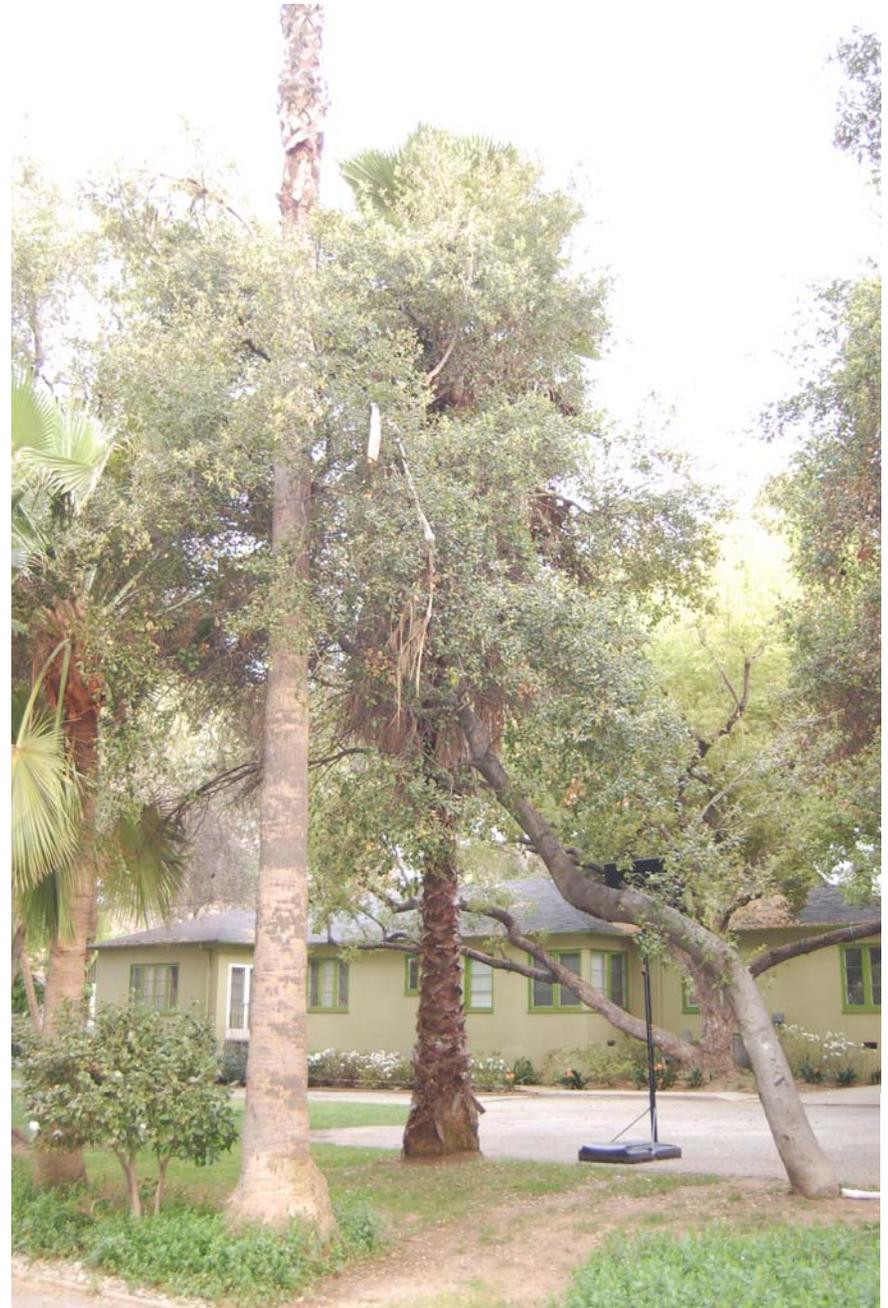
Tree Number: 933

The building footprint of this structure will need to be reduced in order to preserve this tree. In order to make up the loss square footage the structure could be two stories.

Staff Recommendation: Retain.

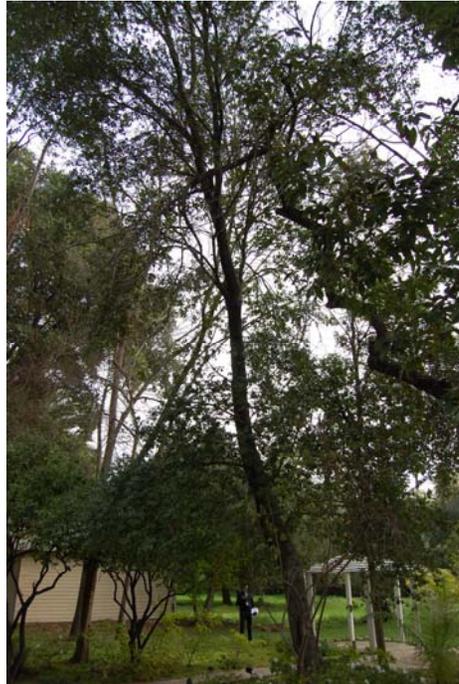
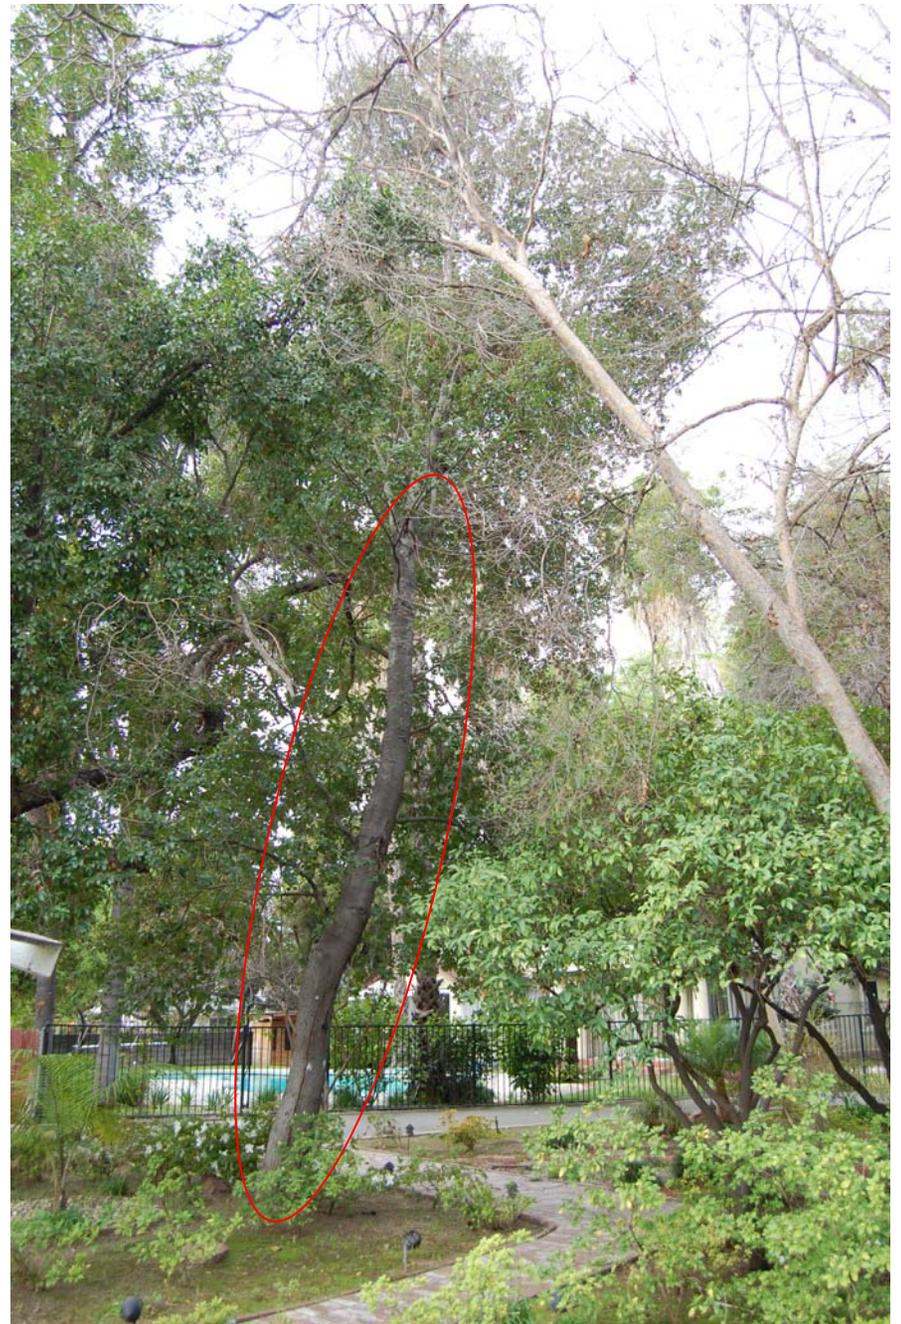
Tree Number: 858

Remove. Directly in the middle of the access road. Moving the access road would take out more trees.

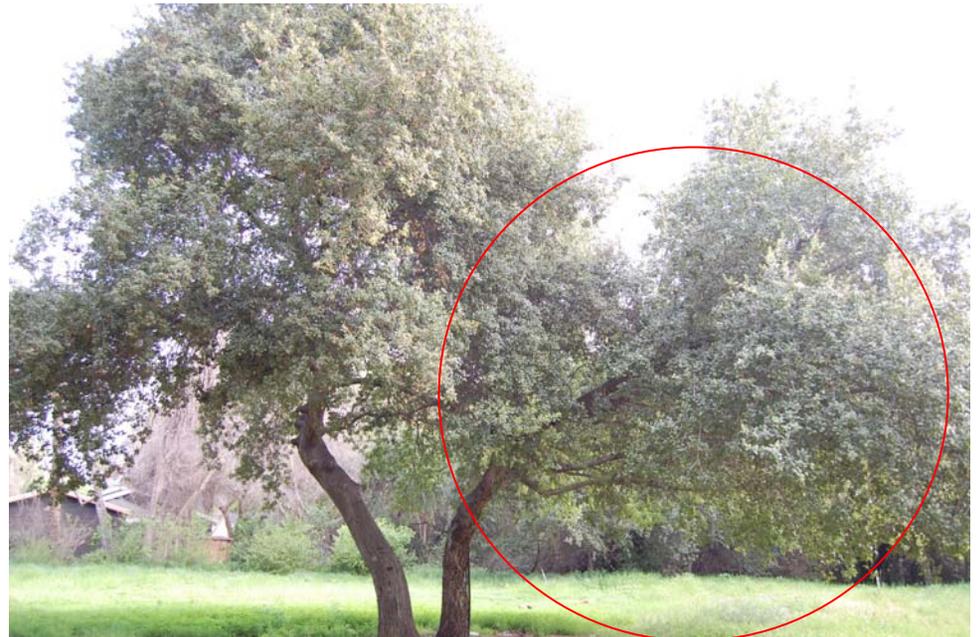
Tree Number: 830

Leaning strongly to the east.

Little canopy due to adjoining tree's shade.

Roots could be strangling other tree.

Staff Recommendation: Retain

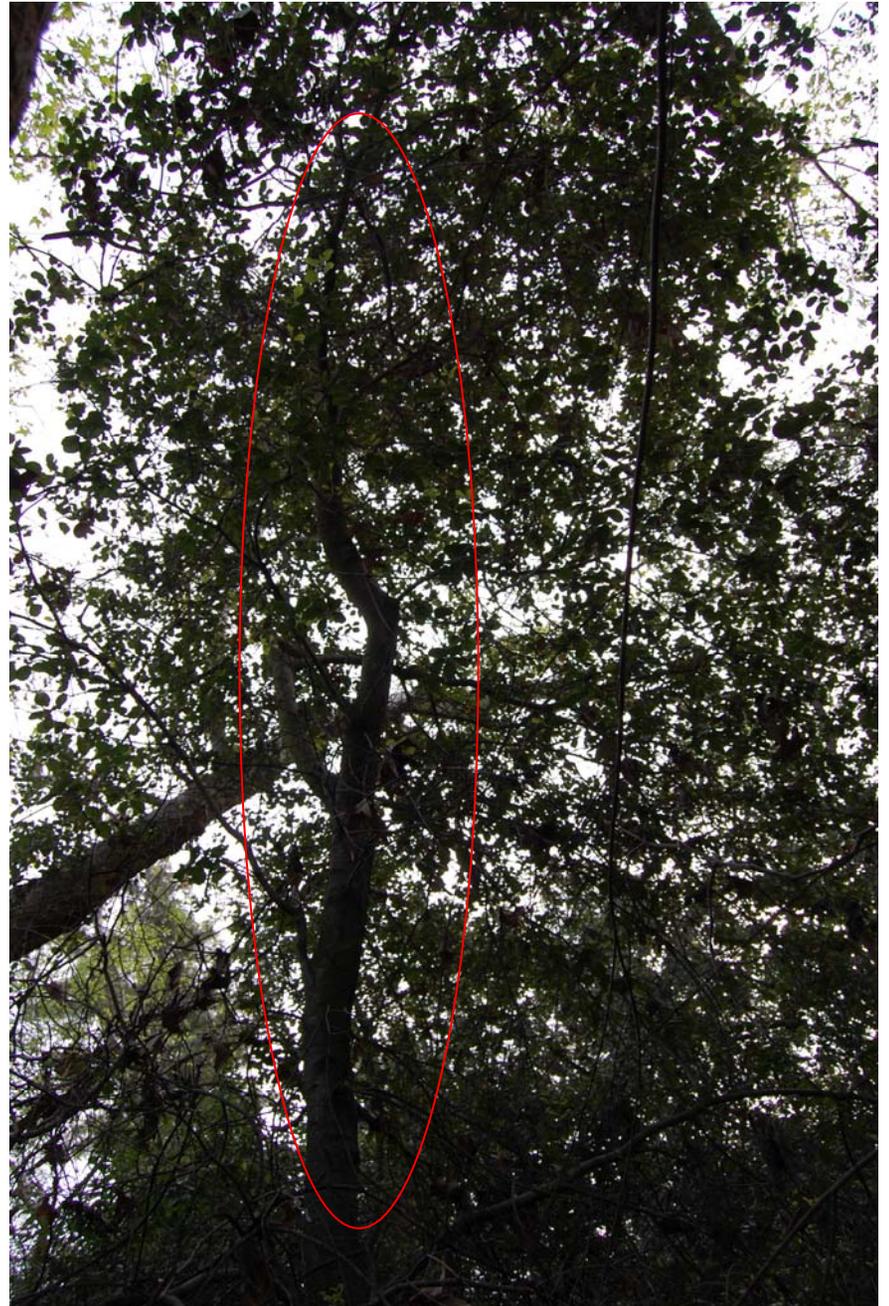
Tree Number: 810

Tree is strongly shaded by  
surrounding sycamore trees.

Structure is poor.

Few leaves.

Staff Recommendation: Remove

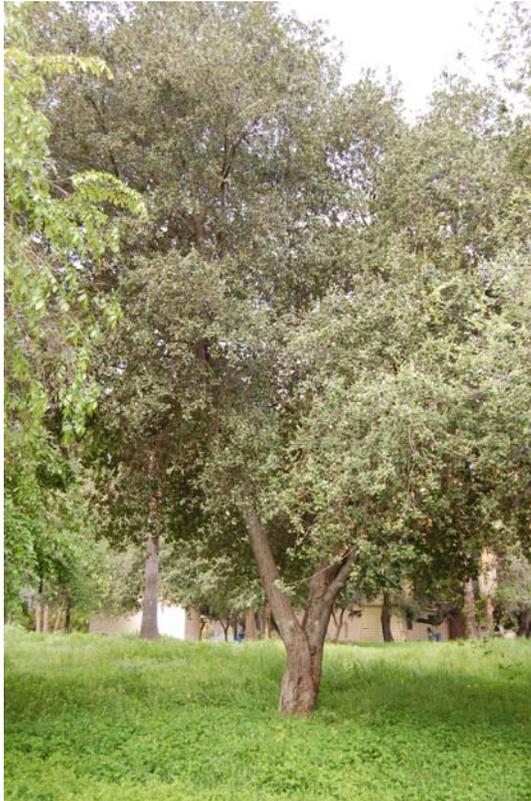
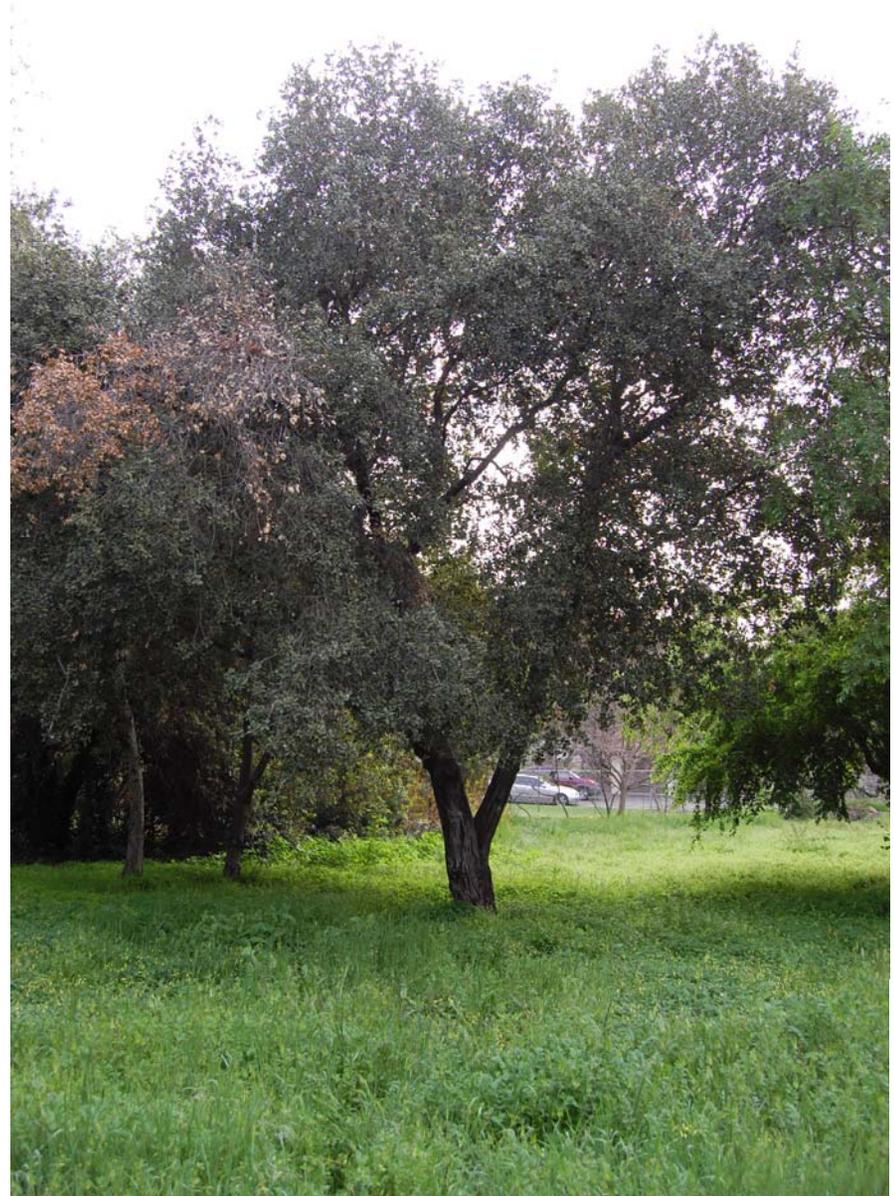
Tree Number: 798

Garage for this unit will be moved to the south.

Staff Recommendation: Retain

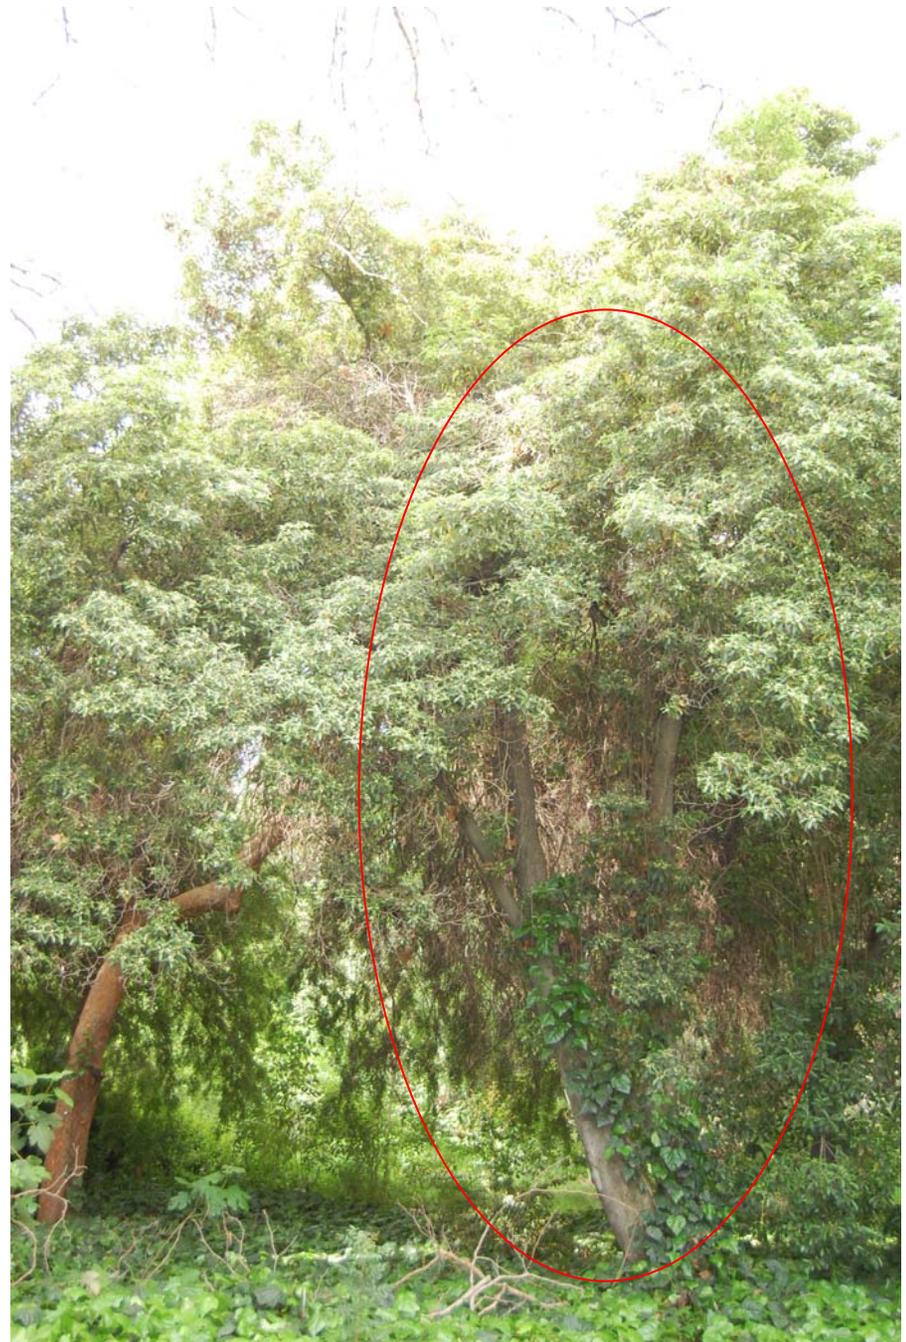
Tree Number: 615

Poor structure.

Crowded.

In the path of required fire road.  
Better to give more room from  
tree 619, a London Plane Tree.

Staff Recommendation: Remove.

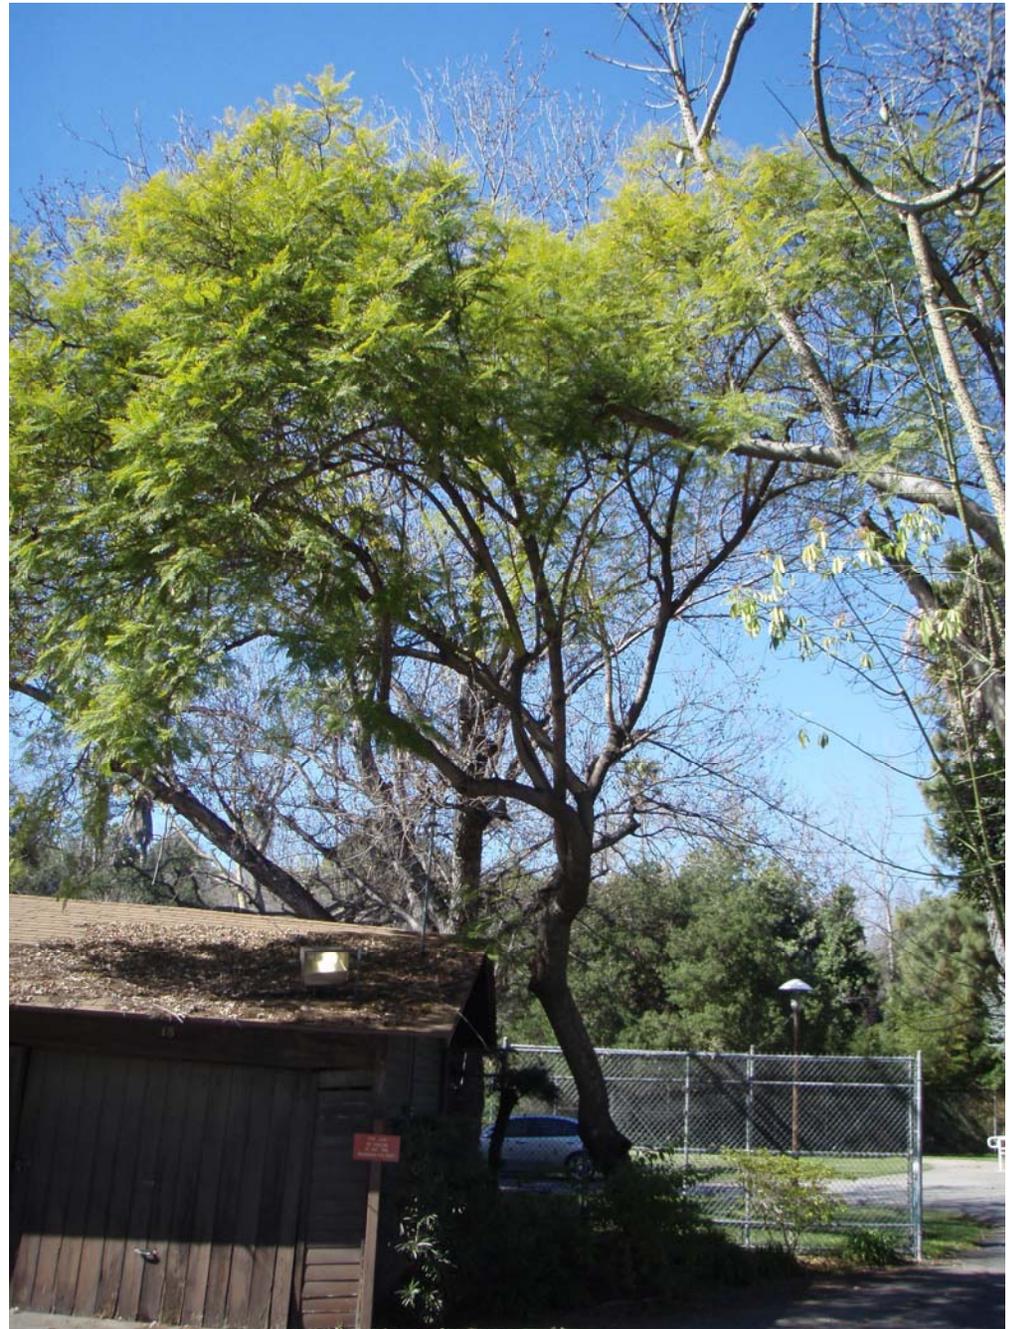
Tree Number: 582

Directly in the fire access road.

Must be removed if barn is  
relocated.

Staff Recommendation: Remove

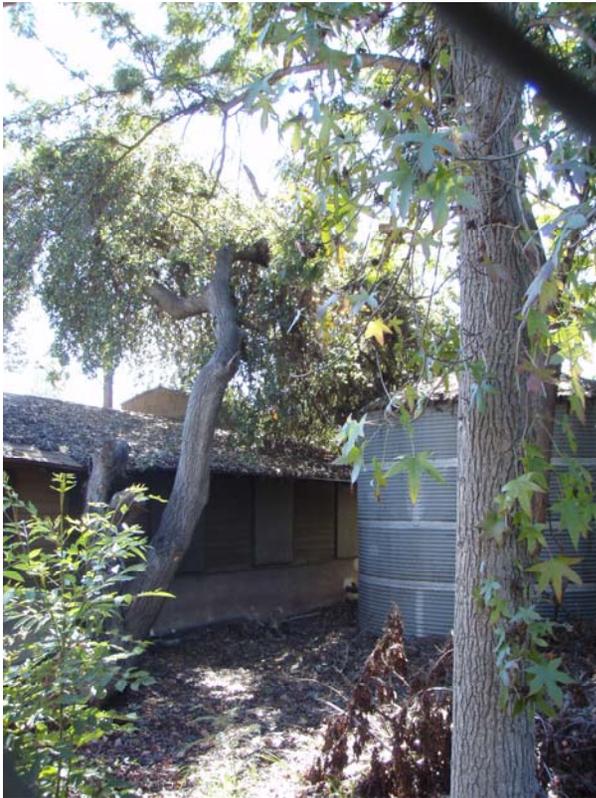
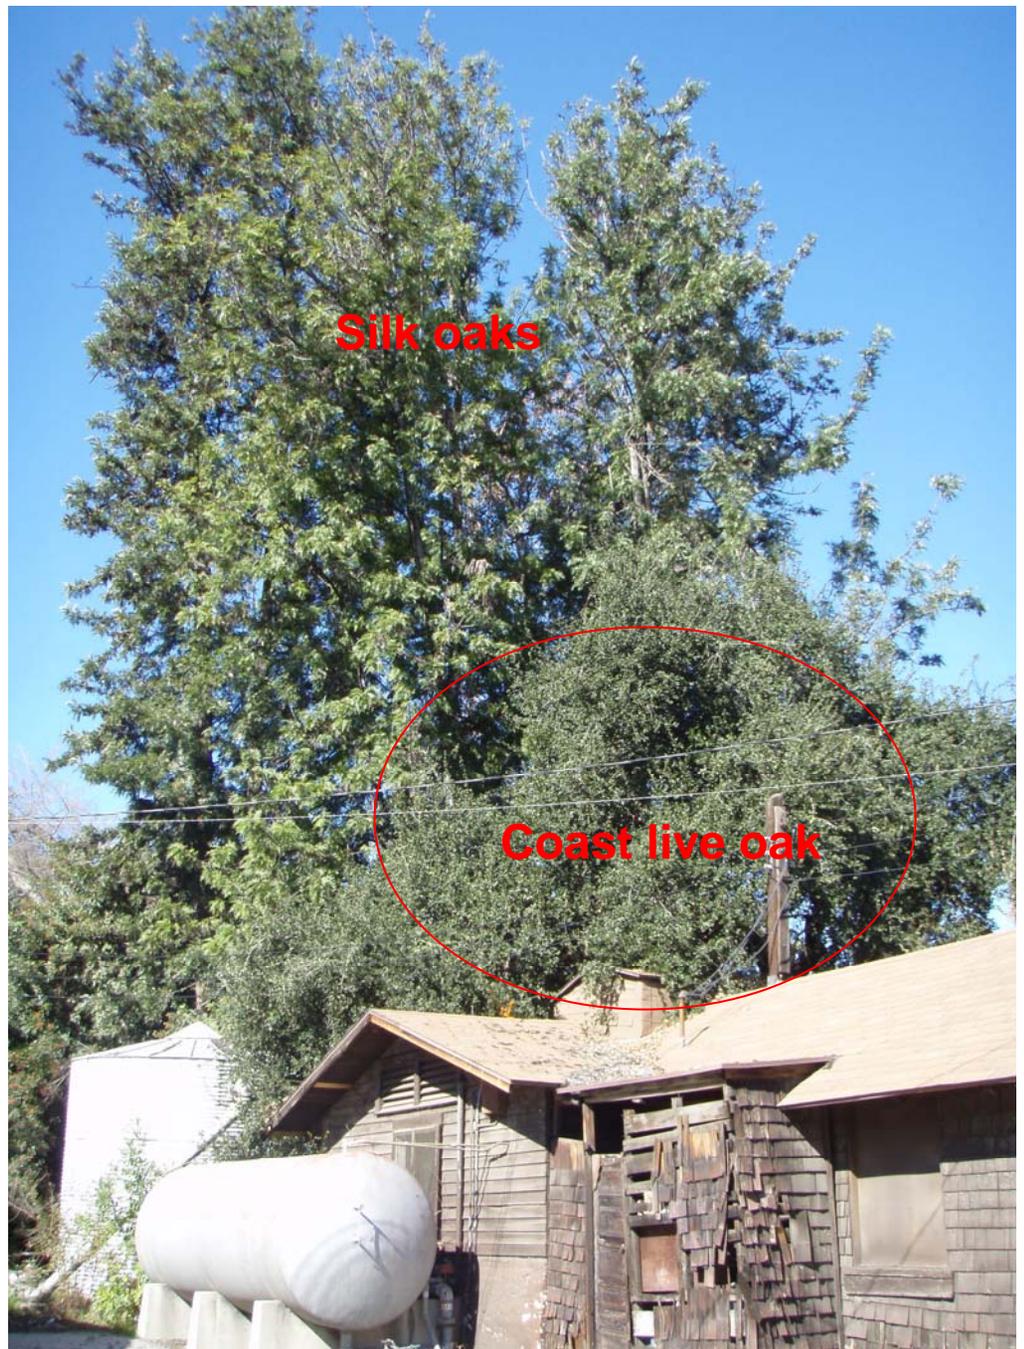
Tree Number:

Staff Recommendation: Remove  
Location of Fire access road;  
Must remove if barn is relocated.
