ATTACHMENT A

1022 N. MARENGO AVENUE

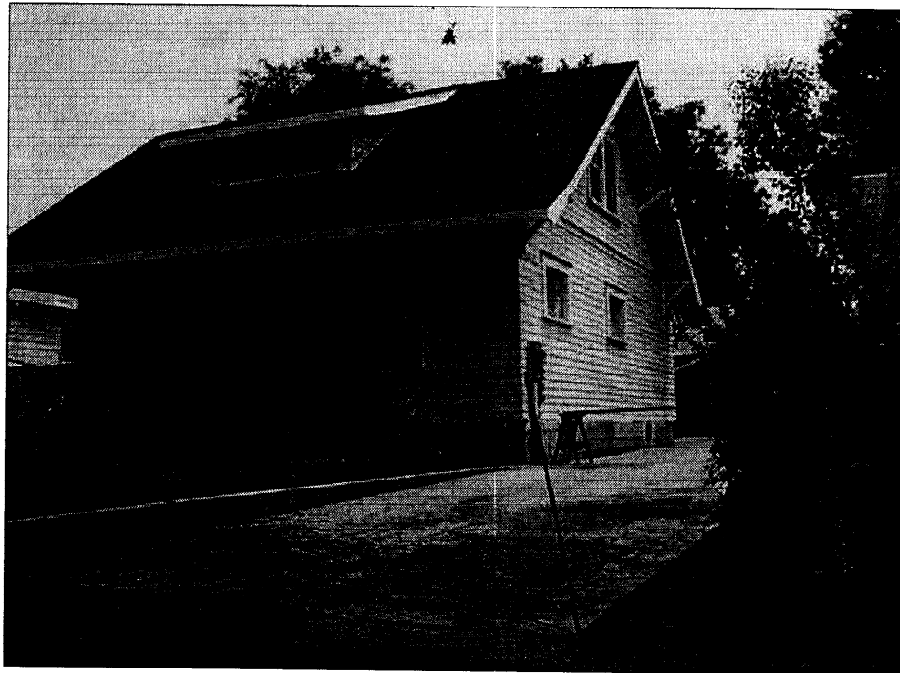
Front & south side elevations (with new openings for windows #1 & #2)

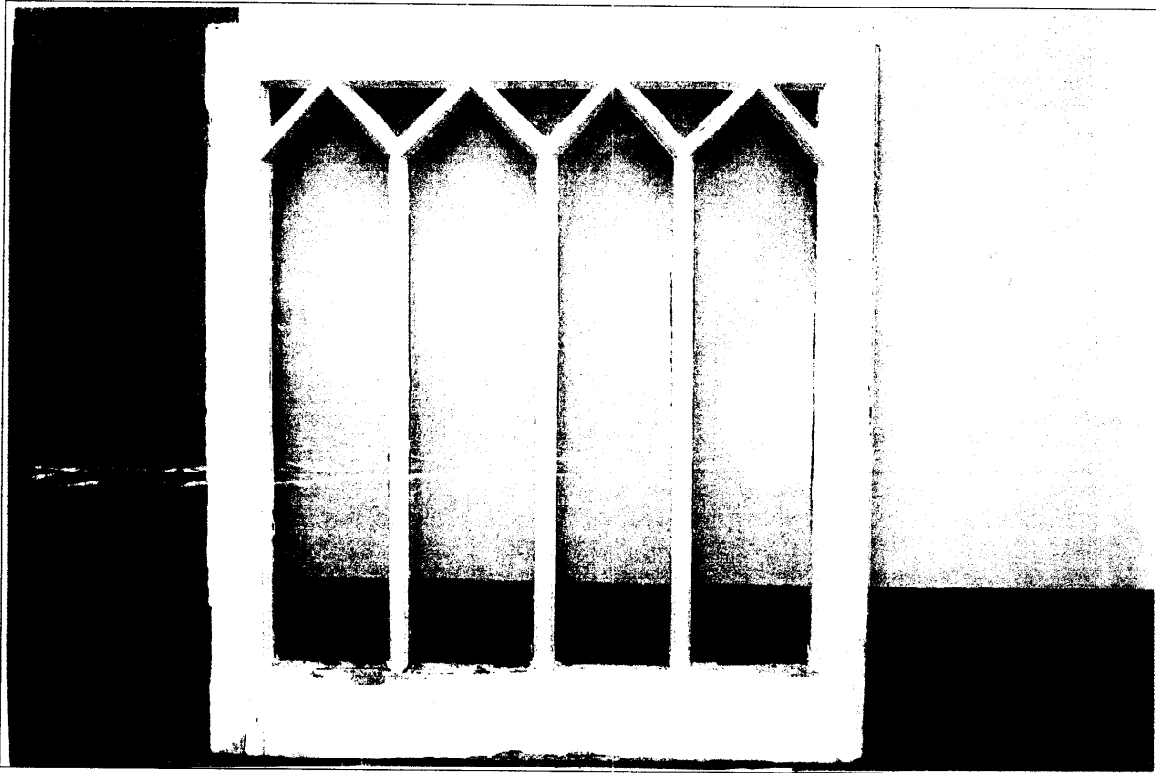
Window #1

Original window (one of two in casement window pair) to be replaced with exact same material, style, size and construction.

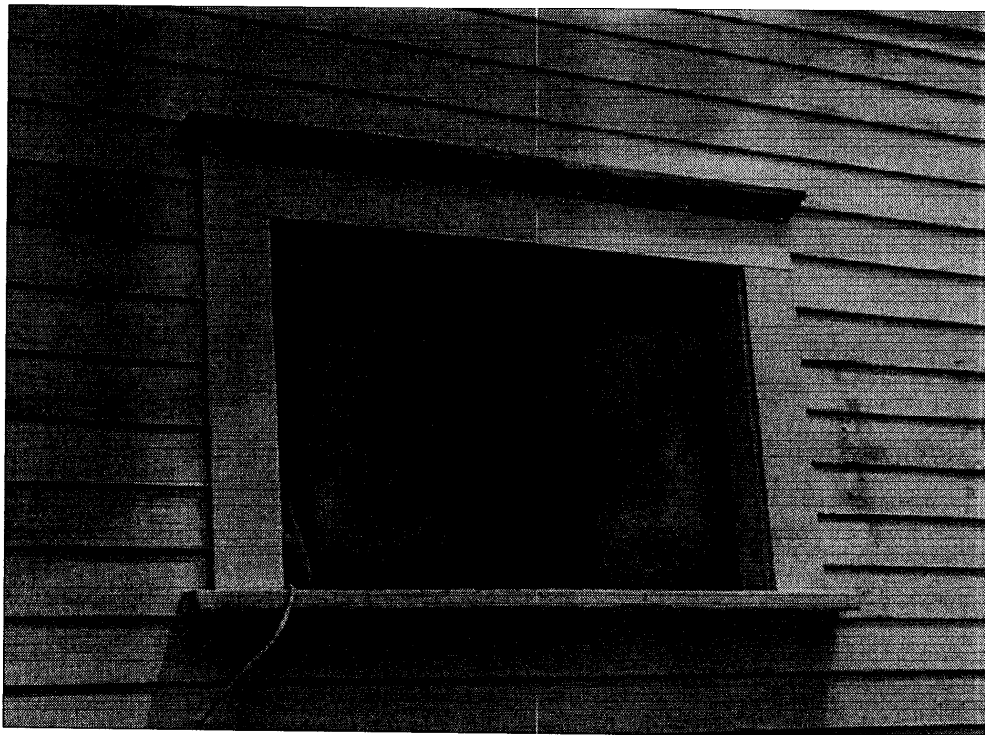
Window #1 opening (photo taken on May 4, 2005)

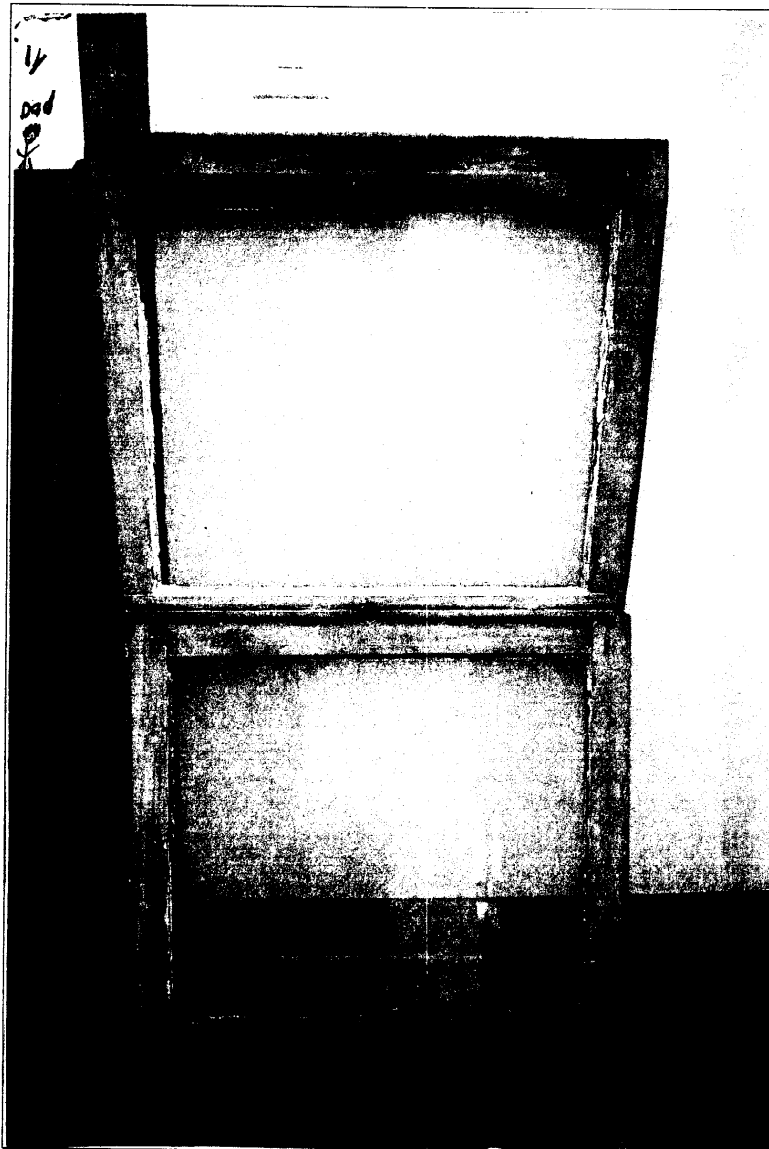
Window #2

Original window (one of the three double-hung windows) that was removed.

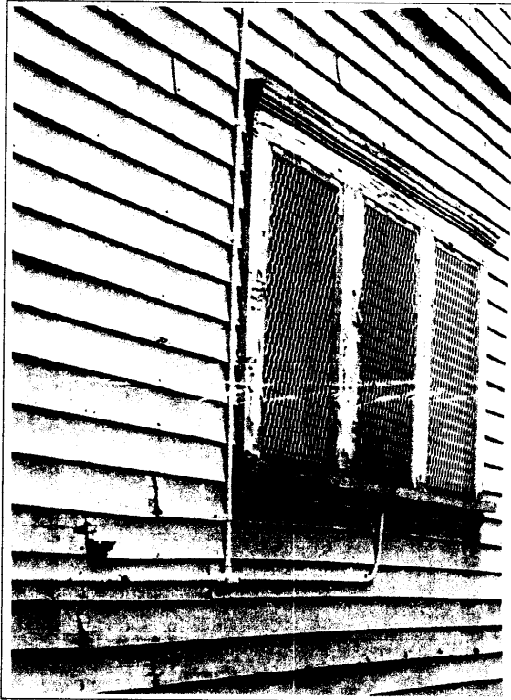
Window #2 Continued

Previous window opening #2 covered in metal screening. New opening is decreased in size by 31" in width and 12" in height.

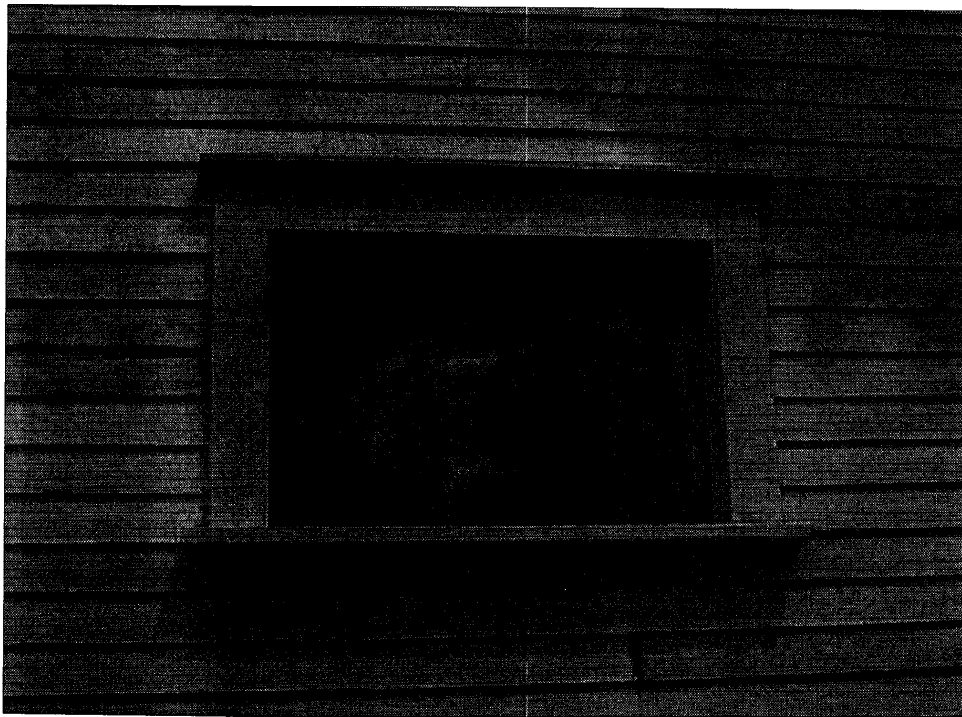
New window #2 (photo taken on May 4, 2005)
