Hillsides Master Development Plan Phase 4

940 Avenue 64
Pasadena, California 91105

Historical Evaluation of Proposed Rehabilitation

.....
March 13, 2015

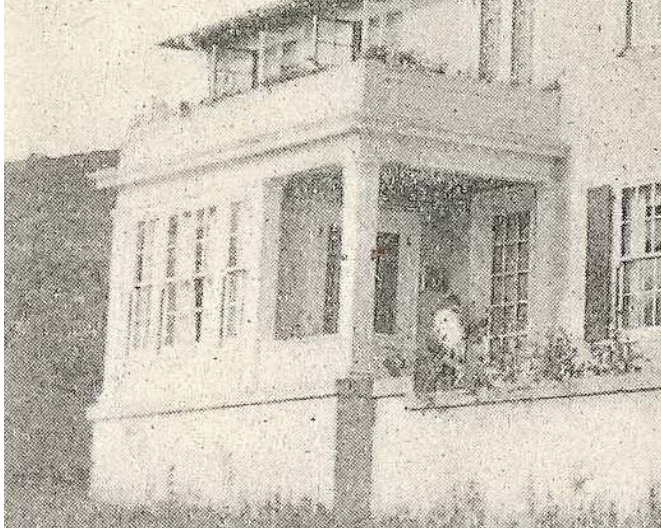
<p>Detail of historic photo of North Annex showing doors and door types, roof configuration, etc. Planter boxes were located on roof but it is not necessary to replicate this function. Restoration of porch to include reconstruction of upper low wall of porch roof based on the feature's appearance historic photos.</p> <p>Access to roofs should be restricted to avoid code issues (maintaining and repairing, if possible, or replacing in kind, the original doors from second floor).</p>

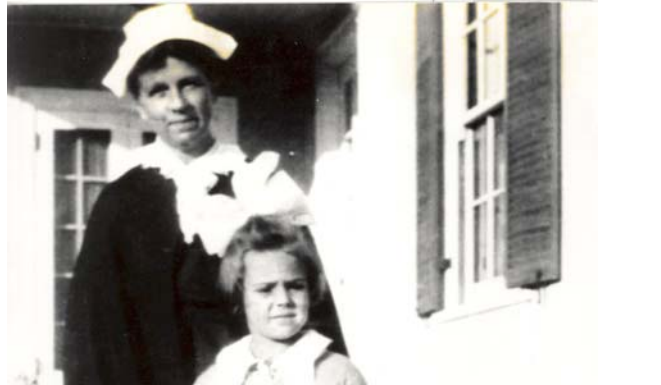
<p>Detail of historic photo of the North Annex shows further detail of the paired doors and screens (left) to aid with Master Plan Phase 4 intent of restoring the porches of the Annexes.</p>

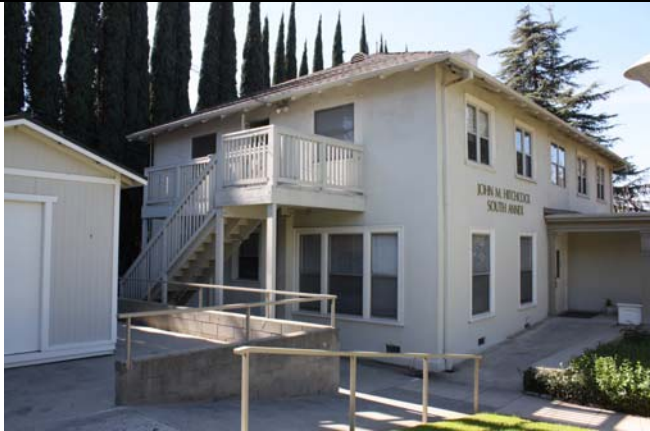
<p>Existing exit staircase (not a historic feature) will be removed. There was no staircase on this façade originally, but one was likely added in early years as at the North Annex. Its elimination from this façade provides more space for the addition proposed for the south side of the Administration Building, directly opposite. Open stairs of similar type proposed to be relocated to rear of building, to the left.</p>

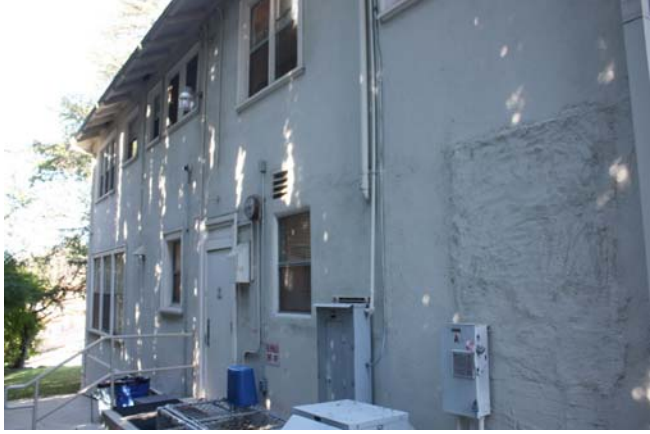
A photograph showing the rear of a light-colored, multi-story building. The wall is mostly blank with some utility boxes and a small window. A concrete foundation is visible at the bottom.	<p>Rear of South Annex (view south) where new stair will be added.</p>

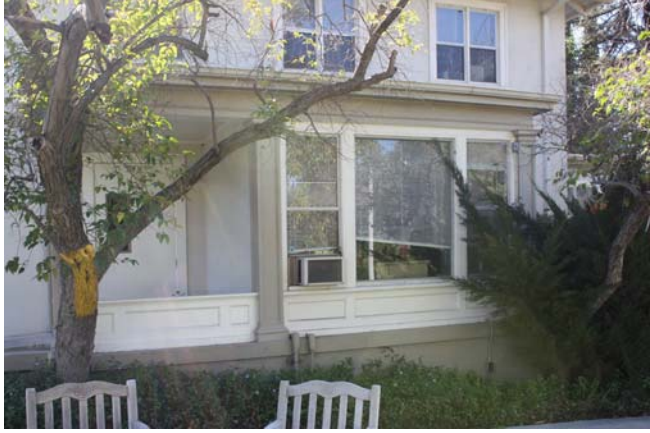
A photograph of a front porch with a white railing and a large window. A tree is in the foreground, and a white chair is visible on the porch.	<p>Master Plan proposes the restoration of the original configuration of the porches. Note that they were originally partially enclosed as seen today. Windows seen here replaced the originals. Fabricate windows matching the historic examples in the corresponding area on the North Annex for the enclosed porch based on the historic material, details, profile, etc. Since intent is to restore the porches, recreate the opening and paired multilight doors that led directly to the porch and replace the current main entrance door with a 3 by 5 light door. See also historic detail view below.</p>

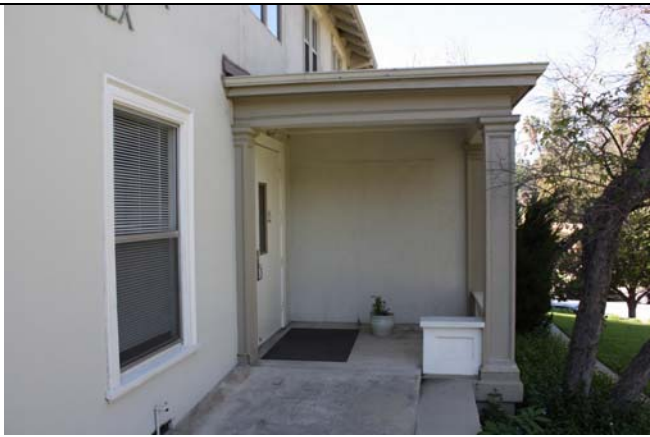
A close-up photograph of the porch entrance, showing a white door and a window. The porch has a concrete floor and a white railing.	<p>Doors to north side of porch were eliminated. Since intent is to restore the porches, recreate the opening and paired multilight doors that led directly to the porch and replace the current main entrance door with a 3 by 5 light door. See also historic detail view below.</p>

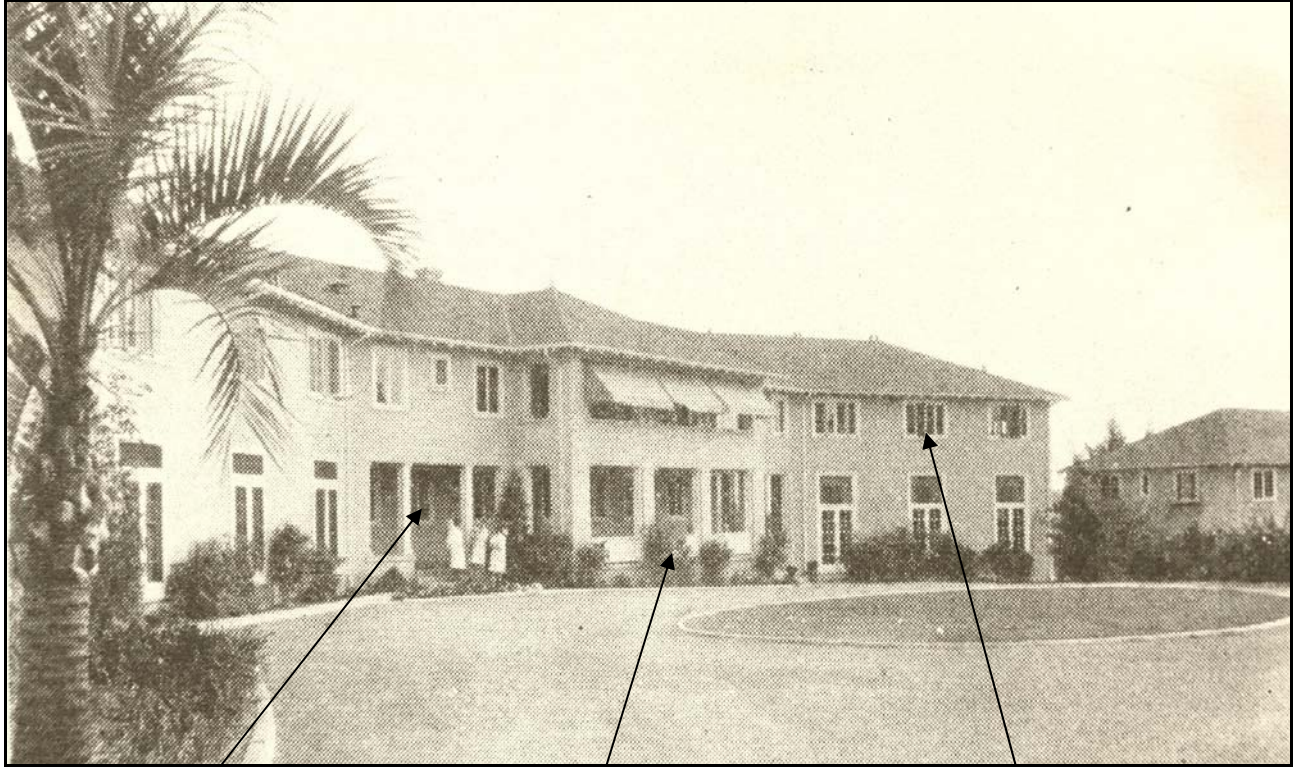
Recent window replacements in this porch are double-hung windows instead of the historical type, which, seen here, were casement sash. Acceptable to maintain current replacements, which are compatible with the style and era of the building.

Central bay of front porch was originally closed. Acceptable to maintain this alteration for passage to the center of the façade. Maintain the low wood walls in adjacent bays.

Replace all aluminum frame windows on second floor with two or four casement sash (according to opening size, which indicates original configuration).

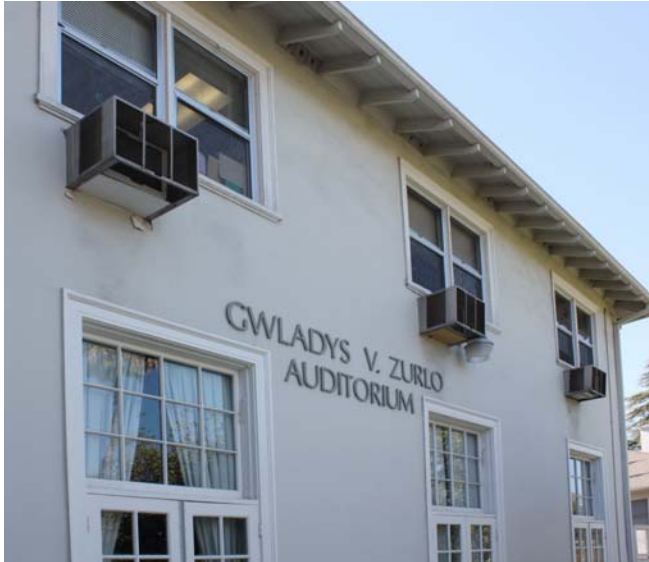
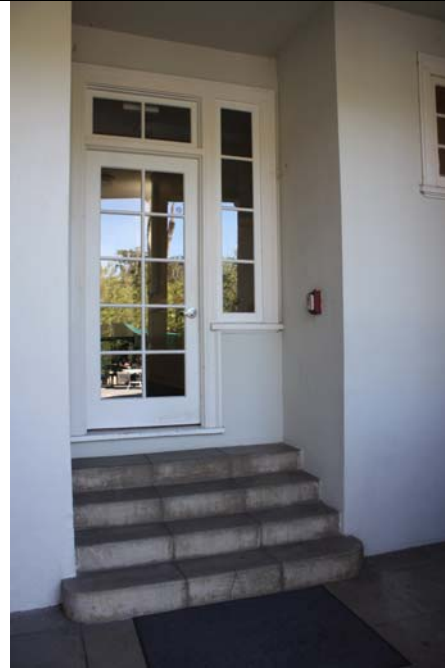
Retain character-defining entrances and exits. The appearance of this entrance was restored after being closed for many years.

Remove wall air conditioners. Replace aluminum vertically sliding windows with 8-light wood casement sash according to model of historic photos.
