USDA-FOREST SERVICE

BURNED-AREA REPORT
(Reference FSH 2509.13)

A. Fire Name: Station FireB. Fire Number: CA-ANF-3622C. State: CAD. County: Los AngelesE. Region: 5F. Forest: AngelesG. District: Los Angeles River, San Gabriel River, Santa Clara/Mojave RiversH. Fire Incident Job Code: P5E5VLI. Date Fire Started: August 26, 2009J. Date Fire Contained: TBD (pending winter rains)K. Suppression Cost: \$86,967,661 as of 09/23/09

**WILDLIFE and FISH TECHNICAL SPECIALIST REPORT
BURNED AREA EMERGENCY REHABILITATION for the STATION FIRE**

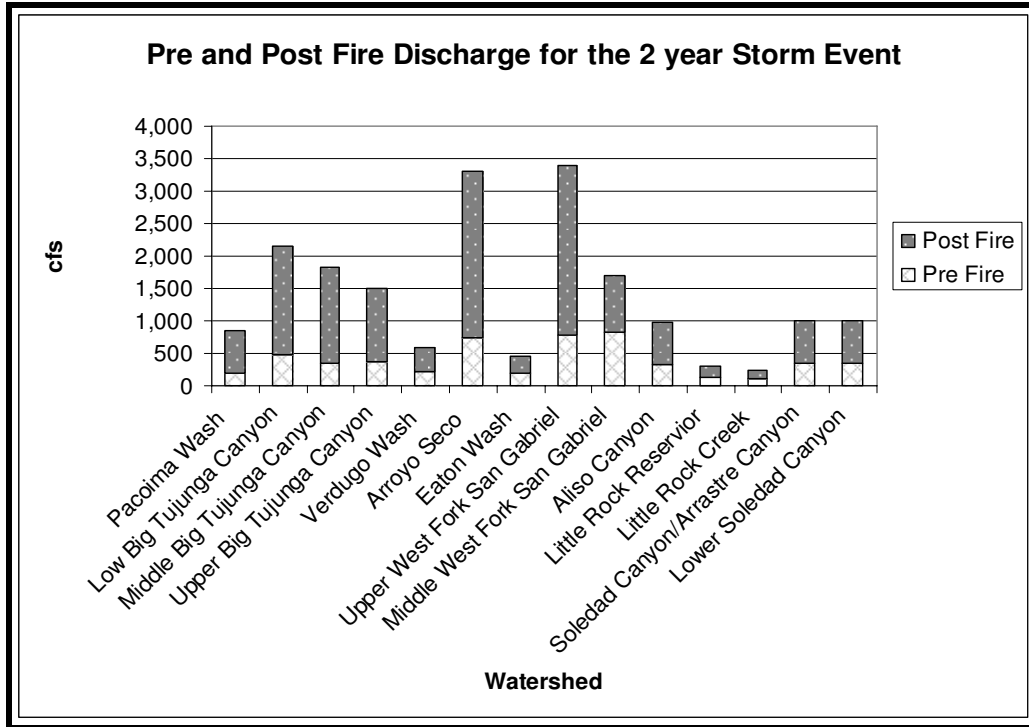
Figure 1

Figures 1 and 2 display the watersheds within the fire areas, percentage of acres burned by watershed, and the expected increased flows during a post-fire two year and five year storm event.
