Re: Construction at 801 So. San Rafael

EXHIBIT TO SUBMISSION FOR 815 S. SAN RAFAEL PROPERTY

This Old House, LLC
 801 S. San Rafael Avenue, Pasadena
 Pin# 7387.01S

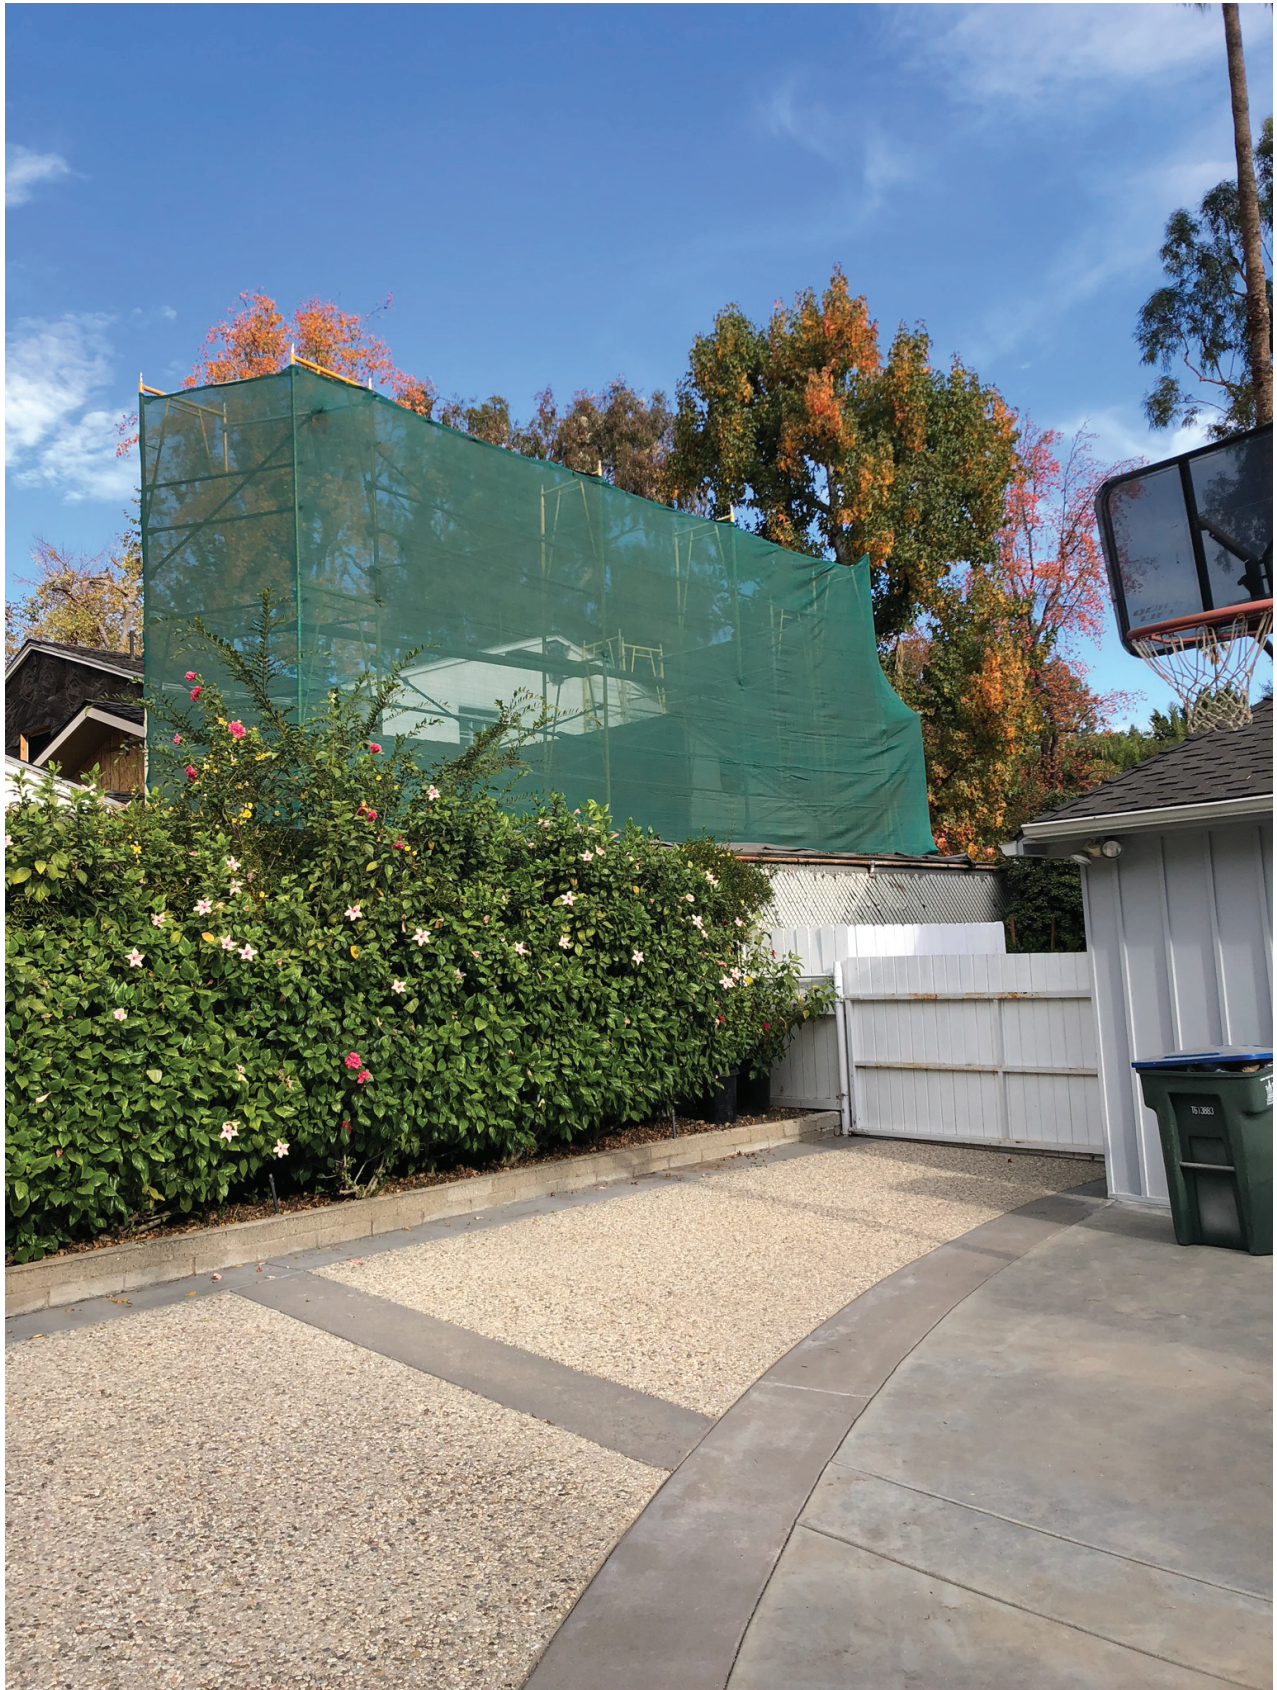
Hibiscus hedge along drive in narrow planter

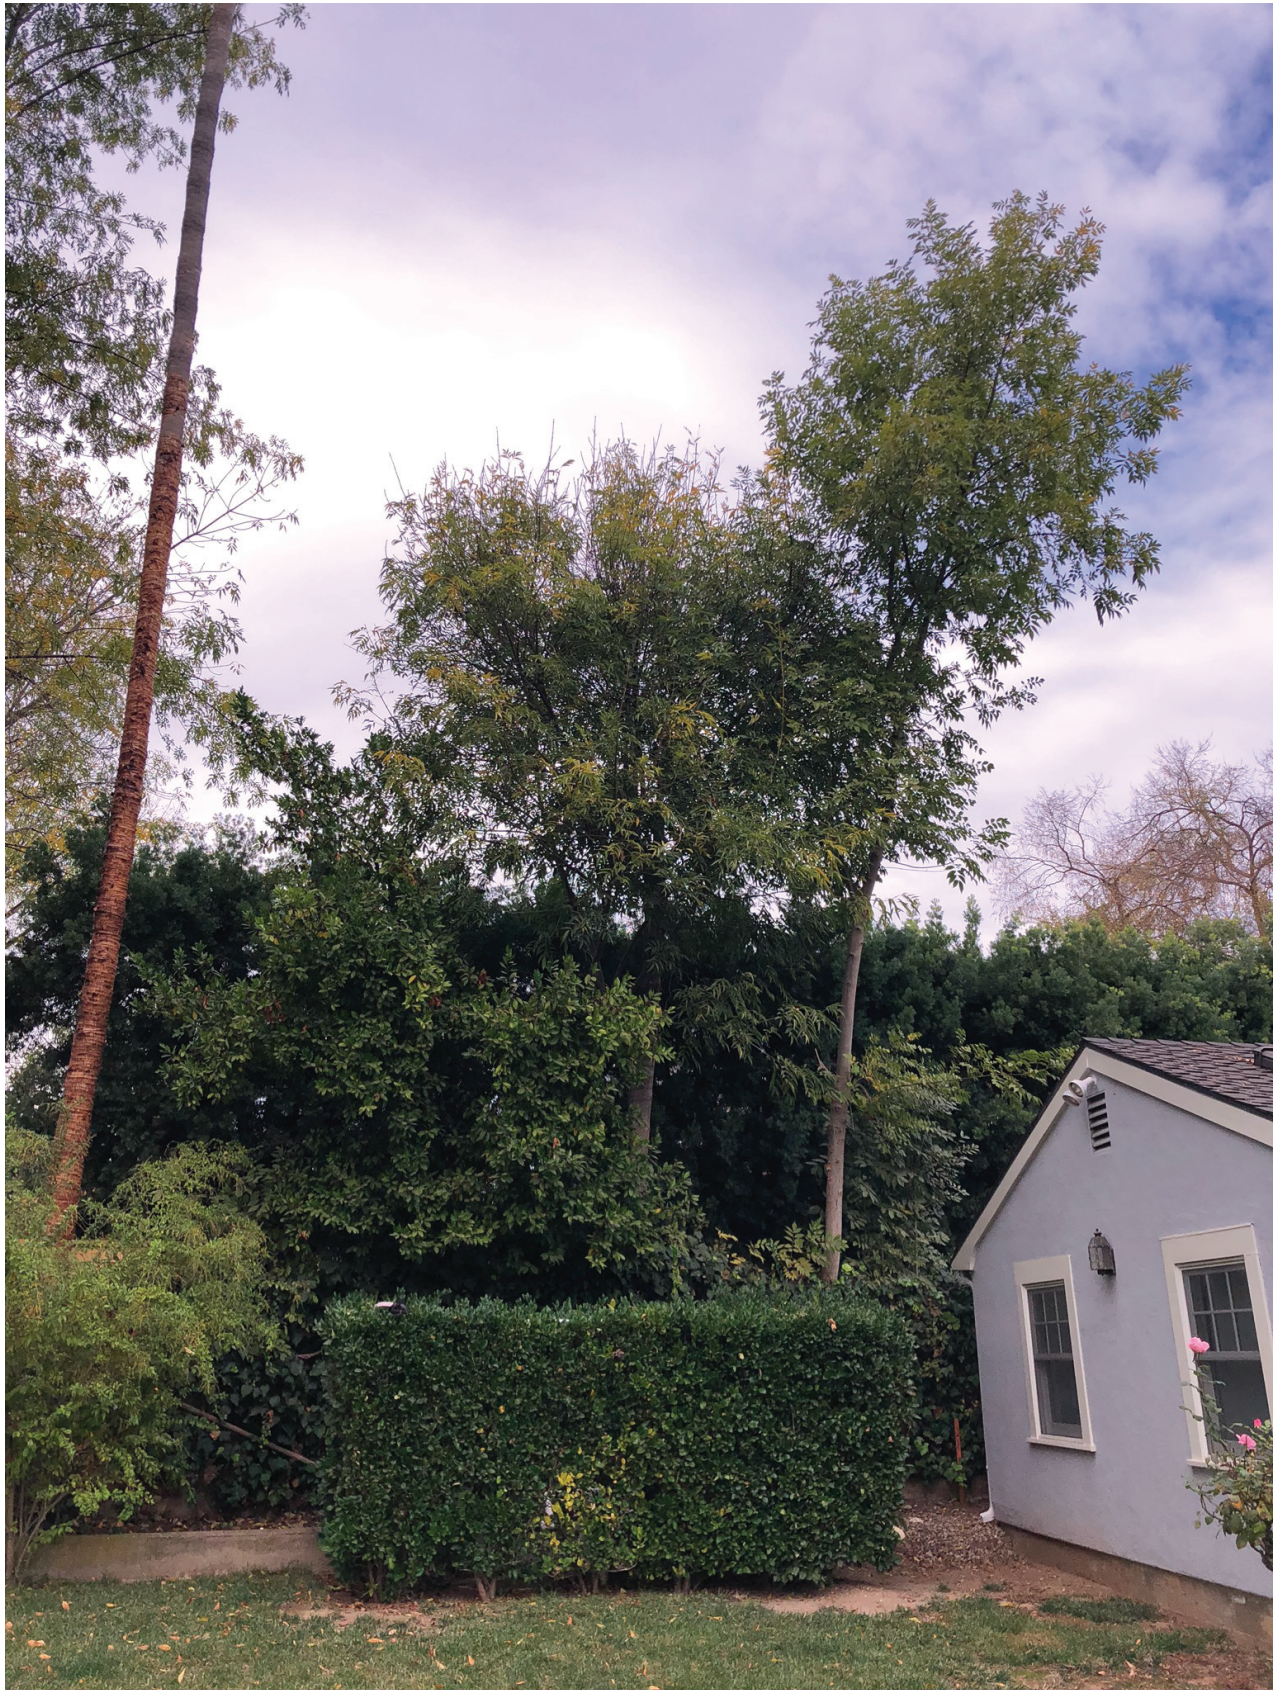
Fern pine hedge from yard behind ash trees 49 and 50

2. The applicant agrees to maintain existing trees using a qualified and licensed tree care service provider to prune with the goal of preserving the height, form and health to maintain privacy (Fern Pine #51-62, Ash trees 49 and 50, Trees 41-47). In other words, applicant agrees not to top or severely shorten the trees or otherwise deliberately cause damage to the roots, trunk or canopy of said trees except as consistent with the aforementioned pruning and the owner's property rights.

3. The applicant should confirm, via a licensed civil surveyor, the locations of trees 49 and 50 which appear to be on the property line between the two lots, in order to resolve any issue of ownership, property right, and liability for impacts during the proposed construction.

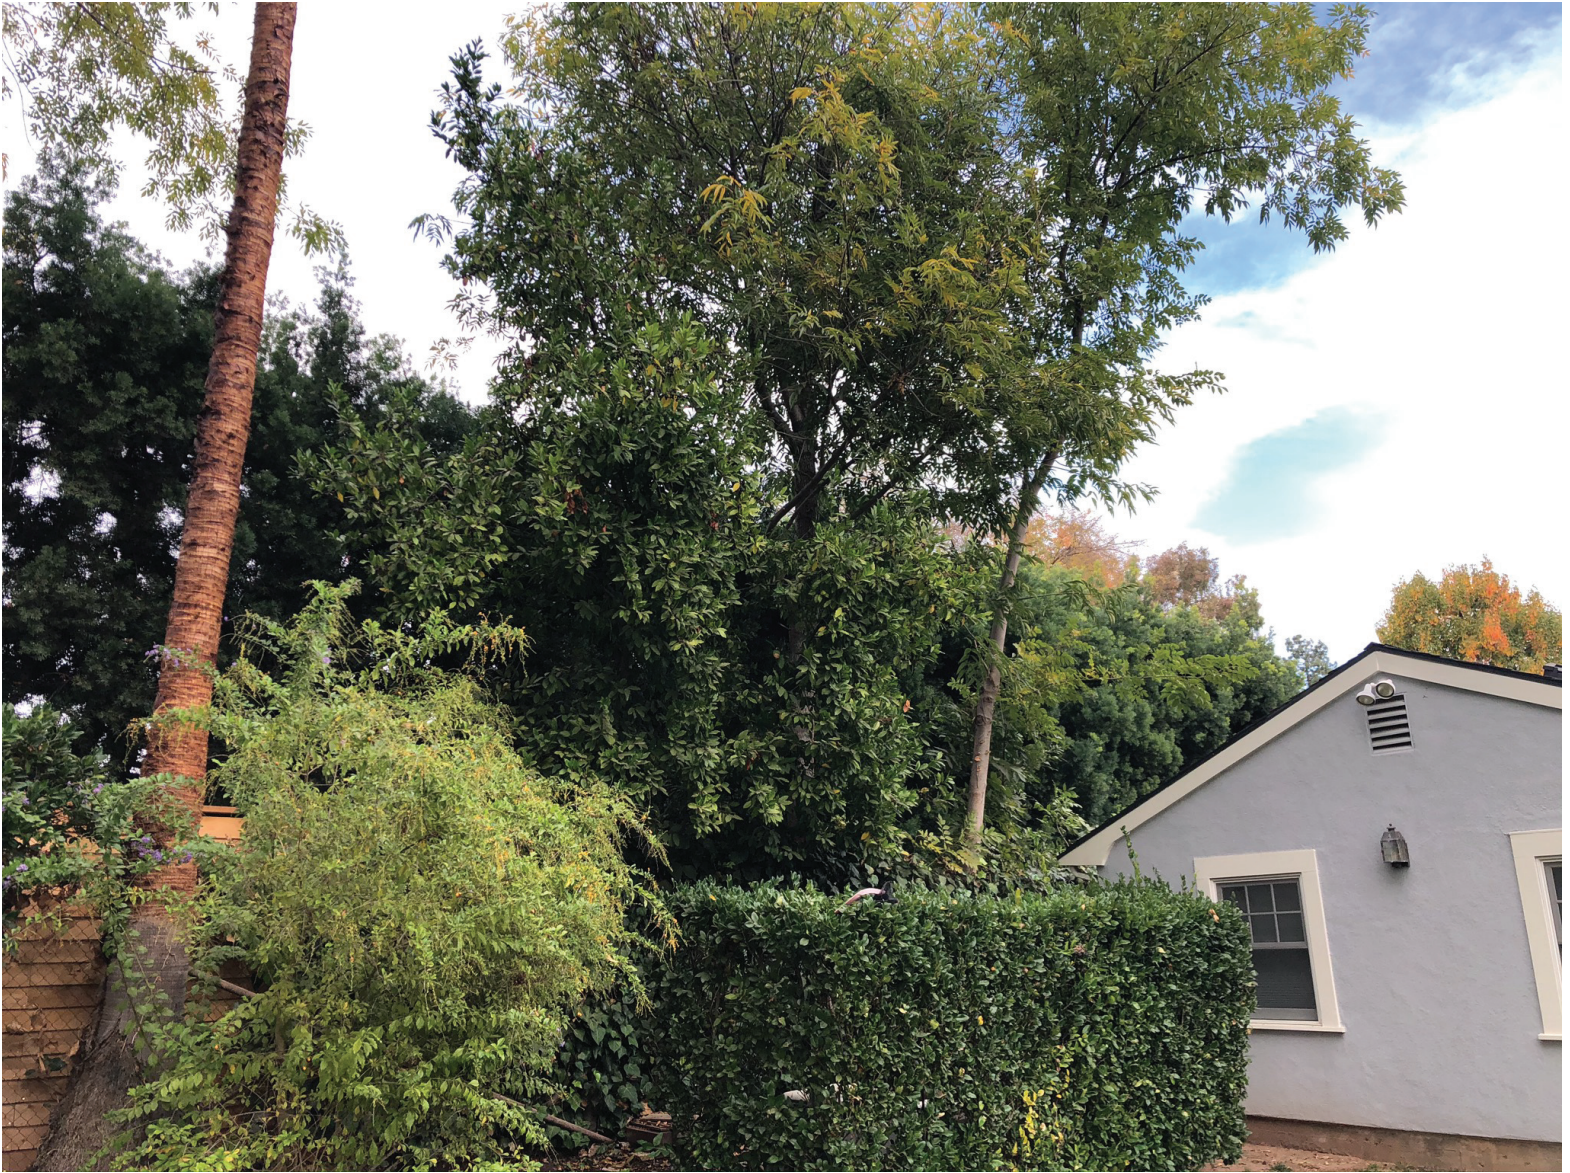
Fern pine hedge in background of shot – Ash trees 49 and 50 in foreground

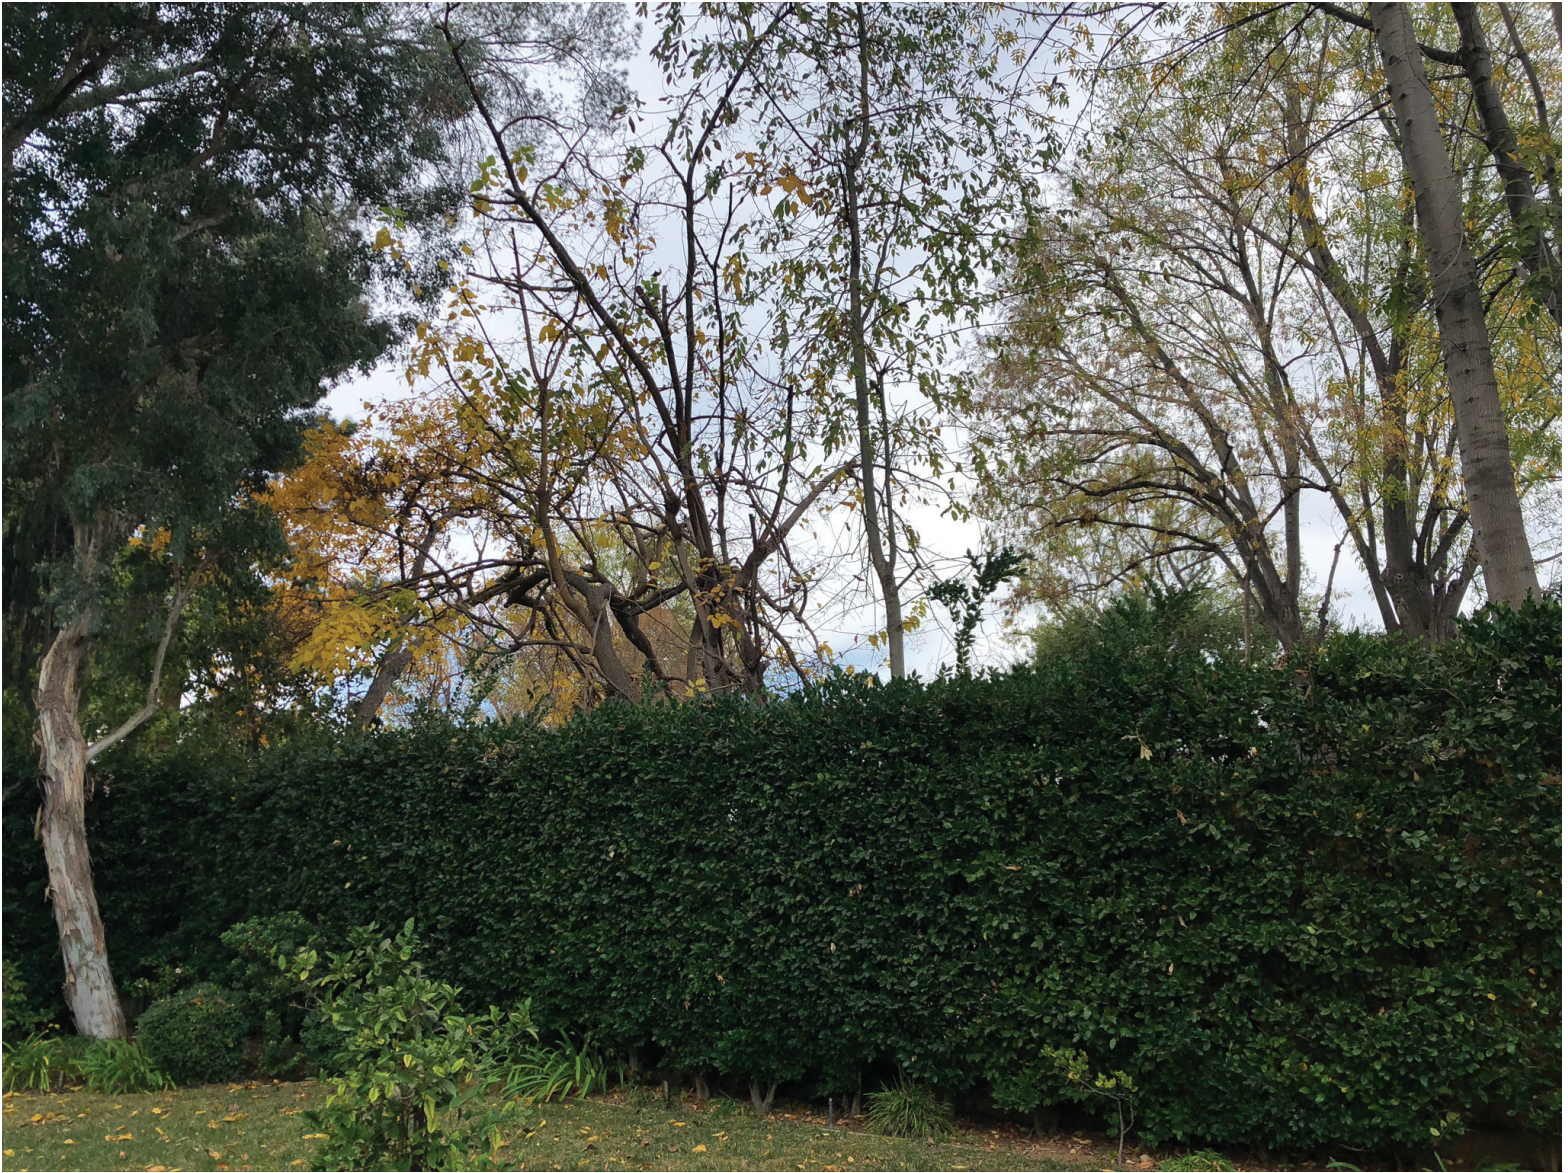
OP 42 – Silver Dollar Eucalyptus in left corner – Screening trees 39-44 at 801 S San Rafael

1. The applicant provides permanent plantings maintained at approximately 13 feet tall to screen the new Accessory Structure #3 wall facing 815 S. San Rafael in the 10-foot side yard setback.

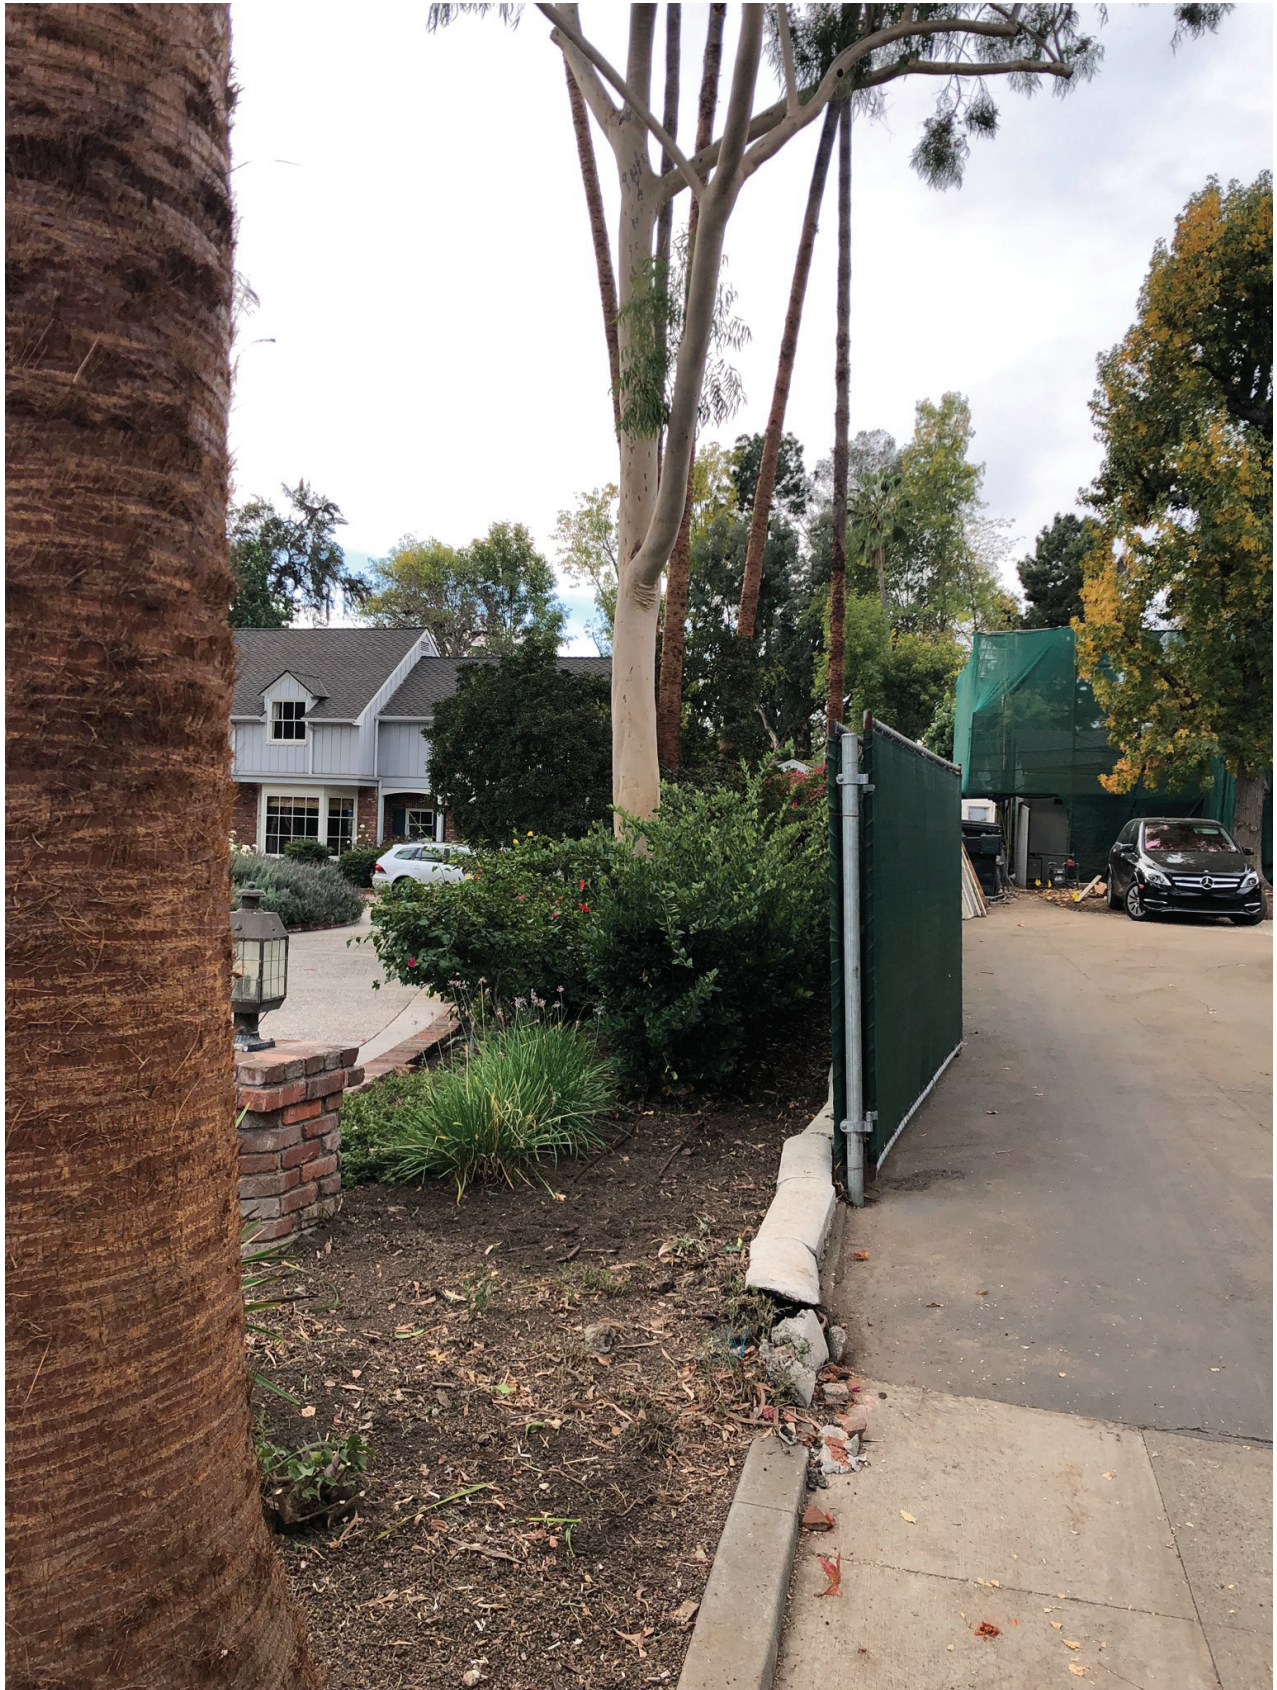
Proximity of two dwellings

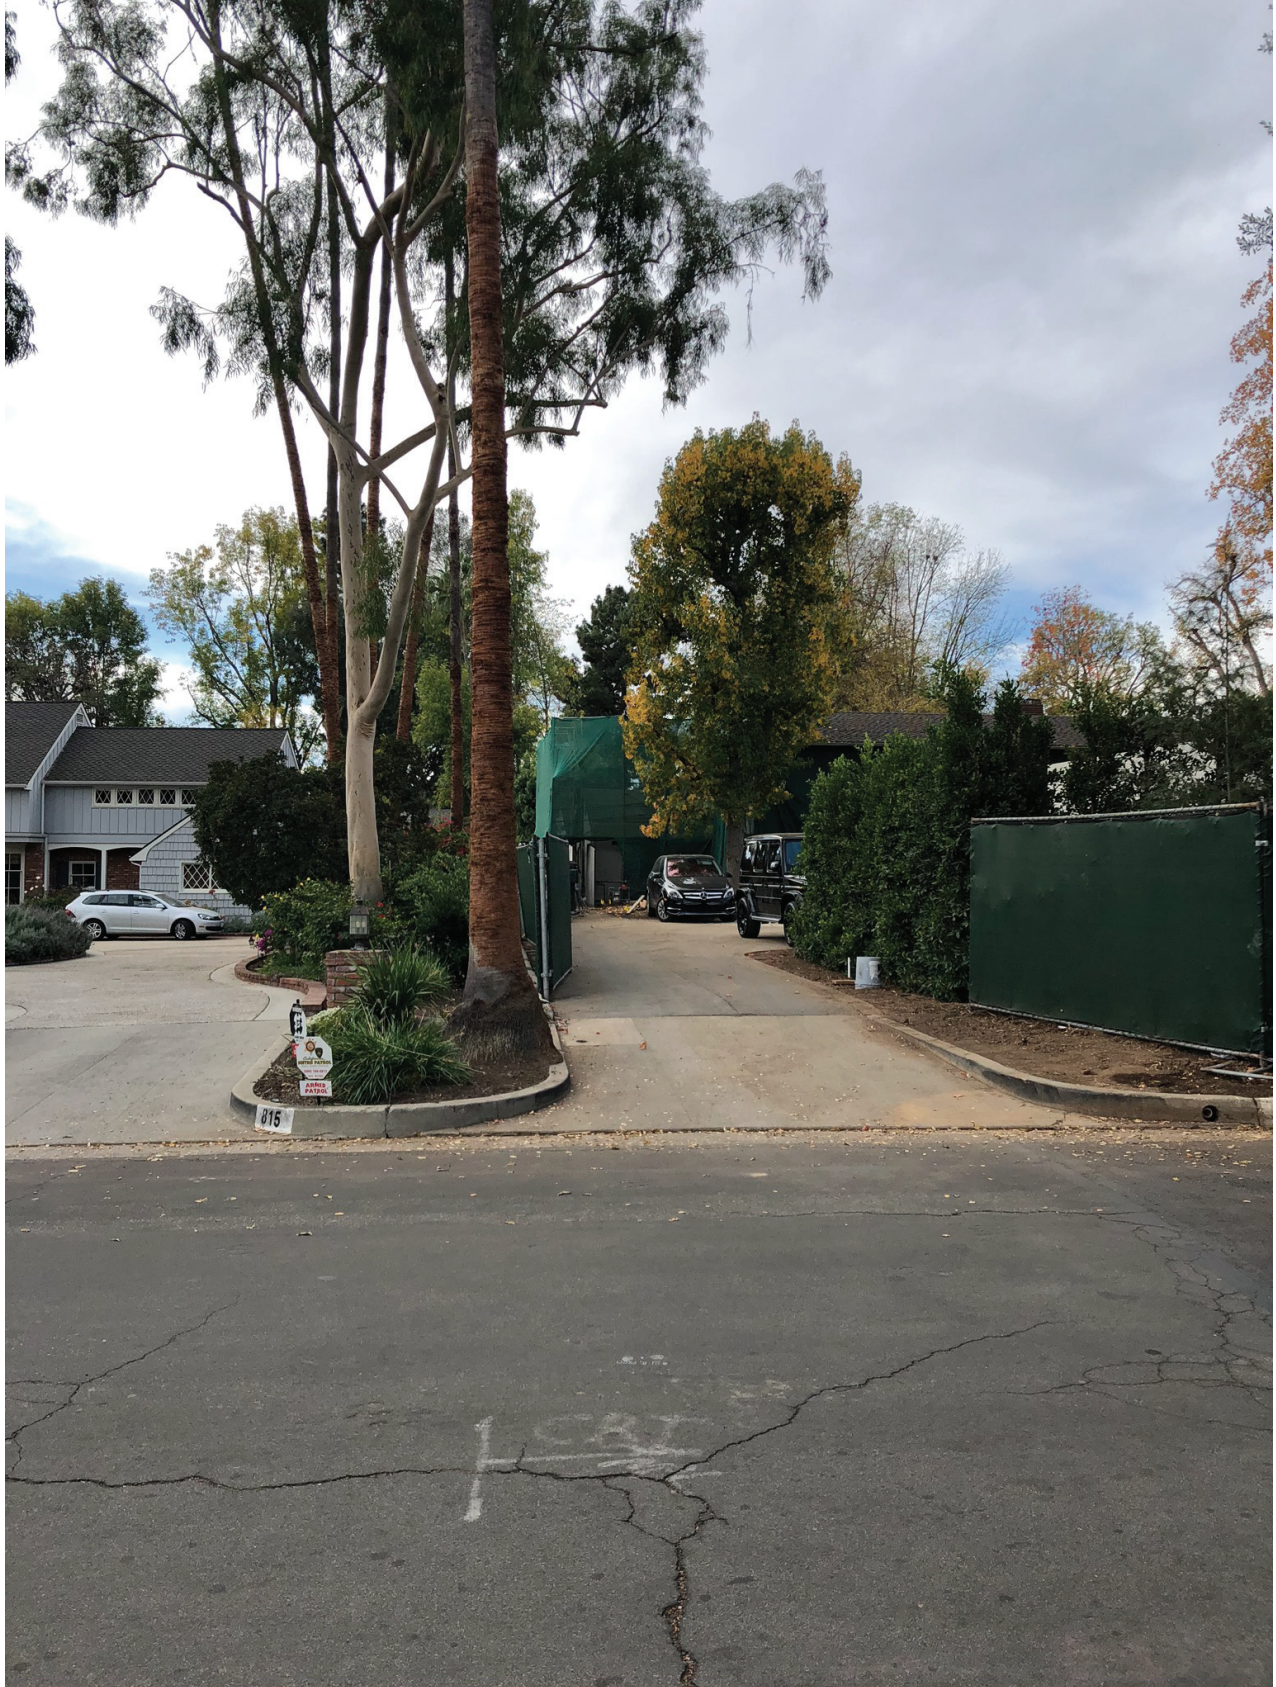
Car parked next to trunk of Tree #15 in front yard

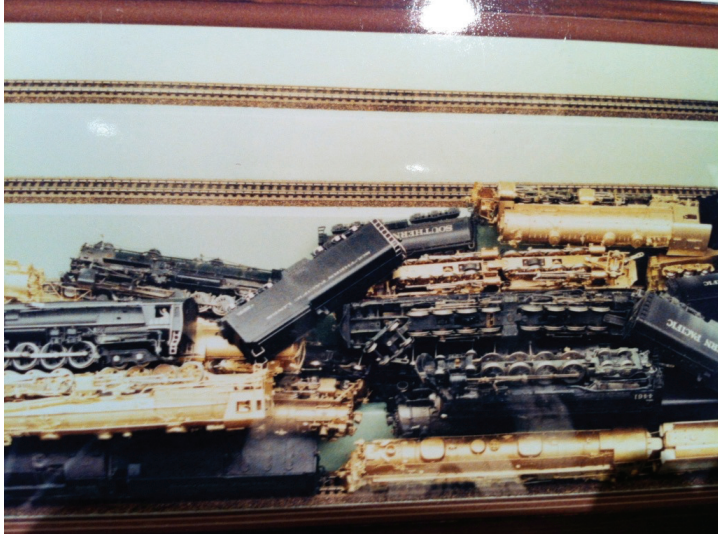
There is wire installed on each shelf that runs along the front of each track. Bob added this restraint system in hopes of preventing the models from falling off their shelves and suffering catastrophic damage in the event of a major earthquake. The wire was installed in 2007 and replaced plexiglass doors along the front of the cases. The doors had clouded and yellowed over time. More importantly, in the Northridge quake, they seemed unhelpful, as trains fell off the tracks and piled up on top of each other against the doors.

[Photo of Northridge earthquake "train wreck" below]

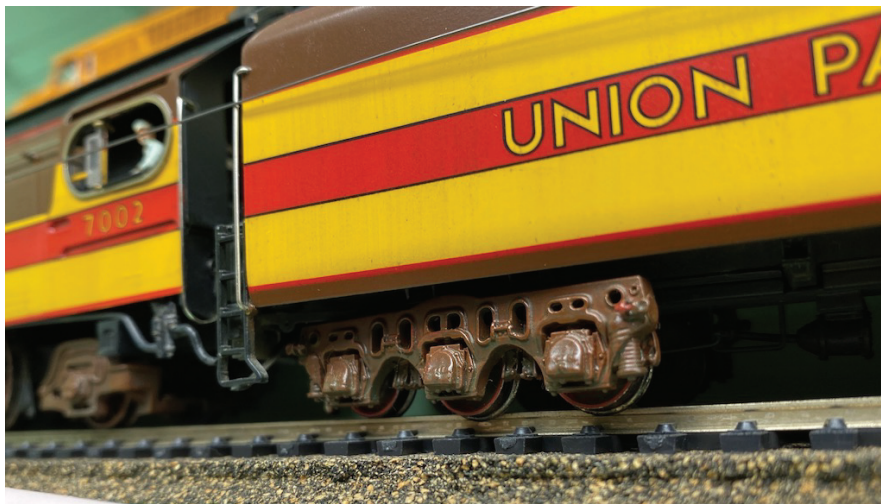
Leaving the risk of a model falling off its track aside, when models are jostled even slightly, the wheels can come off their tracks. The photo shows such a “derailed” train.

[photo of derailed train car below]

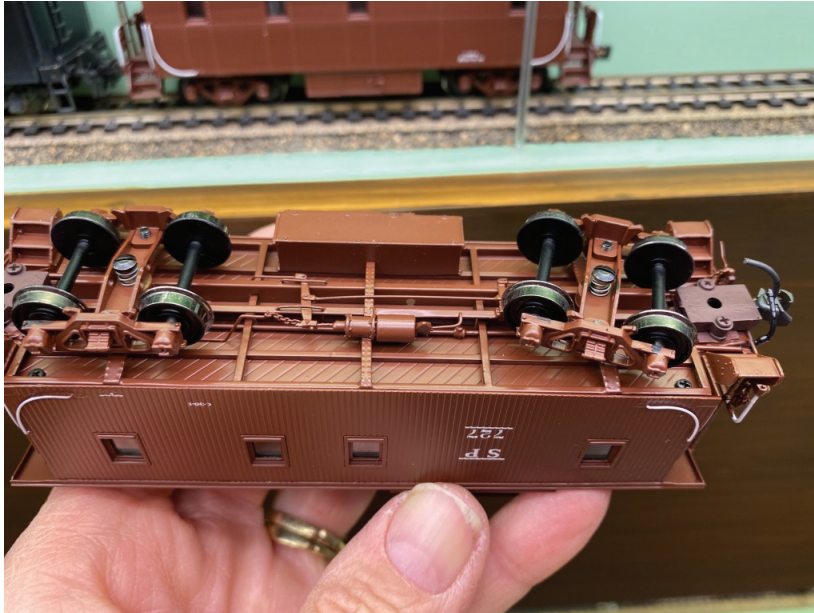
Each set of wheels on models pivots around a very small pole on the underside of the model that holds the wheels in place as shown below.

Each set of wheels consists of several wheels. If a derailed train's wheels are not put back on the tracks, the model can become unbalanced and damaged. It's a bit like parking only one side of a car on a curb. Whenever a model's wheels come off the tracks, they need to be put back on the tracks. Repositioning wheels on tracks is laborious, time consuming and requires special skill.

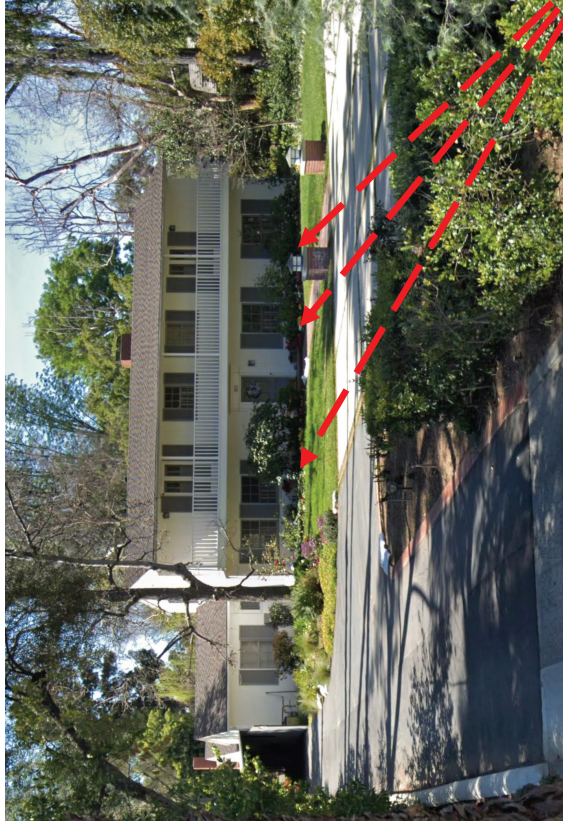
North Façade

Front windows changed to doors
