**RACHLIN PARTNERS**  
 8640 National Boulevard  
 Culver City, CA 90232  
 310-204-3400

**This Old House, LLC**  
 8640 National Boulevard  
 Culver City, California 90232  
 September 12, 2019

**This Old House, LLC**  
 801 South San Rafael Avenue  
 Pasadena, California 91105

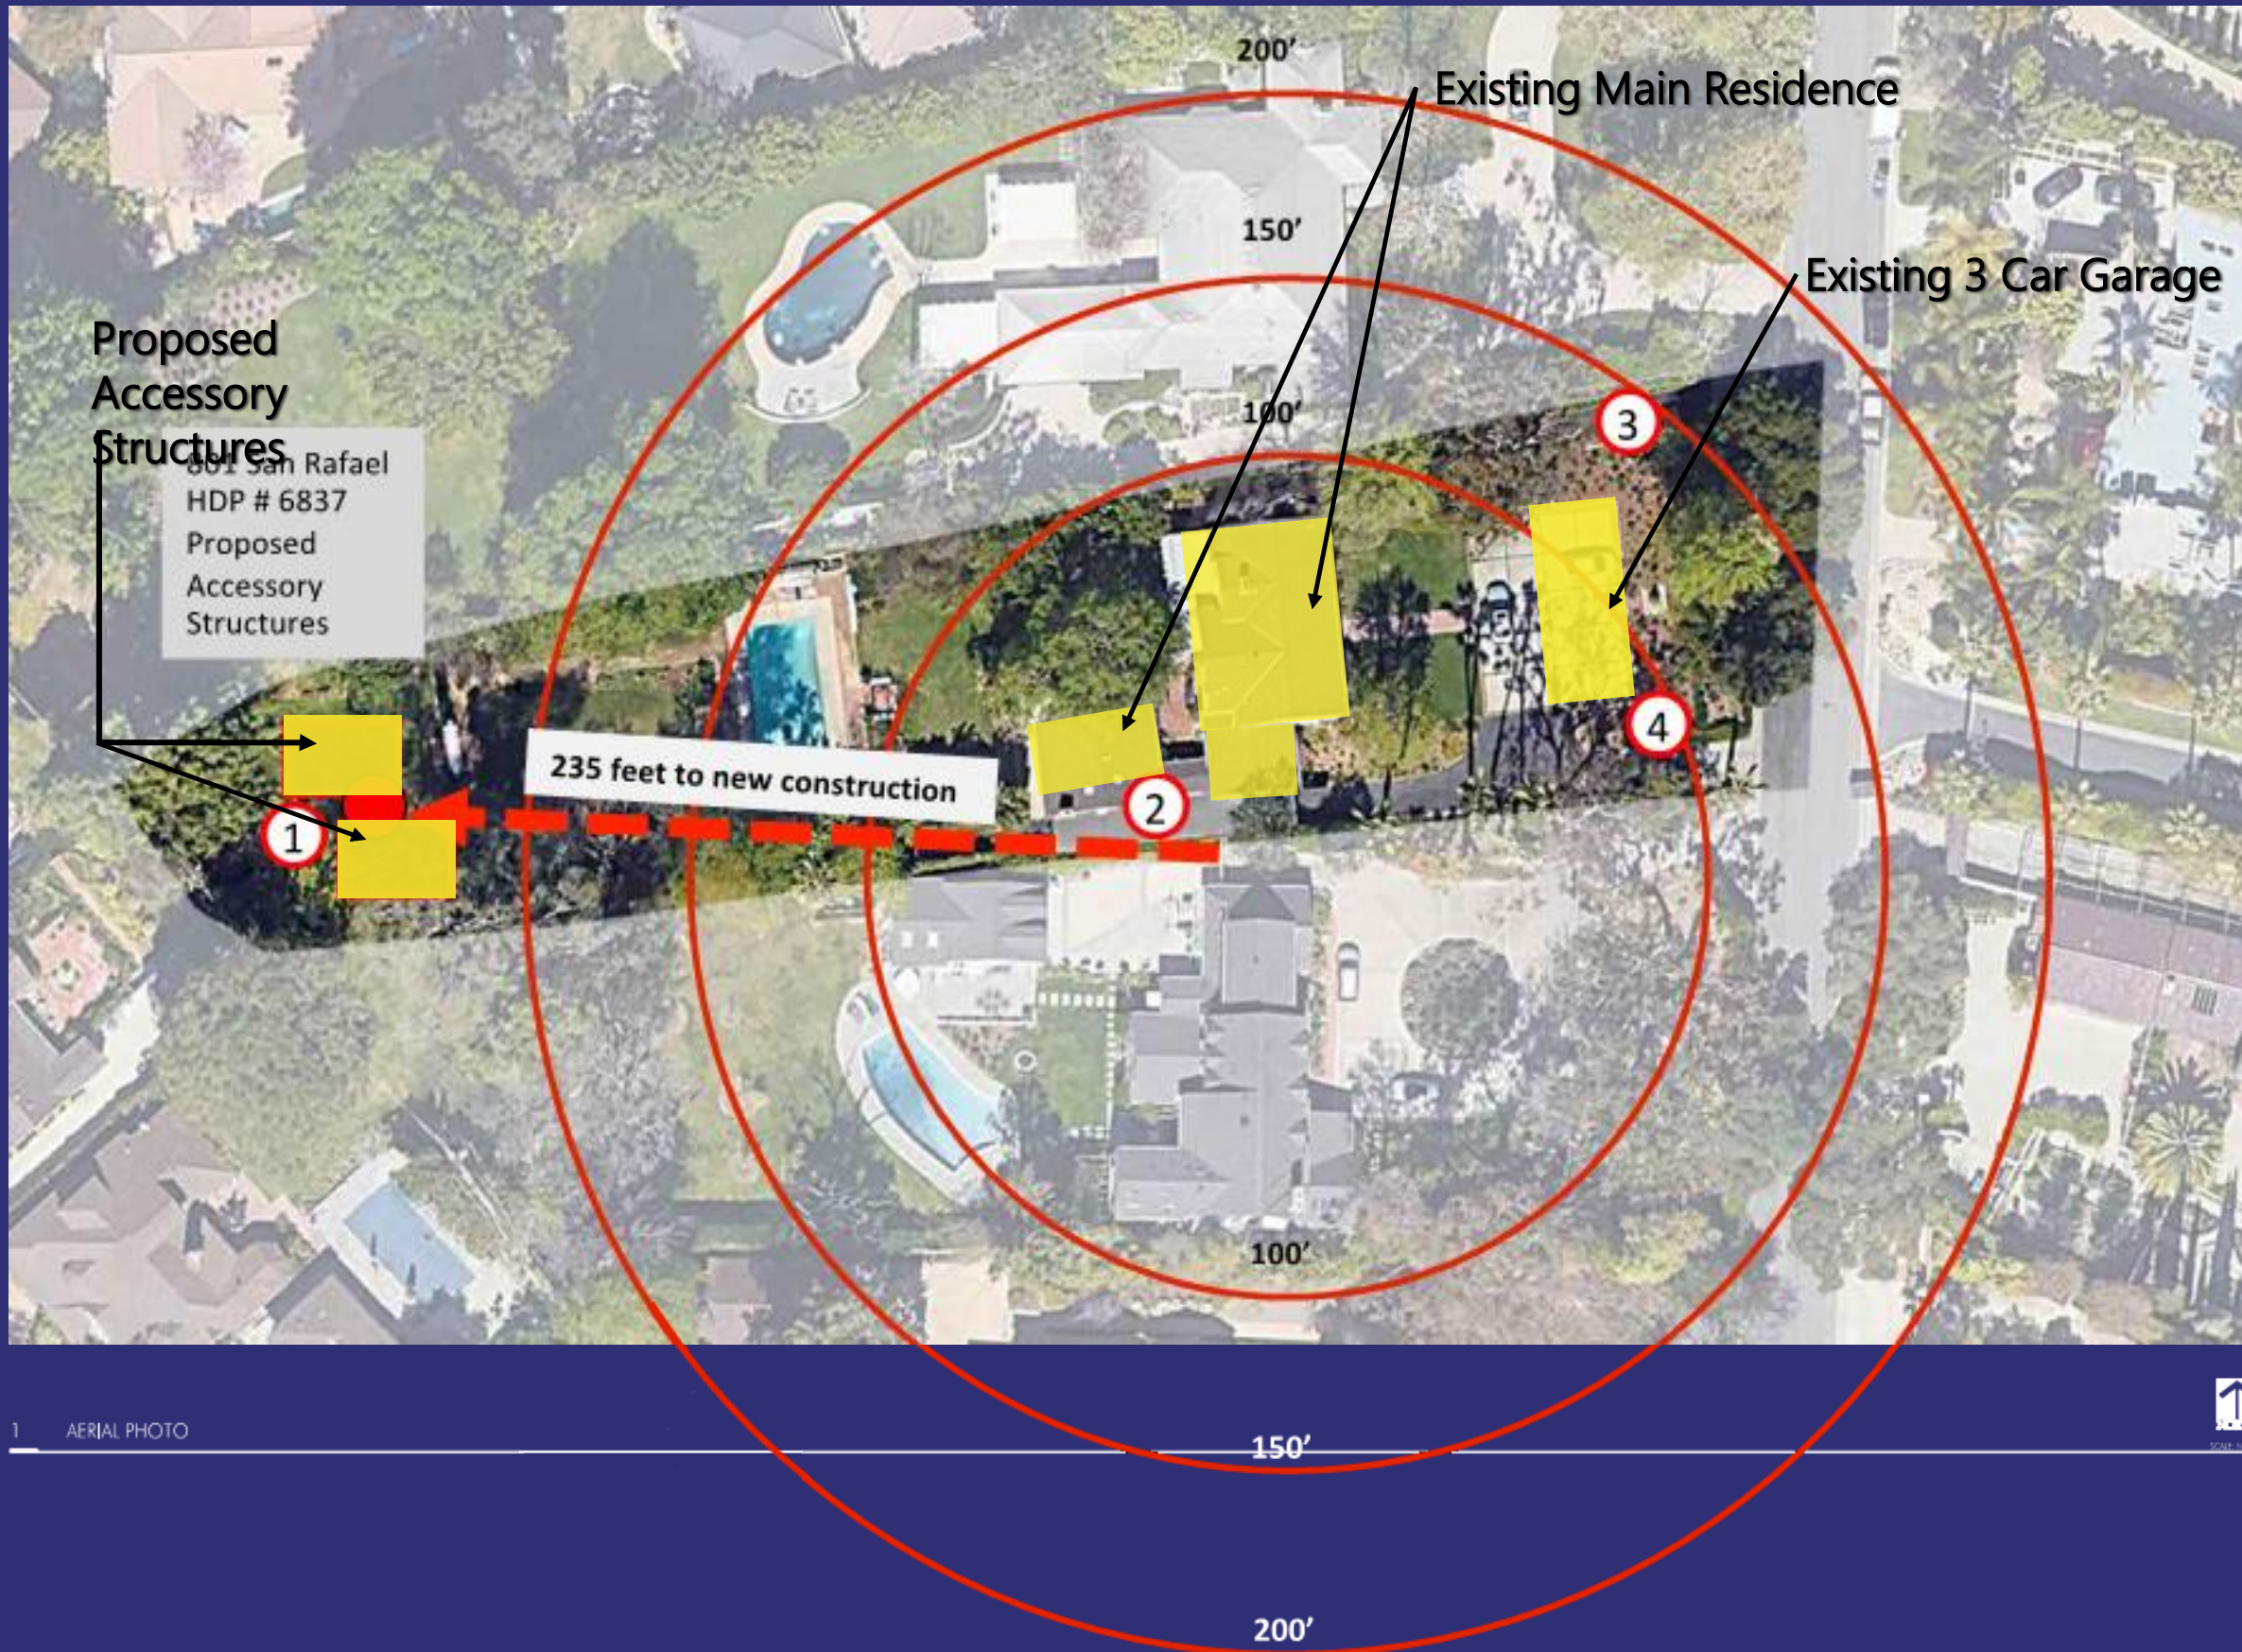
1 AERIAL PHOTO

### Techniques Proposed

1. Deepened Footings Lessens Impact
2. Green Screen Dust Mitigation
3. Primary Product Offloading
4. Secondary Product Offloading

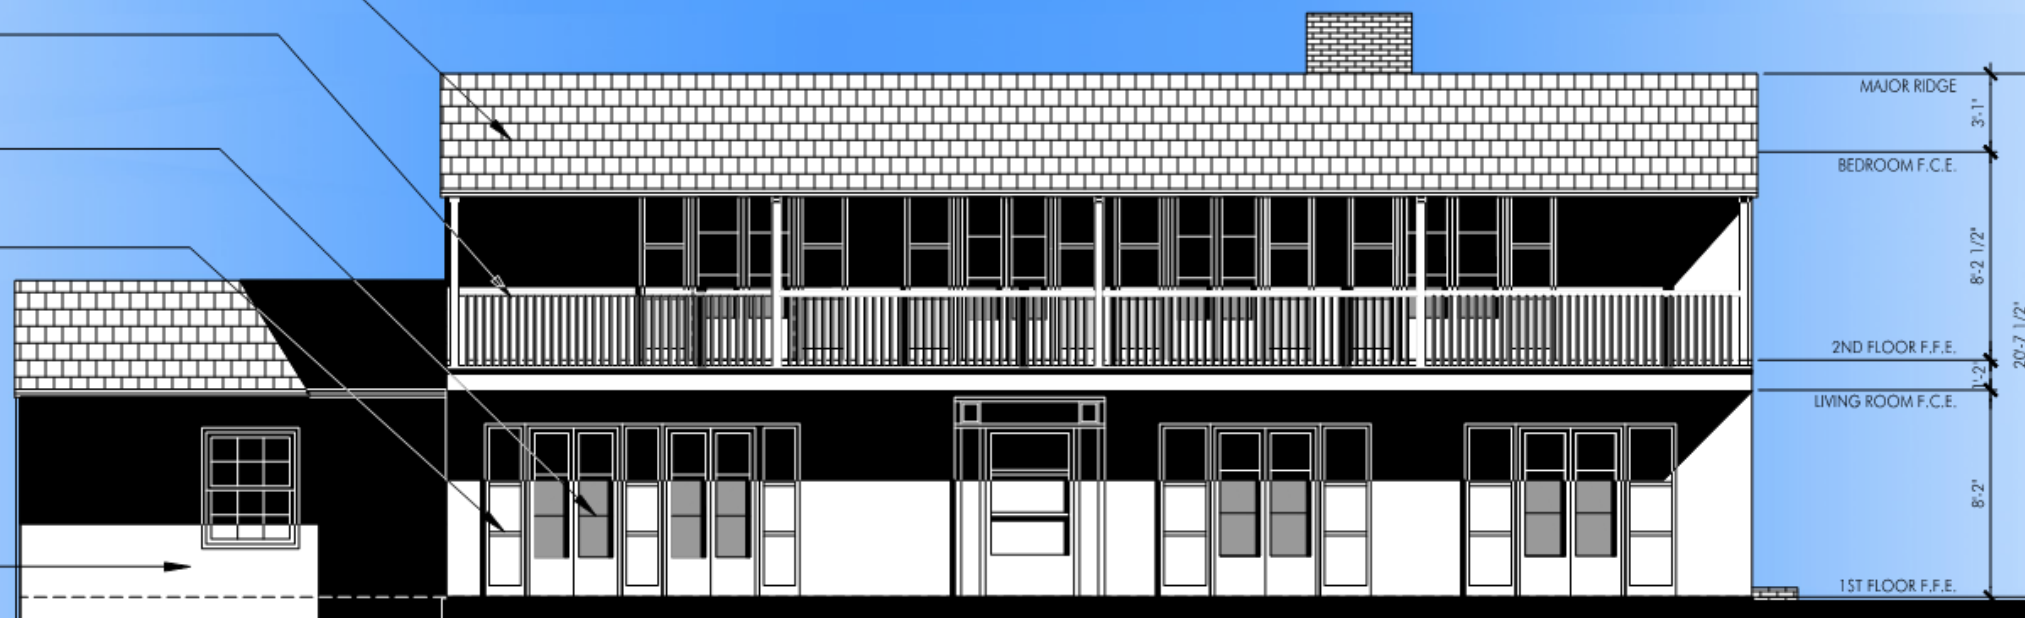
A306

North Elevation
