PROJECT NAME: <i>This Old House, LLC / San Rafael Ave.</i>			EXPLORATION NO: <i>TP 01</i>		PAGE <i>1</i> OF <i>1</i>		
PROJECT NUMBER: <i>PIN 7387</i>			EXPLORATION EQUIPMENT: <i>Hand-Dug</i>				
Comments: <i>See attached Site Plan for location.</i>							
Sample Graphics	Recovery (No. of Rings)	Moisture Content (%)	Unit Dry Wt. (pcf)	Depth (ft.)	Lithologic Graphics	Logged By: <i>CLK</i>	Total Depth: <i>10.0'</i>
						Date Started: <i>August 15, 2019</i>	Top Elevation (ft.):
					Date Completed: <i>August 15, 2019</i>	Excavation Width: <i>24"x36"</i>	
LITHOLOGIC DESCRIPTION							
1	6	17	91	0		Earth Fill (ef) Silty Sand - medium brown fine- to coarse-grained, some gravel, slightly moist to moist, moderately compact, some rootlets	
2	-	8		2		Alluvium (Qa) Silty Sand - medium brown, fine- to medium-grained, clay binder, moist, moderately dense	
3	6	5	103	4		hand augered 4.0' - 10.0'	
4	6	7	119	6		7.0' - Clayey Sand - medium brown, fine- to medium-grained, moist

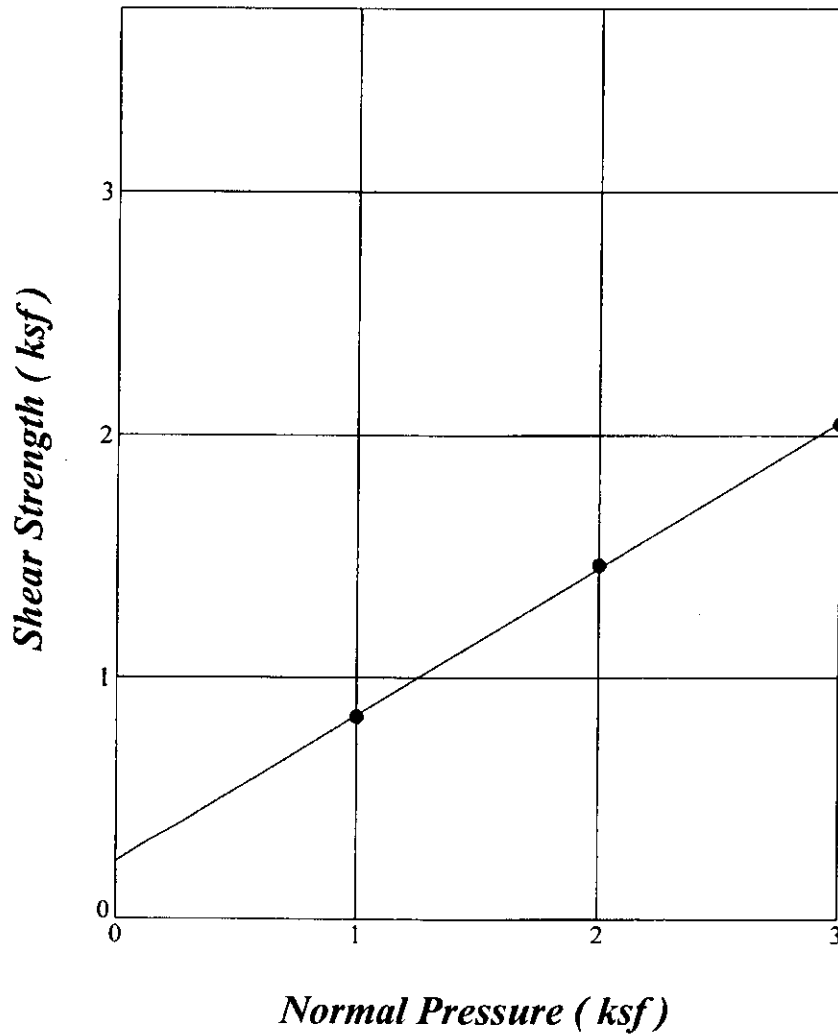
SHEAR TEST DIAGRAM

PROJECT NAME: <i>This Old House, LLC / San Rafael Ave.</i>	SAMPLE ID: <i>TP 01 @ 2.50'</i>
PROJECT NUMBER: <i>PIN 7387</i>	MATERIAL DESCRIPTION: <i>Alluvium (Qa)</i>
TEST METHOD: <i>90% Remolded Ultimate Saturated Shear</i>

MOISTURE CONTENT (%)	DENSITY (pcf)	RESULTS
In Situ: 8.4	Dry Density:	Phi (deg.): 31.0
Saturated: 22.0		Cohesion (ksf): 0.245

Direct single-shear tests were performed on representative undisturbed samples to determine their strength characteristics. The desired normal load was applied to the specimen and allowed to come to equilibrium. The rate of deflection on the sample is approximately 0.005 inches per minute. Depending upon the sample location and future site condition, samples may be tested at field moisture. The results are plotted on the Shear Test Diagrams and in the Laboratory Recapitulation - Table I. Tests are performed in accordance with the latest version of ASTM D 3080.

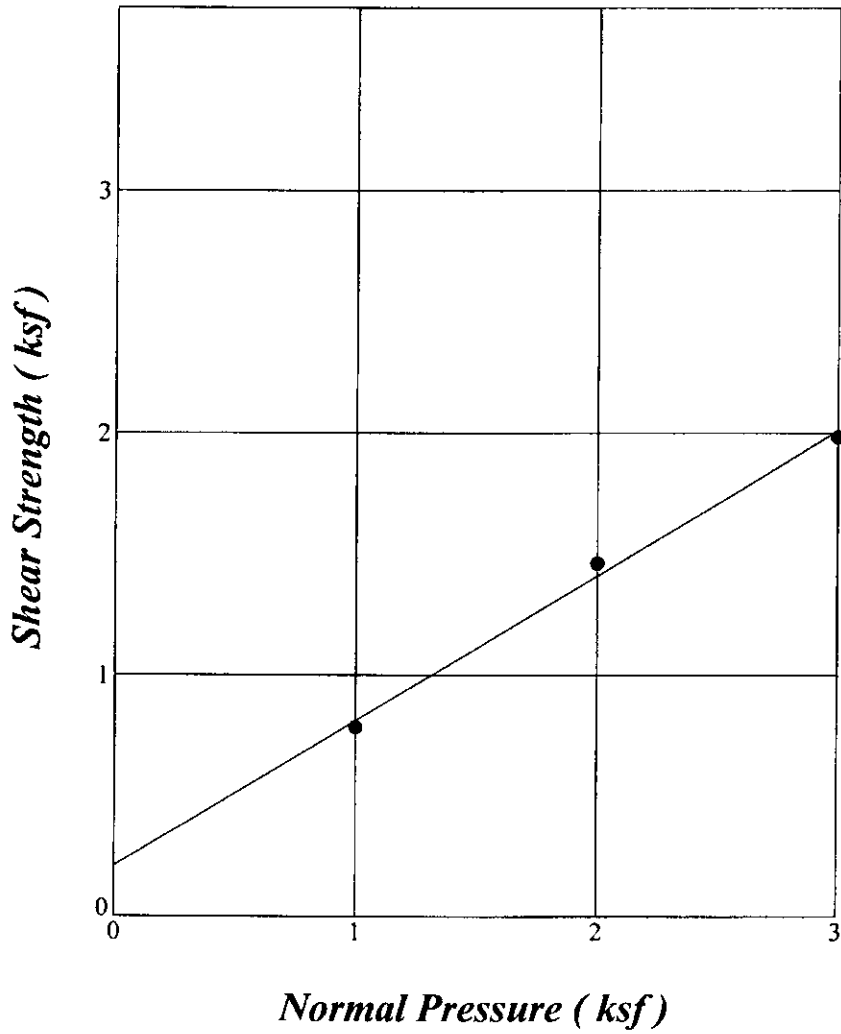
SHEAR TEST DIAGRAM

PROJECT NAME: <i>This Old House, LLC / San Rafael Ave.</i>	SAMPLE ID: <i>TP 02 @ 2.00'</i>
PROJECT NUMBER: <i>PIN 7387</i>	MATERIAL DESCRIPTION: <i>Alluvium (Qa)</i>
TEST METHOD: <i>Ultimate Saturated Shear</i>

MOISTURE CONTENT (%)	DENSITY (pcf)	RESULTS
In Situ: <i>12.7</i>		Phi (deg.): <i>31.0</i>
Saturated: <i>20.9</i>	Dry Density: <i>114.9</i>	Cohesion (ksf): <i>0.210</i>

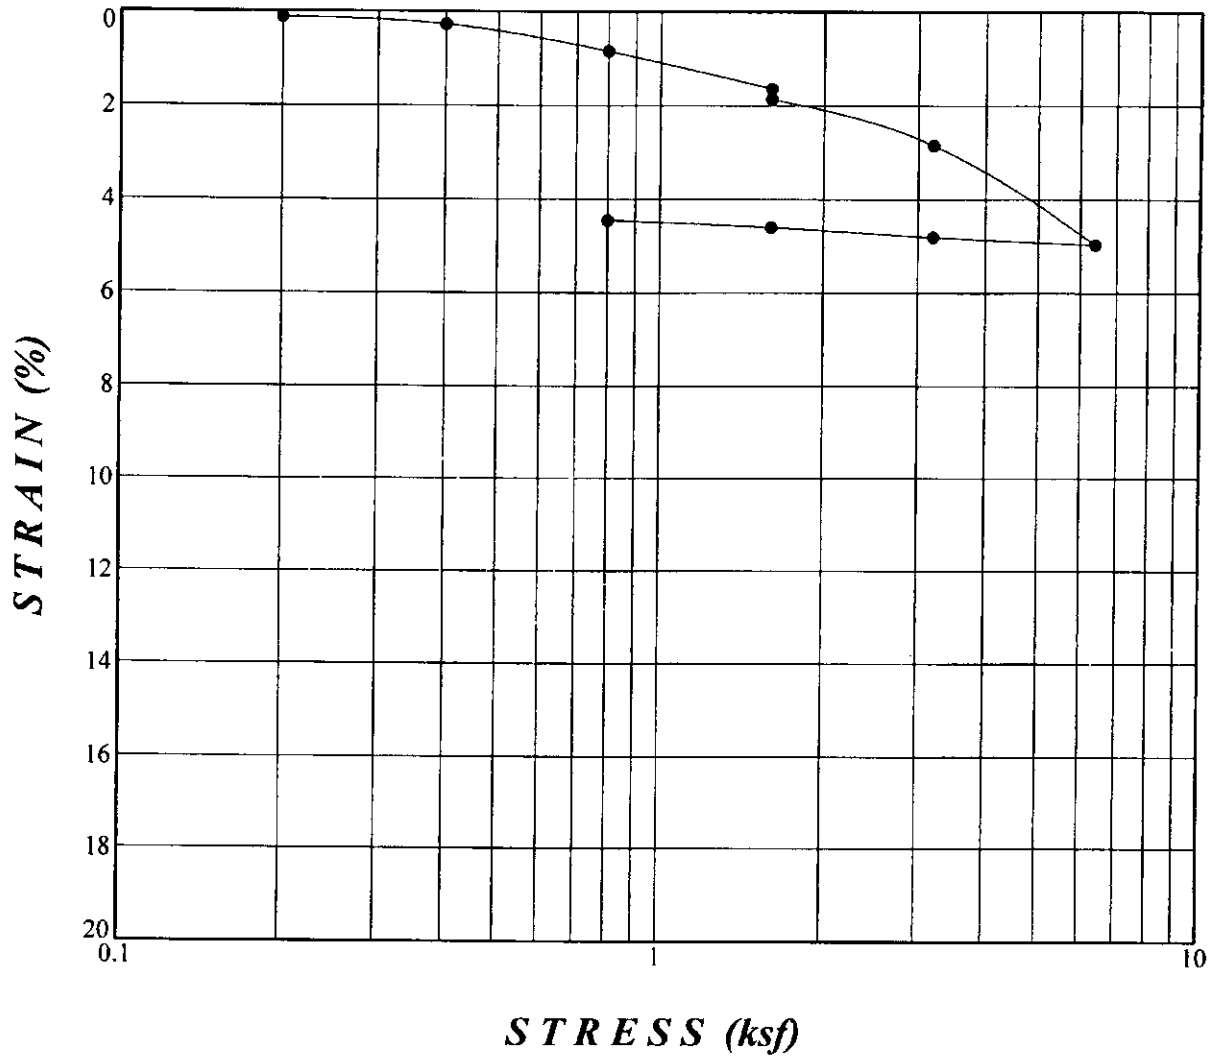
MATERIAL DESCRIPTION: *Alluvium (Qa)*

Load (psf) water added to test at: 1600

Consolidation tests were performed on undisturbed samples to predict the soils behavior under a specific load. Loads are applied in increasing load increments and the results are recorded. The samples are usually inundated at a designated load to determine the effect of water contacting the bearing soil. The results are plotted on the "Consolidation Pressure Curve," figures. The load at which the water is added is noted on the drawing. Tests are performed in accordance with the latest version of ASTM D 2435.

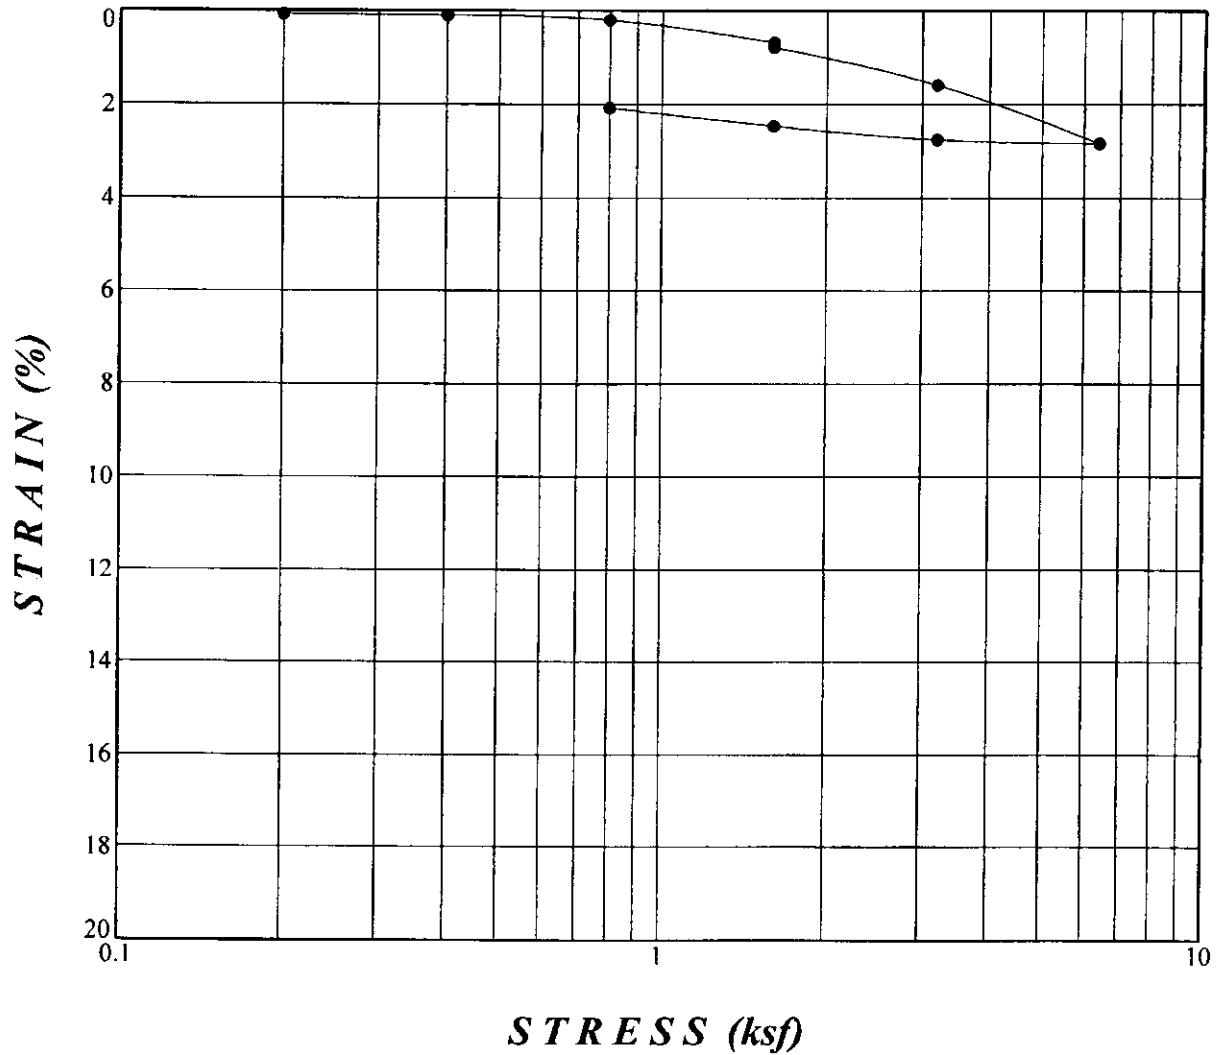
PROJECT NAME: <i>This Old House, LLC / San Rafael Ave.</i>	SAMPLE ID: <i>TP 01 @ 6.00'</i>
PROJECT NUMBER: <i>PIN 7387</i>	MATERIAL DESCRIPTION: <i>Alluvium (Qa)</i>

Load (psf) water added to test at: 1600

MOISTURE CONTENT (%)	DRY DENSITY (pcf)	RESULTS
In Situ: <i>7.2</i>	Before Test: <i>119.2</i>	Initial Void Ratio: <i>0.4306</i>

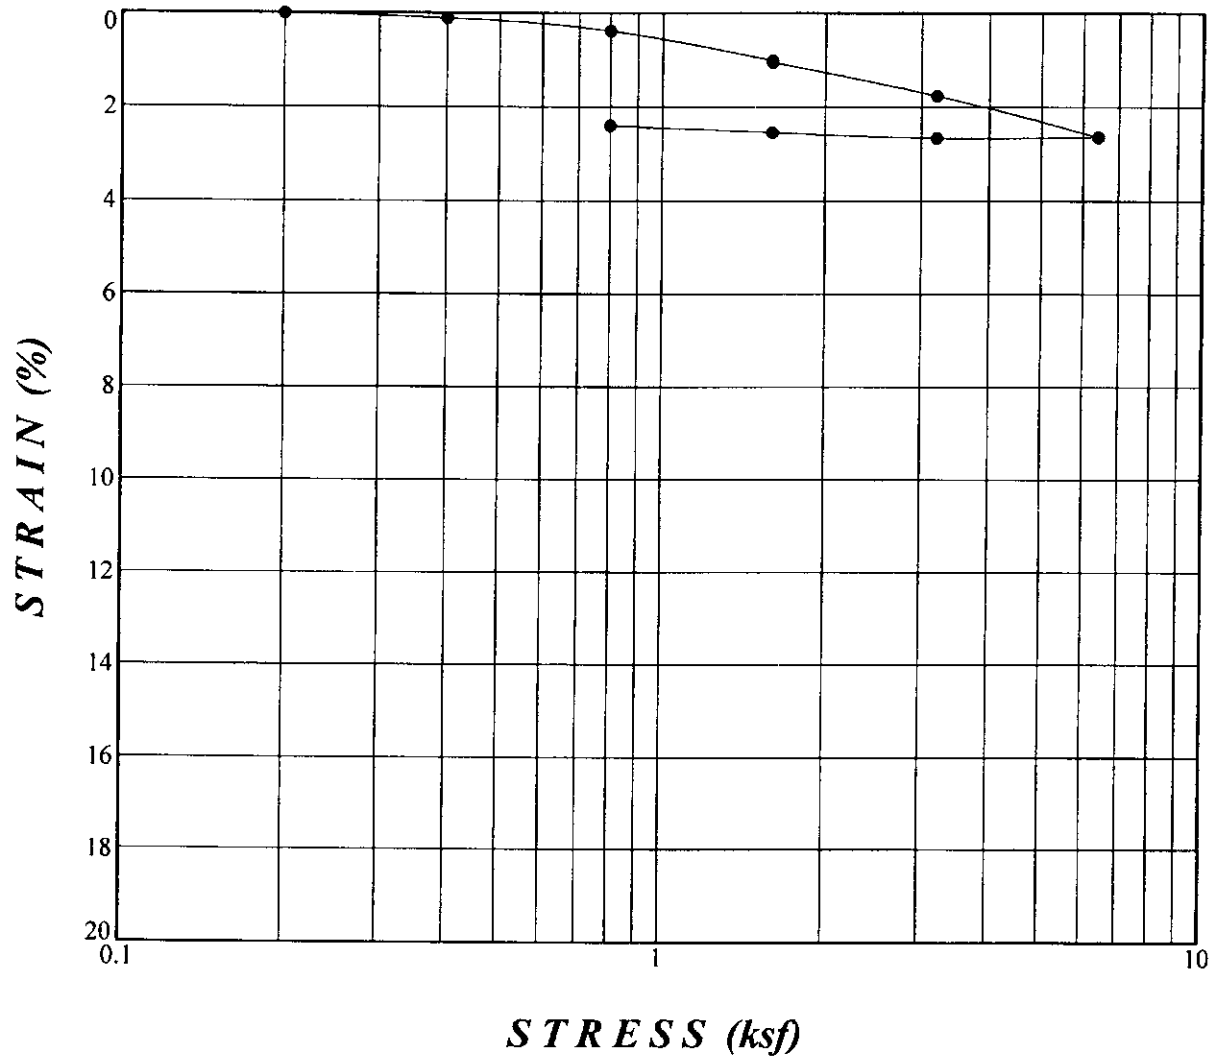
PROJECT NAME: <i>This Old House, LLC / San Rafael Ave.</i>	SAMPLE ID: <i>TP 02 @ 2.00'</i>
PROJECT NUMBER: <i>PIN 7387</i>	MATERIAL DESCRIPTION: <i>Alluvium (Qa)</i>

Load (psf) water added to test at: 1600

MOISTURE CONTENT (%)	DRY DENSITY (pcf)	RESULTS
In Situ: <i>12.7</i>	Before Test: <i>114.9</i>	Initial Void Ratio: <i>0.4661</i>

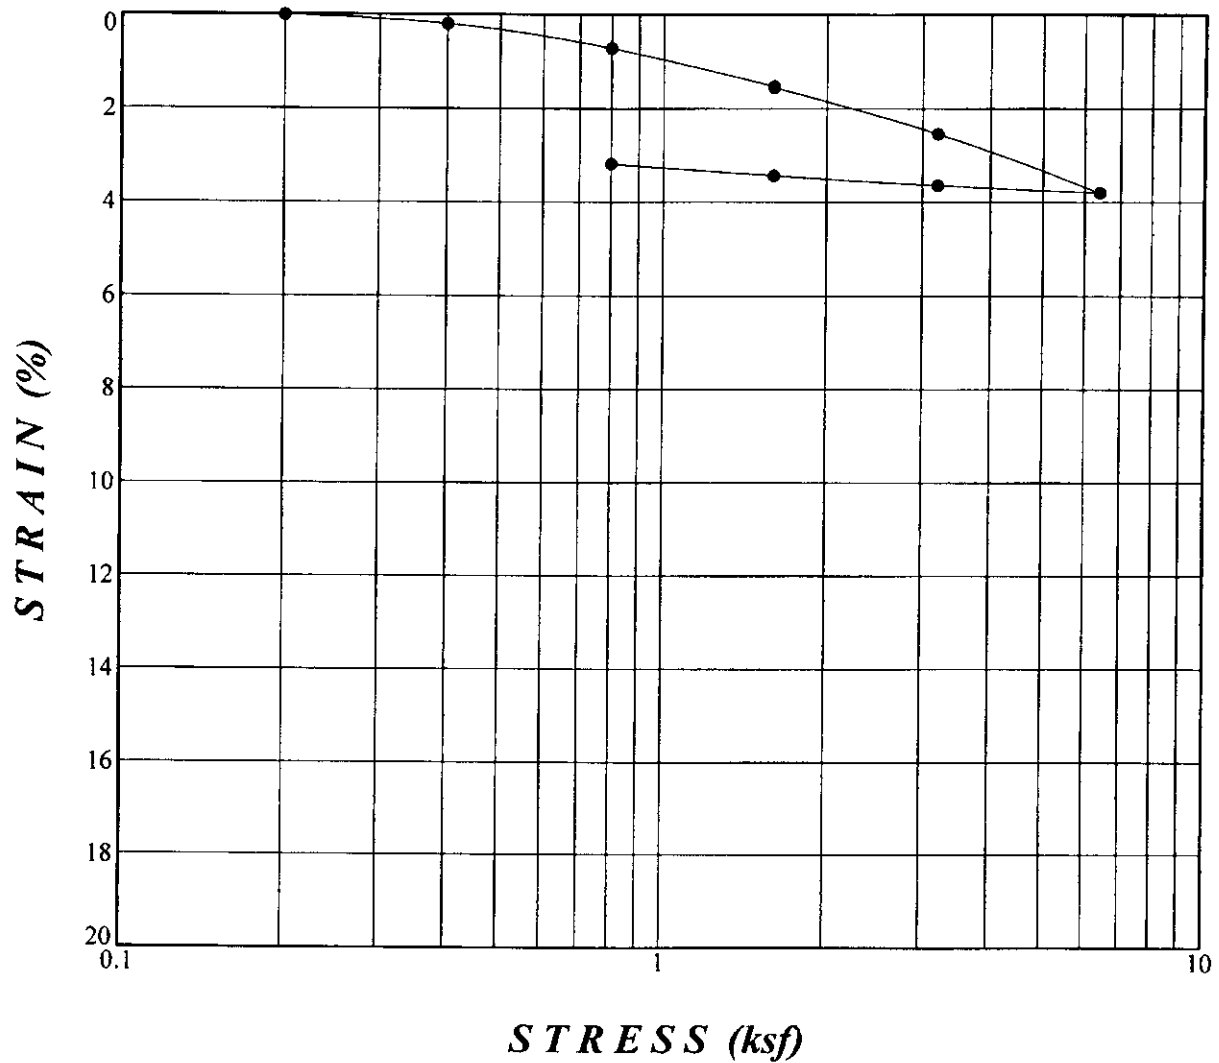
PROJECT NAME: <i>This Old House, LLC / San Rafael Ave.</i>	SAMPLE ID: <i>TP 02 @ 5.00'</i>
PROJECT NUMBER: <i>PIN 7387</i>	MATERIAL DESCRIPTION: <i>Alluvium (Qa)</i>

Load (psf) water added to test at: 1600

MOISTURE CONTENT (%)	DRY DENSITY (pcf)	RESULTS
In Situ: <i>6.0</i>	Before Test: <i>122.8</i>	Initial Void Ratio: <i>0.3721</i>
