Techniques Proposed

This Old House, LLC
 8640 National Boulevard
 Culver City, California 90232
 September 12, 2019

Exterior Elevations

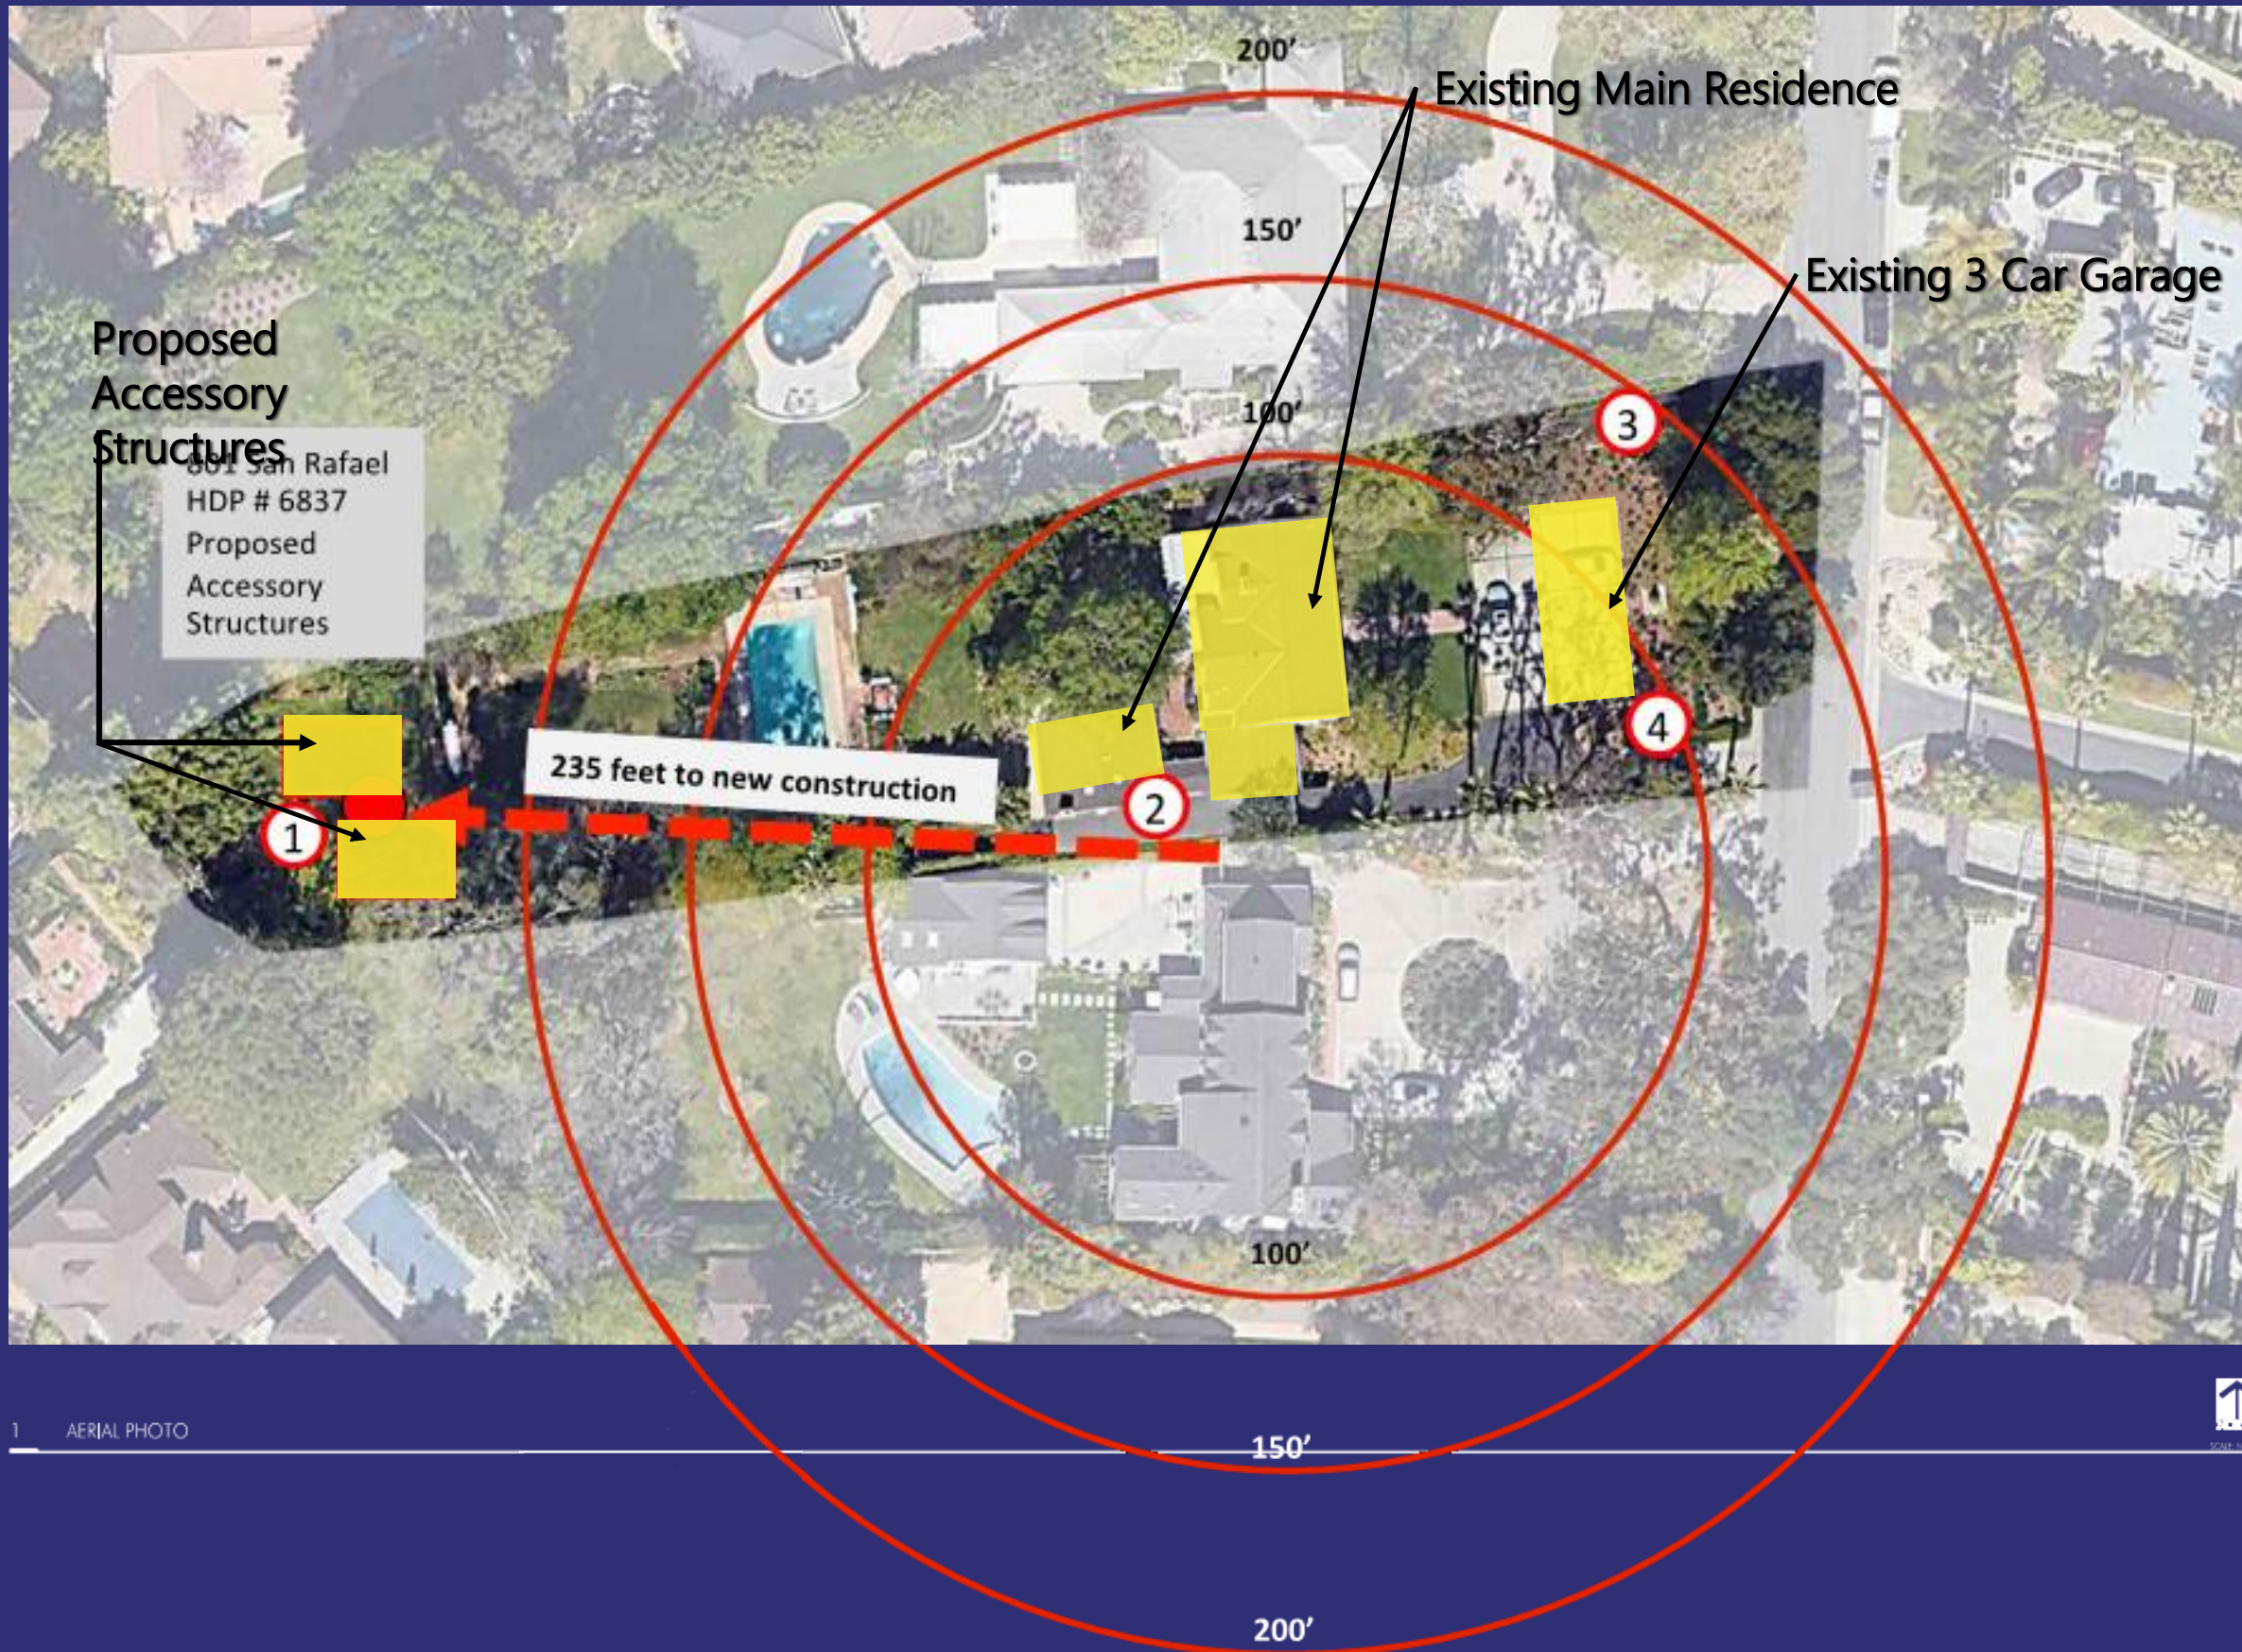
1 AERIAL PHOTO

1. Deepened Footings Lessens Impact
2. Green Screen Dust Mitigation
3. Primary Product Offloading
4. Secondary Product Offloading

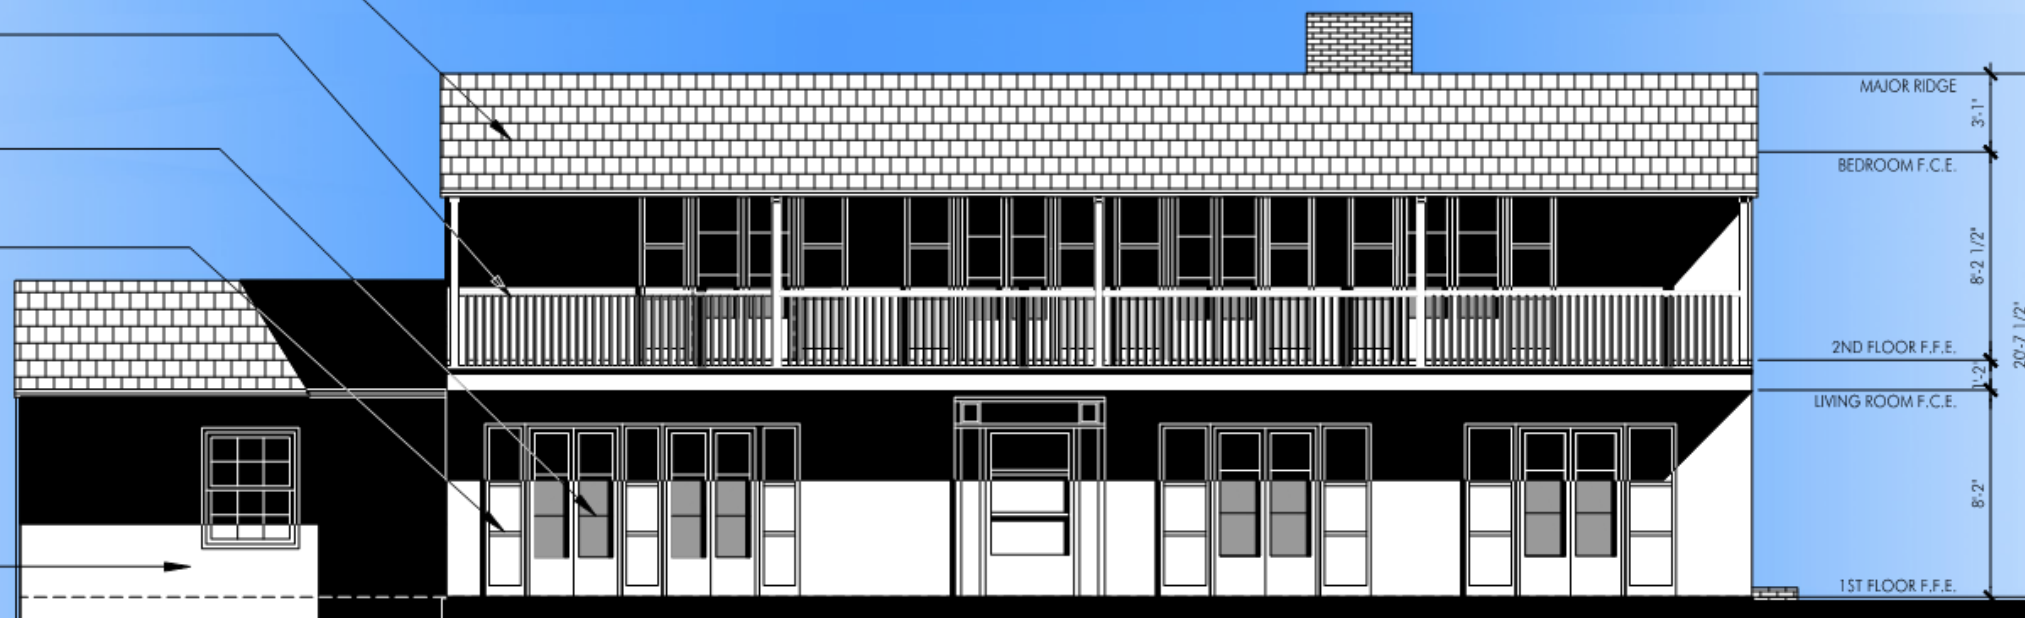
A306

North Elevation
