# Assisted Living Building

Building 32

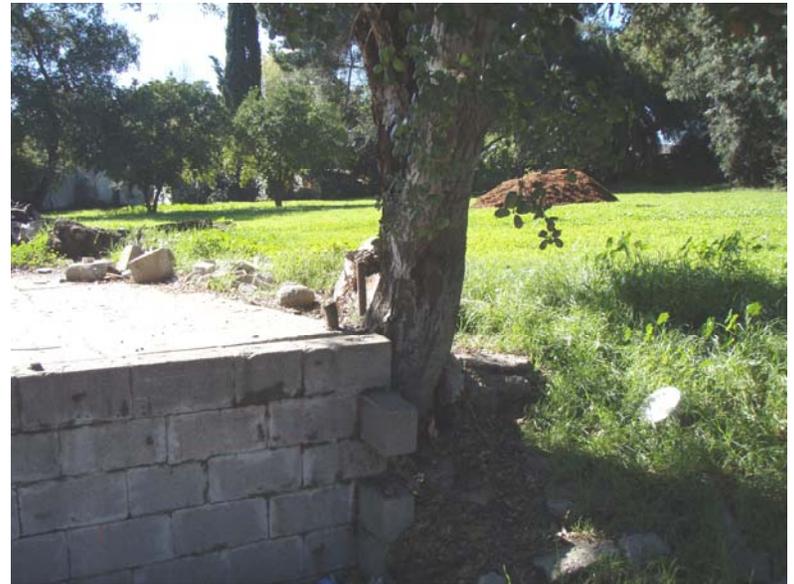
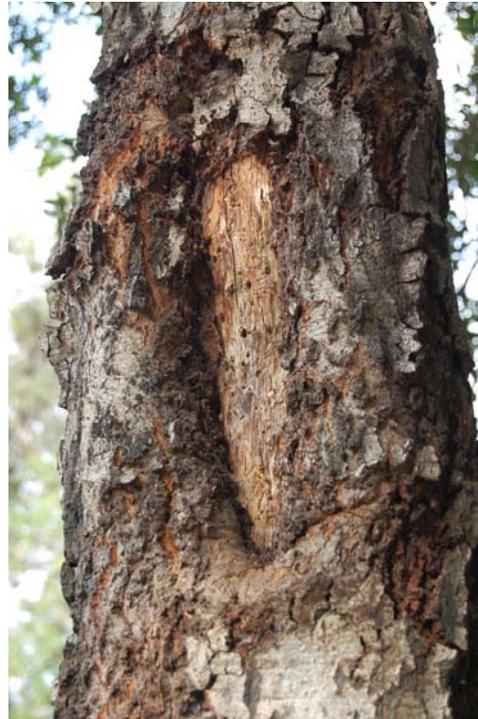
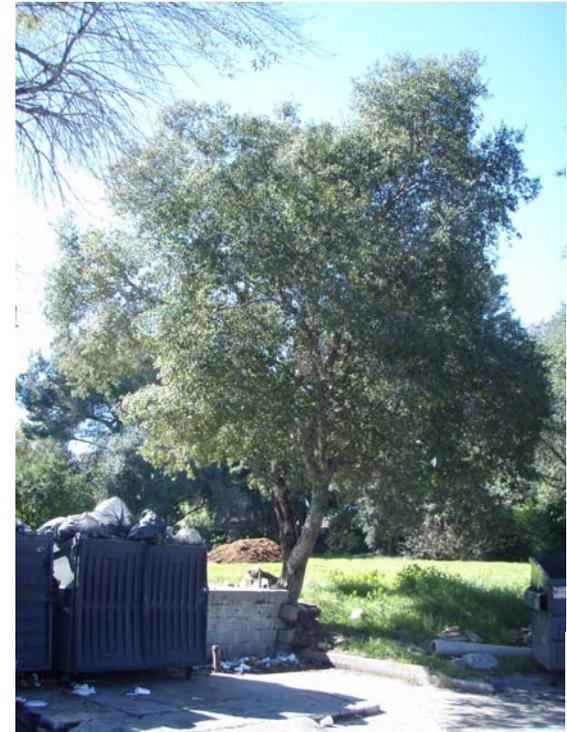
Wounded at base of trunk.

Demolition and construction will be very difficult.

Staff Recommendation:  
Remove.

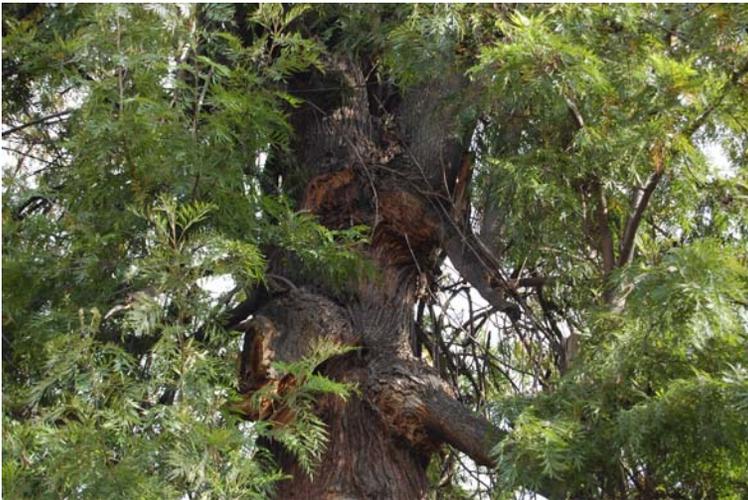
Topped.

Very poor structure.

Staff Recommendation: Remove.

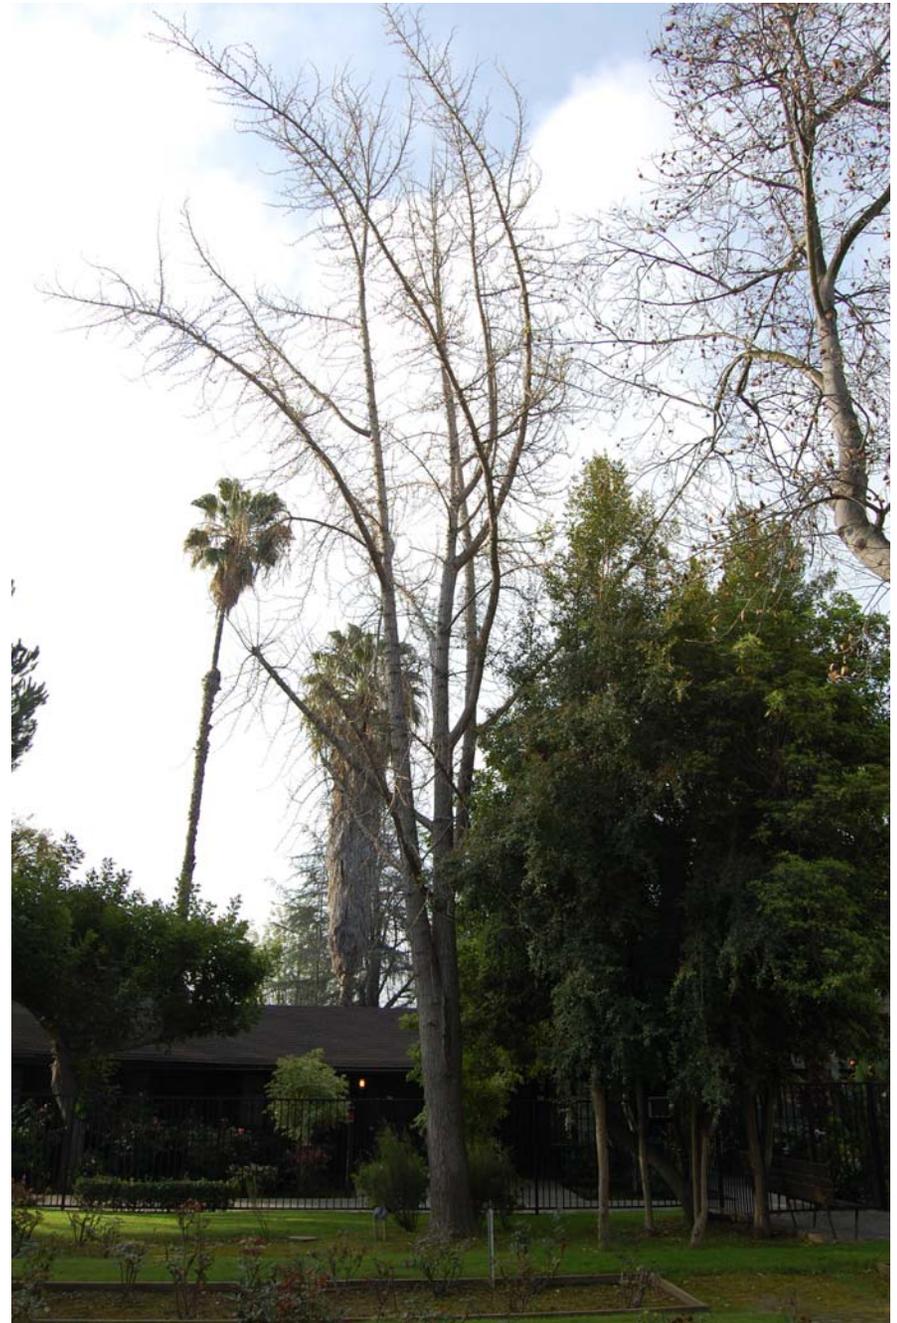
Staff Recommendation: Retain  
Good health and structure.

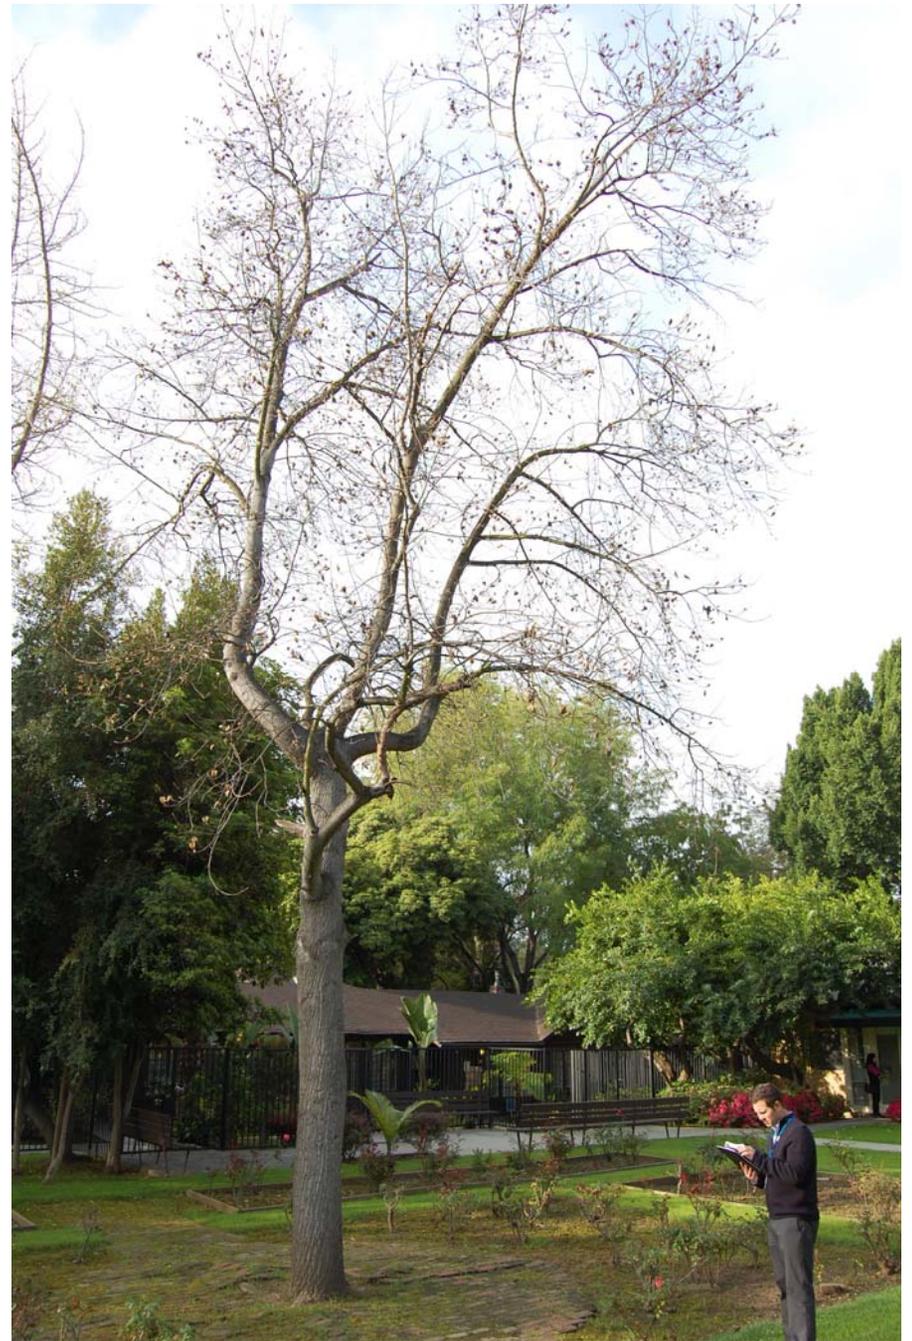
Tree Number: 666

Good health and structure.

Staff Recommendation: Retain

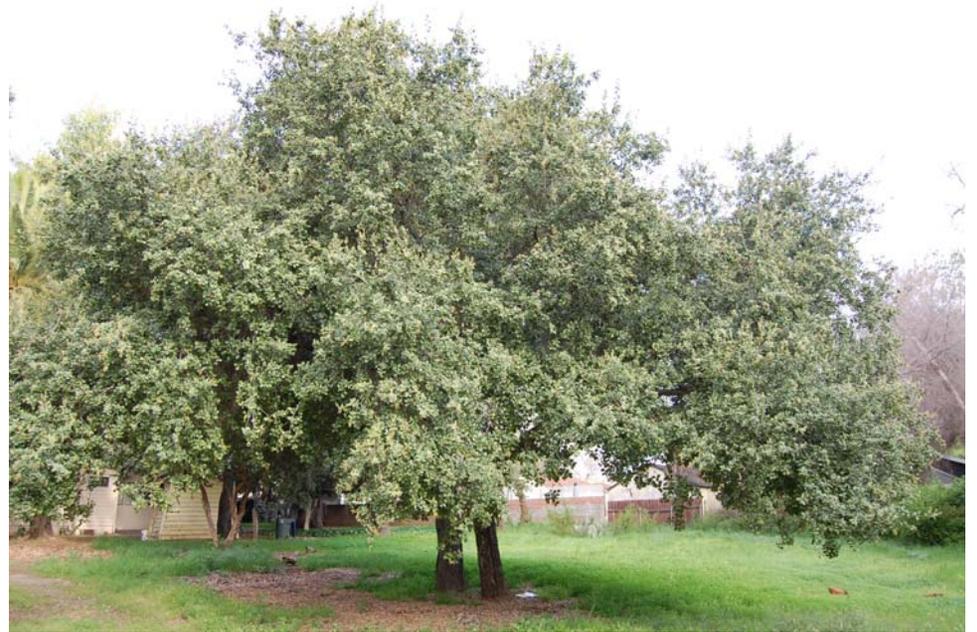
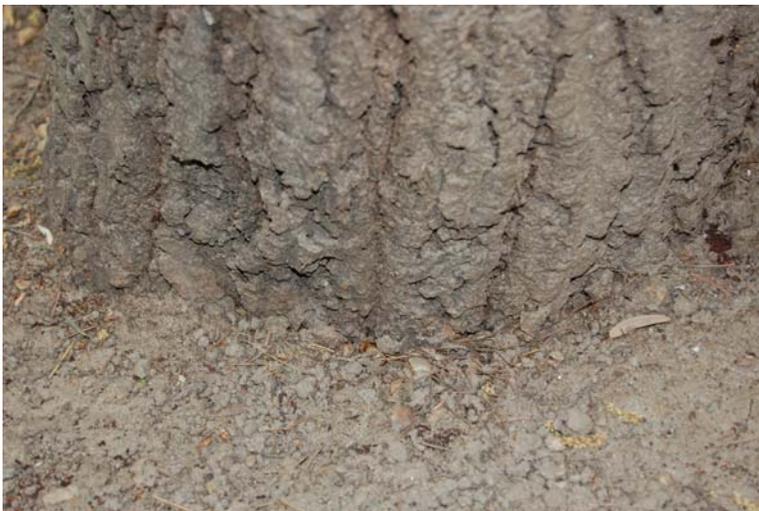
Little canopy due to adjoining tree's shade.

Roots could be strangling other tree.

Staff Recommendation: Retain

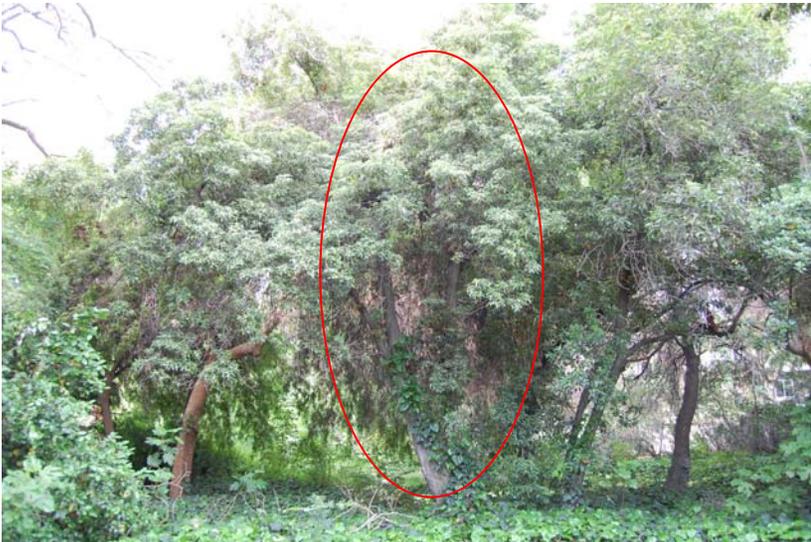
Crowded.

In the path of required fire road.  
Better to give more room from  
tree 619, a London Plane Tree.

Staff Recommendation: Remove.
